**ANIMAL VEHICLE CRASH  
MITIGATION USING  
ADVANCED TECHNOLOGY  
PHASE I: REVIEW, DESIGN AND  
IMPLEMENTATION**

**Final Report**

**SPR-3(076)**

**August 2006**

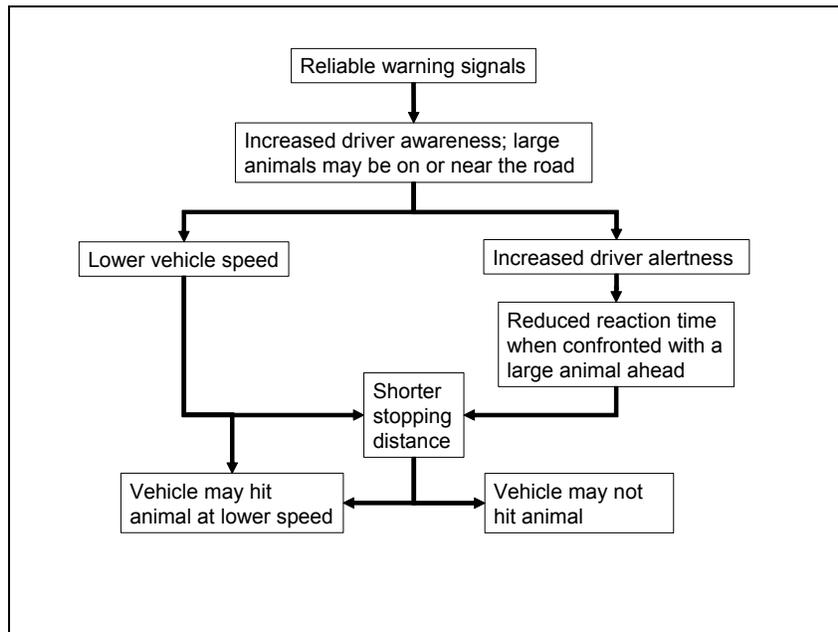
Figure 2.2: Warning signals and driver response

Once an animal detection system reliably detects the target species and the warning signals and signs are activated, driver response determines how effective the system ultimately is in avoiding or reducing animal-vehicle collisions. Figure 2.2 splits driver response into two components: increased driver alertness and lower vehicle speed.

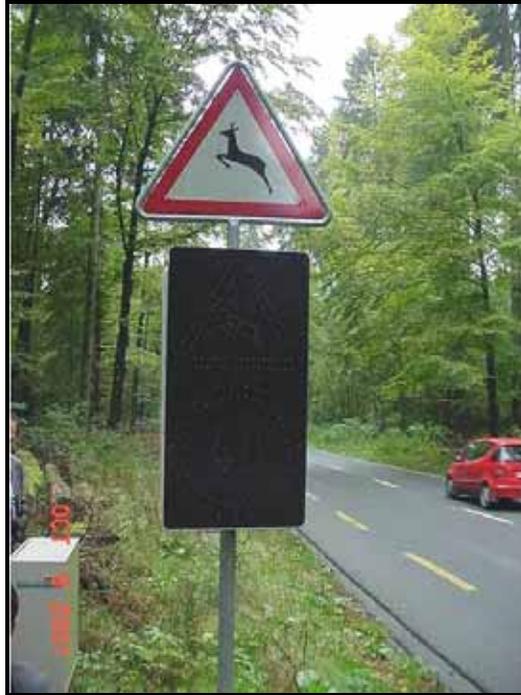
Figure 4.3: Warning signs with 40 km/h (25 mi/h) speed limit at a location in Switzerland (Photo: Mary Gray/FHWA).

The sensors were installed in a 20-30 m (21.8-32.7 yd) wide zone on both sides of the road. Once an animal was detected LED signs with a deer symbol were activated to alert the drivers. Once activated, the signs stayed on for 45 sec. Five of the sites also had an LED sign with an enforceable maximum speed limit (40 km/h, 24.8 mi/h) (Figure 4.3); one of the sites (Warth) had an enforceable speed limit of 30 km/h (18.6 mi/h) until November 1996 (*Anonymous 1994a*; *Anonymous 1994b*, *Anonymous 1996*; *Kistler 1998*). The seven systems were only activated during the night. A time clock and light sensor switched the systems on and off automatically. The rationale was that human activities during the daytime would cause a high number of false detections. In addition, the sensors were relatively sensitive to differences in temperature, which occurs frequently during the day.

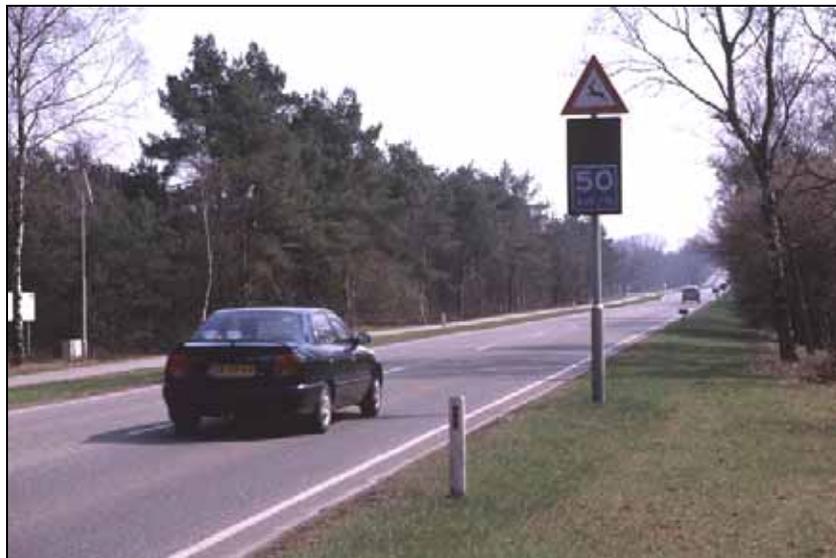
Figure 4.4: Warning signals and sign in 't Harde, The Netherlands (Photo: Marcel Huijser/WTI/MSU)

There were two systems installed in The Netherlands: one near 't Harde (N309) (Figures 4.4-4.8) and one near Ugchelen (N304) (Figures 4.9 and 4.10) (Herman van Zandbrink, Provincie Gelderland, personal communication; *van den Hoorn 2000*). The system manufacturer was Calonder Energy AG, the same as discussed in Sections 4.4.1 and 4.4.4. The two systems in the Netherlands are designed to detect wild boar (*Sus scrofa*), roe deer and red deer. They are solar powered (Figure 4.7) and operate on a focused infrared beam that is positioned at  $\pm 50$  cm ( $\pm 19.5$  in) above the ground (Figure 4.6 and Figure 4.10). The crossing areas are about 200-250 m (218-272.5 yd) wide and have about 500 m (545 yd) long fences before and after the crossing area on both sides of the road (Figure 4.6). Once an animal is detected LED warning signs with a red deer in combination with an advisory 50 km/h (31.1 mi/h) speed limit sign are activated (Figure 4.4, Figure 4.5, and Figure 4.9). The systems are only switched on during the night. The animals tend to stay away from the road during the daylight hours (Herman van Zandbrink, Provincie Gelderland, personal communication).

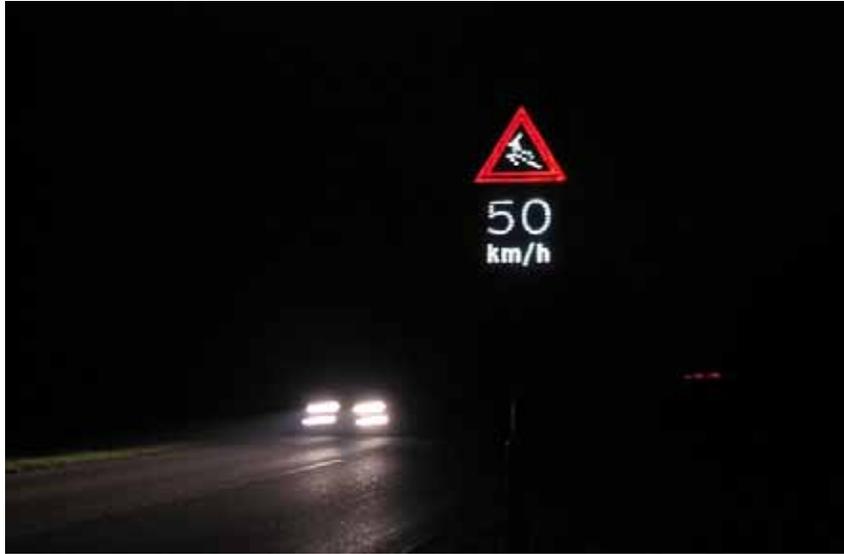
Figure 4.5: Activated warning signal and sign in 't Harde, The Netherlands (Photo: Marcel Huijser/WTI-MSU)

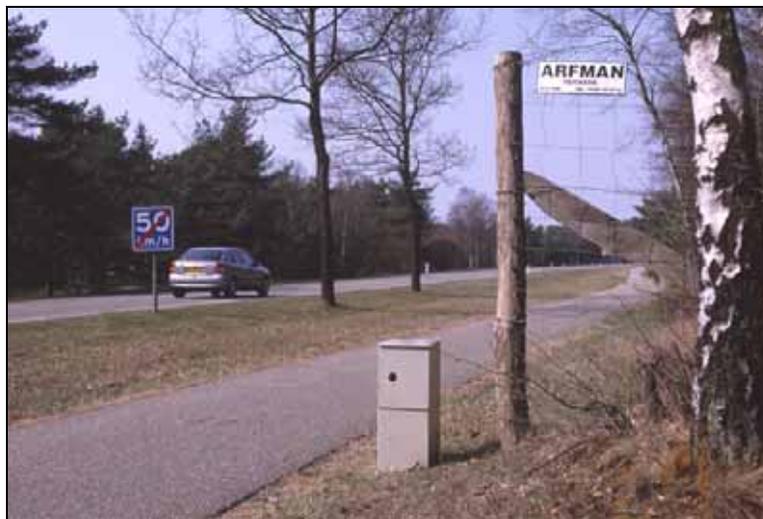
Figure 4.6: Cabinet with infrared sensor in 't Harde, The Netherlands (Photo: Marcel Huijser/WTI-MSU)

The sensor boxes (Figure 4.6 and Figure 4.10) have to be well anchored on a concrete foundation to remain stable (Herman van Zandbrink, Provincie Gelderland, personal communication). Ventilation of the boxes is also an issue, as rain or snow may cause the lens to fog up. The distance between the sensors (200-250 m, 218-272.5 yd) may be a little too far; smaller distances may reduce the number of false detections. Fallen trees and tall grasses can also produce false detections, as the sensors were only  $\pm 50$  cm ( $\pm 19.5$  in) above the ground. From time to time the batteries lose too much power. Lightning has struck one of the sensors, which caused a series of false detections. In addition, vehicles that have run off the road damaged equipment on two occasions: a sensor post and a signal pole. Another problem has been when small birds have used the sensor box as a nesting site (Marcel Huijser, personal observation). Mesh wire in front of the holes has solved this problem (Figure 4.10). One system appears to work well (near 't Harde), while the other system (near Ugchelen) has technological problems (Herman van Zandbrink, Provincie Gelderland, personal communication).

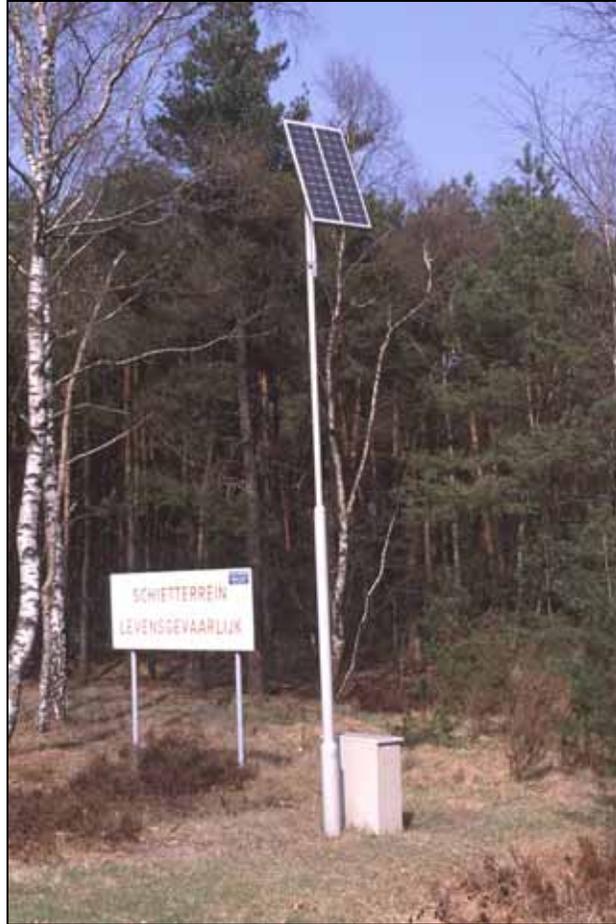
Figure 4.7: Solar panel and control cabinet in 't Harde, The Netherlands (Photo: Marcel Huijser/WTI-MSU)

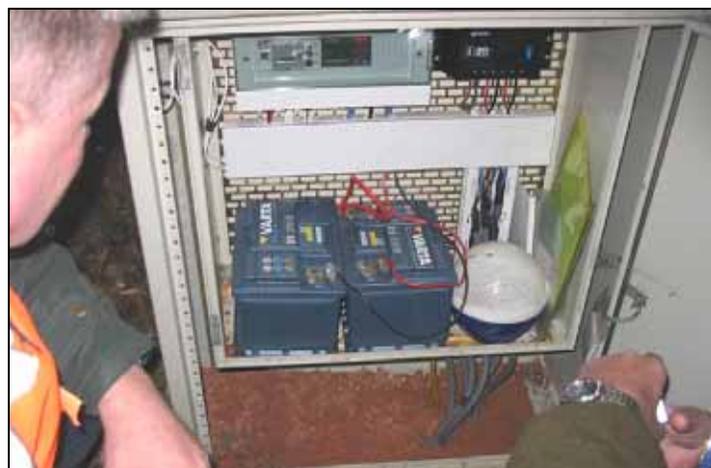
Figure 4.8: Control cabinet in 't Harde, The Netherlands (Photo: Marcel Huijser/WTI-MSU)

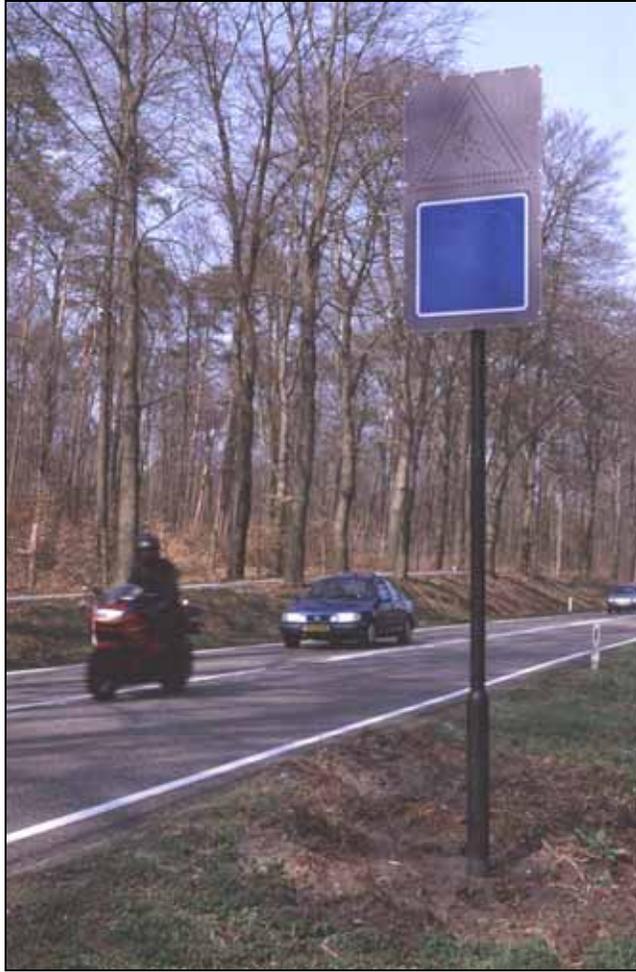
Figure 4.9: Warning signal and sign in Ughelen, The Netherlands (Photo: Marcel Huijser/WTI-MSU)

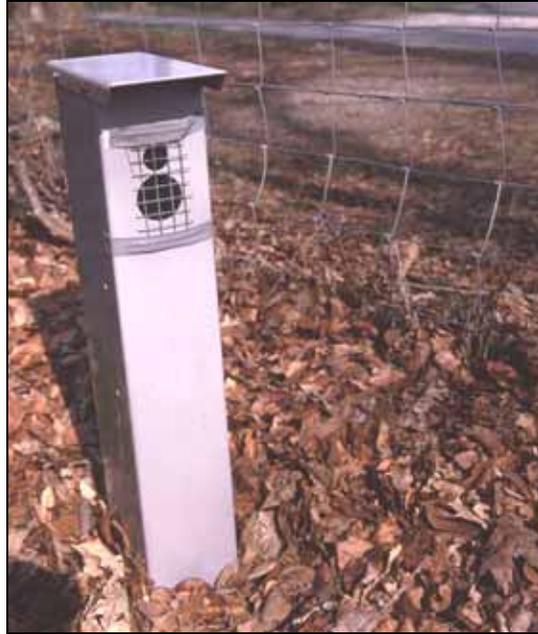
Figure 4.10: Cabinet with infrared sensor in Ugchelen, The Netherlands. The wire in front of the two openings prevents birds from nesting in the box. (Photo: Marcel Huijser/WTI-MSU).

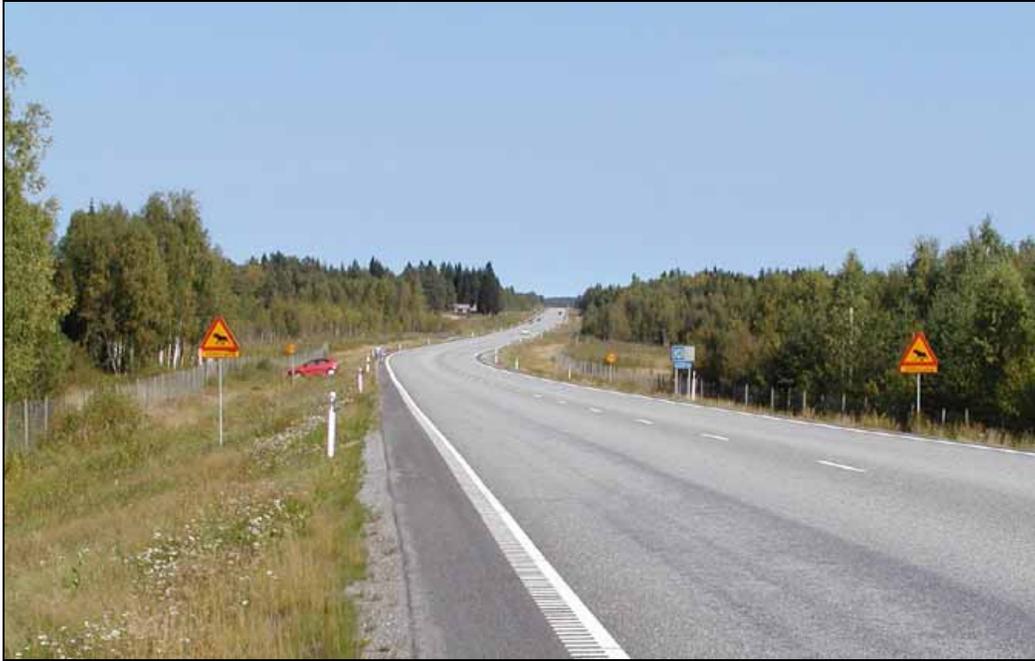
Figure 4.11: Warning signs in Rosvik, Sweden (Photo: Andreas Seiler)

A standard moose crossing sign with the text “wildlife passage” is located just before the crossing area (Figure 4.11). The standard speed limit is 90 km/h (55.9 mi/h) in summer and 70 km/h (43.5 mi/h) in winter. Electricity supply was a major problem, which was resolved in winter 2001/2002. The road was later upgraded and now has two lanes in one direction, and one in the other direction, separated by a wire fence (installed in 2003). Animals using the crossing zone now have to jump over the wire fence in the middle of the road (Figure 4.13).

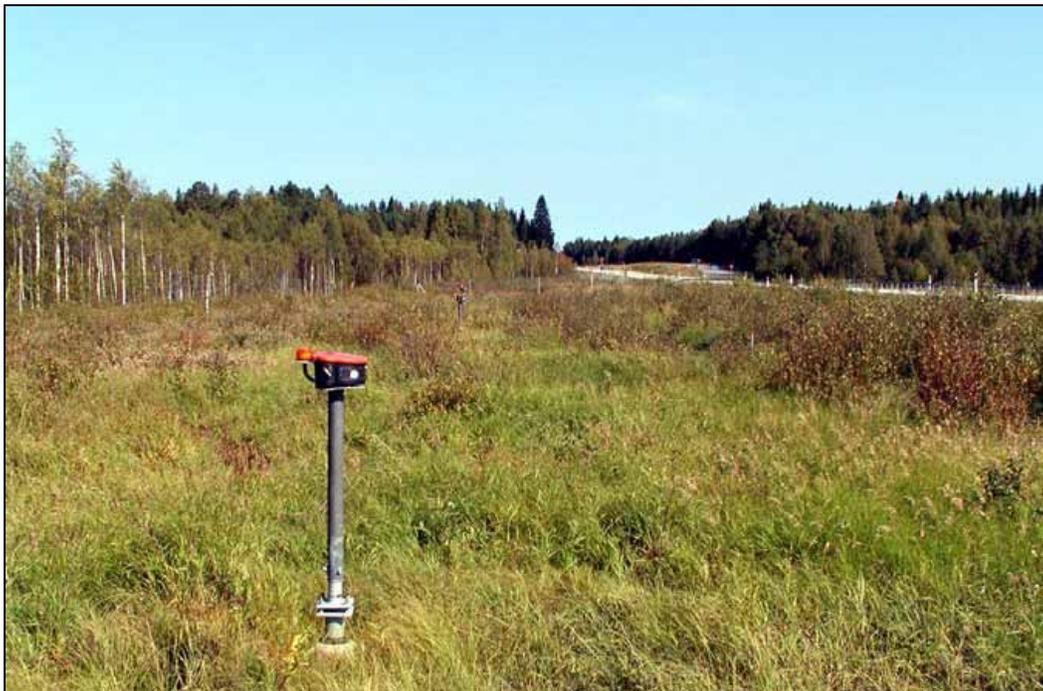
Figure 4.12: The posts holding the lights in Rosvik, Sweden (Photo: Andreas Seiler).

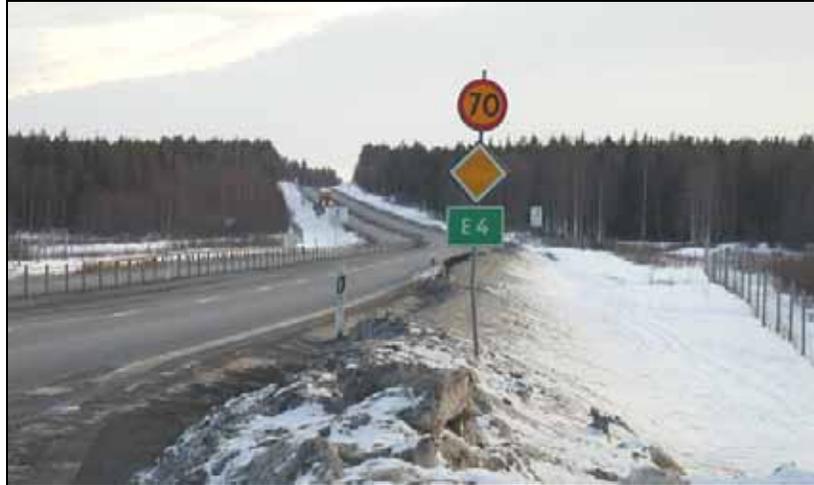
Figure 4.13: The crossing area in Rosvik, Sweden. Note the two lanes one direction and one lane in the other direction separated by a wire fence (Photo: Kjell Ståhl/Road Administration, Luleå)

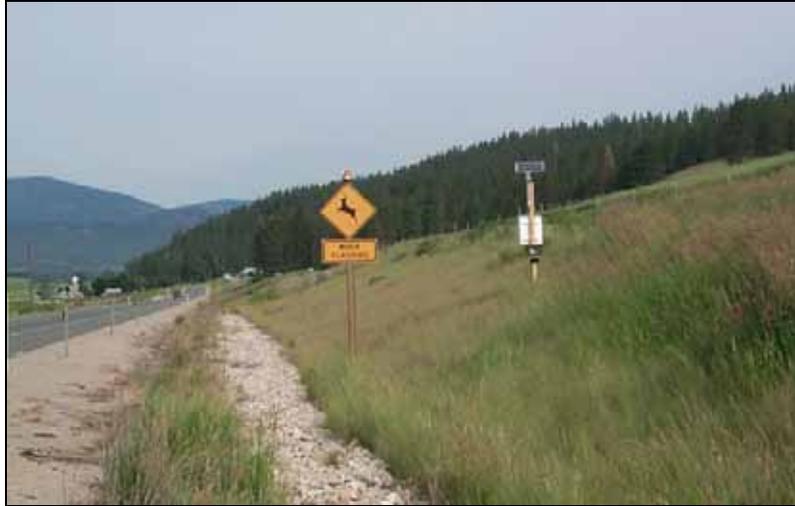
Figure 4.14: Warning signal and sign in Colville, Washington, USA (Photo: Washington Department of Transportation, Eastern Region)

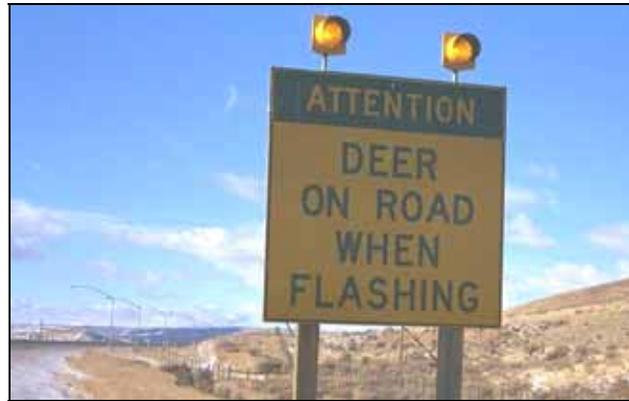
Figure 4.15: Activated warning signals and sign at Nugget Canyon, Wyoming, USA (Photo: Bill Gribble/WYDOT)

The Flashing Light Animal Sensing Host (FLASH), designed to detect mule deer (*Odocoileus hemionus*), consisted of a series of infrared sensors placed at 17-19 m (18.5-20.7 yd) intervals on both sides of Hwy 30, at mile post 30.5, Nugget Canyon, between Kemmerer and Cokeville, Wyoming (Figures 4.15-4.22) (Gordon, et al. 2001; Gordon and Anderson 2002; Gordon, et al. 2004; Stanley Anderson, Wyoming Cooperative Fish and Wildlife Research Unit, personal communication). The FLASH system was designed by Victoria Gooch, and the Mid-American Manufacturing Technology Center (MAMTC) and the Wyoming Department of Transportation (WYDOT) installed the system (John Eddins, WYDOT, personal communication). There were five sensors on each side of the road (Figure 4.16), which spanned a 92 m (100.3 yd) gap in an 11,263 m (12,276.7 yd) long fence. The sensors were designed to detect the body heat of large animals. Once they did, flashing warning lights above a permanently visible warning sign were activated to alert drivers (Figure 4.15). The signs were placed about 300 m (327 yd) before the crossing area. The text read “ATTENTION, DEER ON ROAD WHEN FLASHING.”

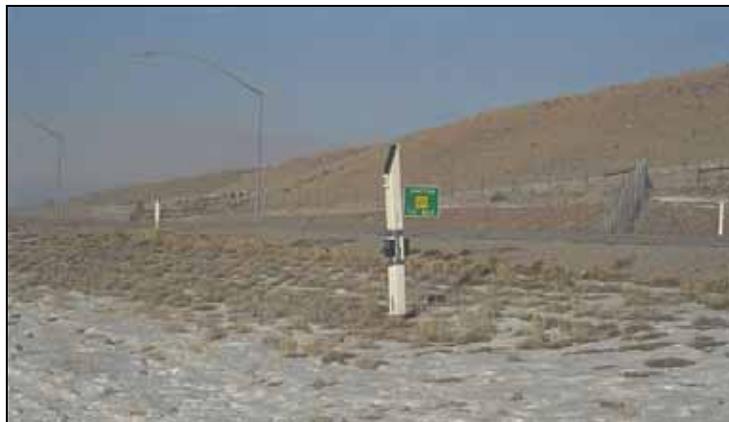
Figure 4.16: Infrared sensors attached to the white posts in the FLASH system at Nugget Canyon, Wyoming, USA (Photo: Bill Gribble/WYDOT)

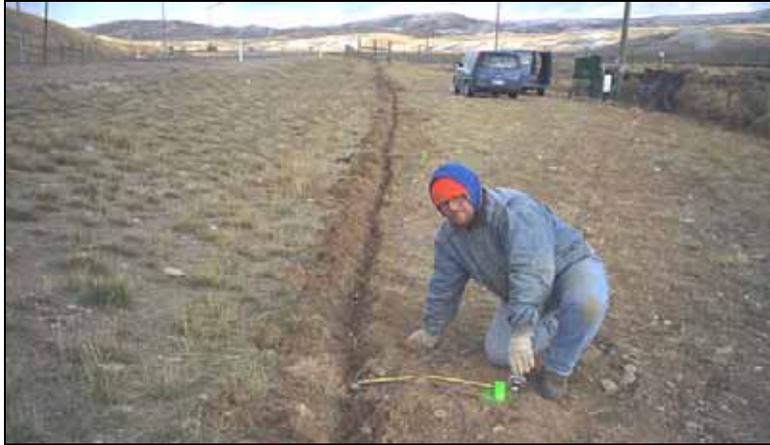
Figure 4.17: Re-installation of the geophone system at Nugget Canyon, Wyoming, USA. The sensors were approximately 10 m (33 ft) apart at a depth of about 10 cm (4 in) below ground level to the top of the sensor. (Photo: Bill Gribble/WYDOT)

In addition, a unique geophone unit (Eagle Telonics, Mesa, AZ), paired with infrared scopes, was installed on the south side of the road (Figure 4.17, Figure 4.18). An additional pair of infrared scopes was installed on the north side of the road in the second year (but no geophone unit), and microwave sensors (Figure 4.19) were installed south of the road. Finally a video-

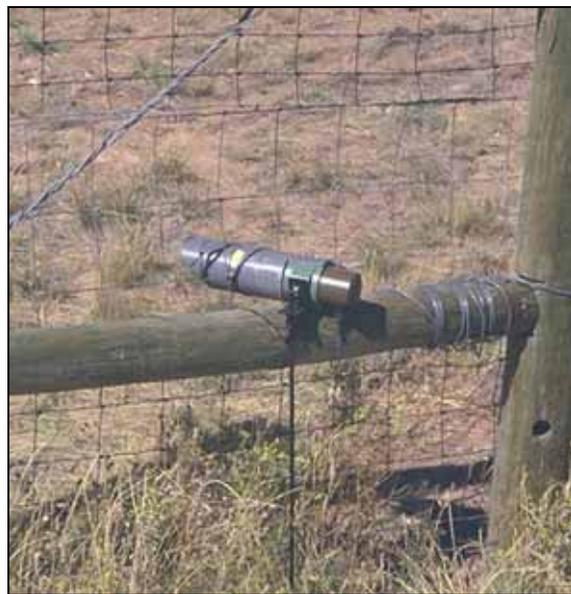
Figure 4.18: Infrared scope for the geophone system at Nugget Canyon, Wyoming, USA (Photo: Bill Gribble/WYDOT)

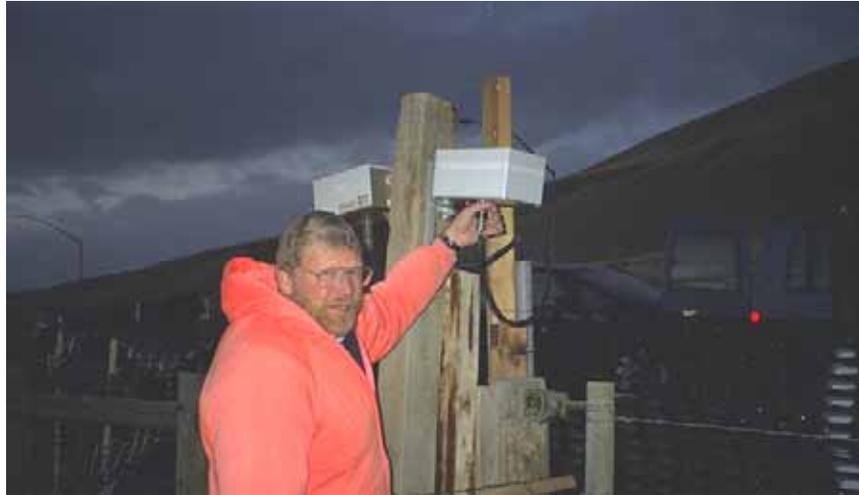
Figure 4.19: Microwave radar transmitters at Nugget Canyon, Wyoming, USA (Photo: Bill Moore, WYDOT)

The microwave sensors formed a separate system, but they did not cover the entire area. This system was susceptible to false detections as a result of passing trucks, vegetation moving in the wind and birds. Repositioning of the radar heads resulted in complete area coverage, but false detections continued and the system was seldom used. The three detection systems were linked to one of three traffic counters to allow for remote access to the data (Bill Gribble, WYDOT, personal communication).

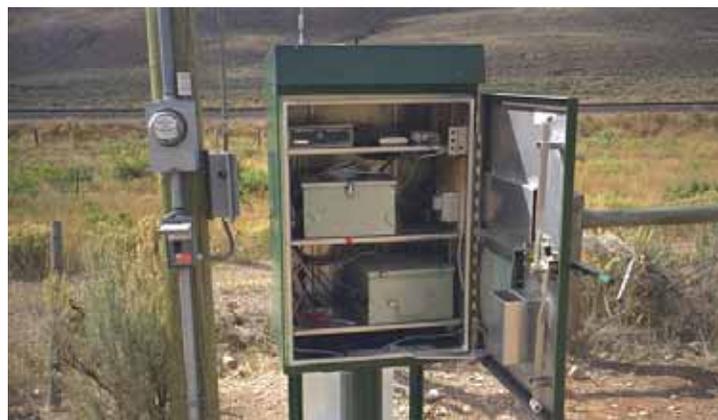
Figure 4.20: Control cabinet at Nugget Canyon, Wyoming, USA. The large boxes are the counters for the animal detections and traffic. The upper shelf holds equipment for downloading data. This equipment used AC power. (Photo: Matt Johnson, WYDOT)

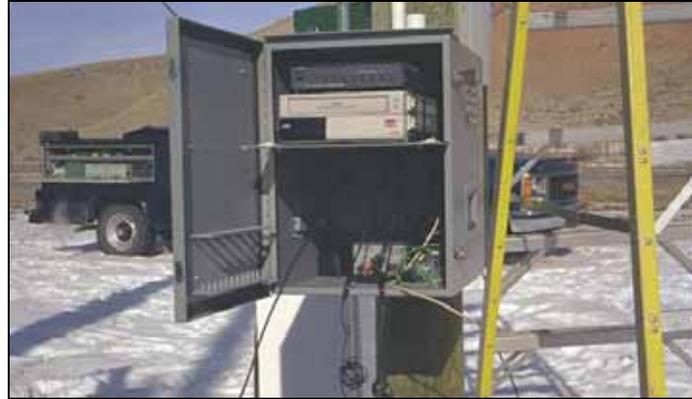
Figure 4.21: Video recorder system at Nugget Canyon, Wyoming, USA (Photo: Bill Gribble, WYDOT)

camera system was installed to monitor deer moving through the crossing area (Figure 4.21 and Figure 4.22). The geophone unit was designed to detect ground vibrations caused by ungulates walking through the crossing area and also served as a control for the FLASH system. The infrared scopes on the south side of the road were part of the geophone system and had to be triggered at the same time as the geophone sensors to result in a valid detection. This was needed to eliminate false detections due to vibrations from passing trains on a nearby railroad and heavy vehicles (*Gordon, et al. 2001*; Bill Gribble, WYDOT, personal communication).

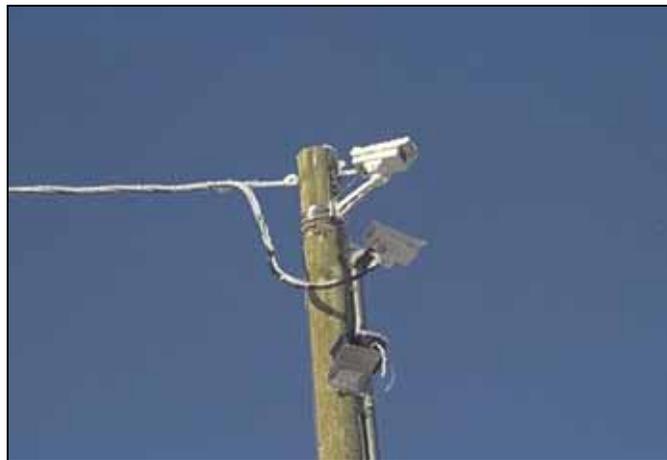
Figure 4.22: Two low-light cameras at Nugget Canyon, Wyoming, USA (Photo: Bill Gribble, WYDOT)

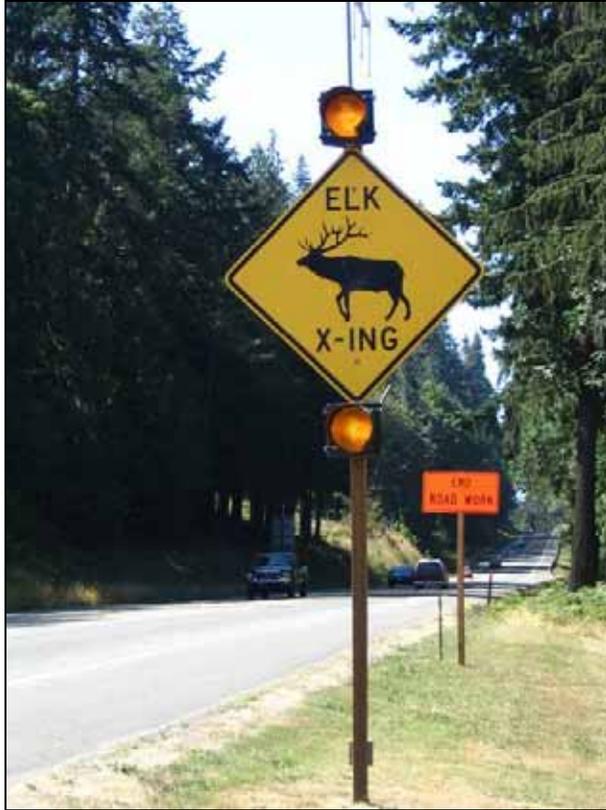
Figure 4.23: Activated warning signal and sign in Sequim, Washington, USA (Photo: Marcel Huijser, WTI-MSU)

Receivers placed along the road scan for the frequencies of the individual radio collars 24 h per day. When the radio-collared individuals come within about 400 m (0.25 mi) of the road, the receivers that pick up the signal activate the flashing beacons that are linked to that receiver (Figure 4.23). Due to the directional antennas, however, the detection distance from the road varies for each location (David Rubin, Sequim Elk Habitat Committee, personal communication).

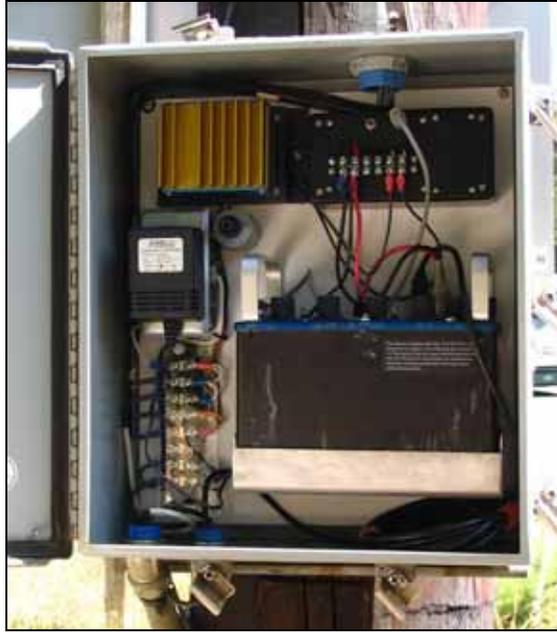
Figure 4.25: Cabinet with electronics for automated scanning for frequencies of radio collared elk and battery at one of the receiver stations in Sequim, Washington, USA (Photo: Marcel Huijser, WTI-MSU)

The system was designed and integrated by Shelly Ament and David Ruben, mostly with off-the-shelf equipment. WSDOT and the Washington Department of Fish and Wildlife installed the system. To block false detections, a device that counted the pulses of the radio signal had to be added (Figure 4.25). This device filtered out signals from other, non-elk radio transmitters. The system became operational in the fall of 2000. The batteries of the radios have a three-year life expectancy, but most of them last much longer.

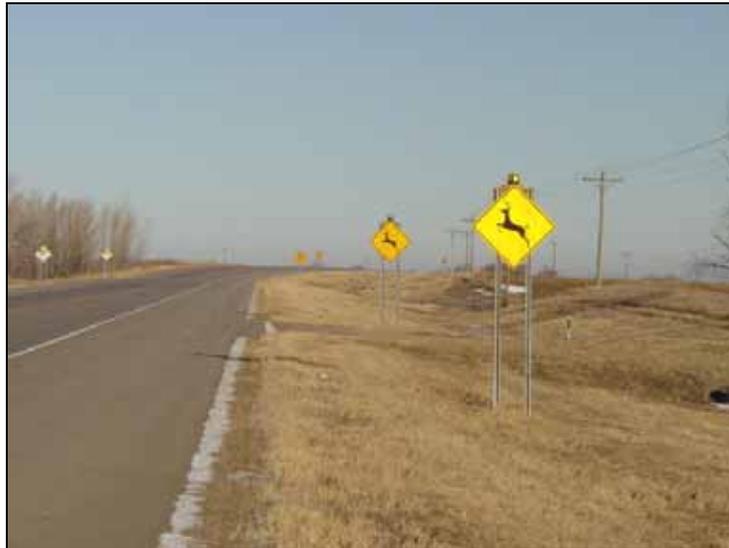
Figure 4.26: Warning signals and signs in Marshall, Minnesota, USA (Photo: Robert Weinholzer, MNDOT)

Around June 2001 an animal detection system was installed along a 1,609 m (1 mi) long section of Hwy 23 at Camden State Park southwest of Marshall, Minnesota (Figures 4.26 and 4.27) (*MNDOT 2001a*). This road section has a state park on one side of the road, and farmland that provides food for white-tailed deer on the other side of the road (Robert Weinholzer, Minnesota Department of Transportation, personal communication). More than 50 white-tailed deer are killed annually here (*The Post Bulletin 2005*).

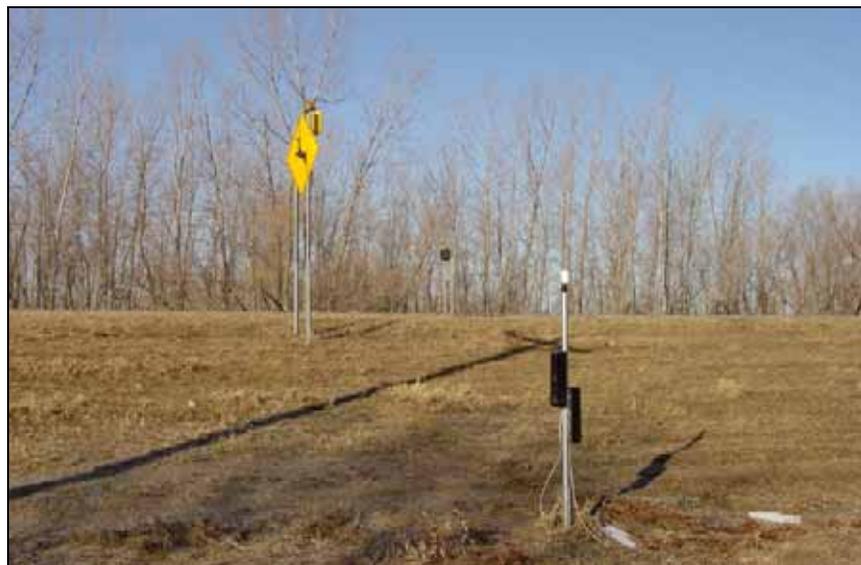
Figure 4.27: The sensors in the right-of-way in Marshall, Minnesota, USA (Photo: Robert Weinholzer, MNDOT)

The system consisted of a series of laser transmitters and receivers (Figure 4.27). It was integrated by Lewis Enterprises Inc., Saint Louis Park, MN. The vendor and MNDOT installed the system. The distance between the stations was approximately 200 m (218 yd) (Erik Lewis, Lewis Enterprises Inc., personal communication). The system had two laser beams between all stations. The lowest beam was about 65 cm (25.6 in) from the ground, and the second beam was about 30 cm (11.8 in) above the first (Robert Weinholzer, Minnesota Department of Transportation, personal communication; *MNDOT 2001b*). The system was only triggered when

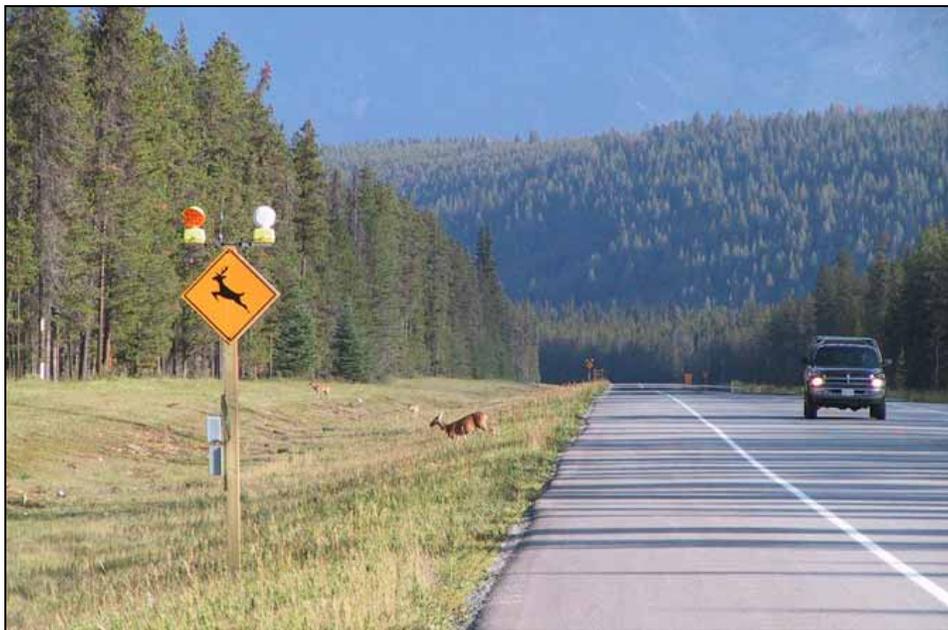
Figure 4.28: Warning signal and sign in Kootenay, British Columbia, Canada (Photo: Alan Dibb/Parks Canada)

In June 2002 an animal detection system was installed along Hwy 93, in Kootenay National Park in British Columbia, Canada, about 60 km (37.2 mi) north of Radium, immediately north of the Dolly Varden Day-use Area (Figures 4.28 and 4.29) (*Kinley, et al. 2003; Newhouse 2003*). The system was designed to detect large animals, specifically white-tailed deer (*Odocoileus virginianus*). ICBC, QWIP Technologies, OCTEC Ltd., Intranstech and FLIR Systems Inc. all provided support for research and development, and Parks Canada helped install the system. The system had standard black on yellow deer warning signs with amber flashing lights on top to warn drivers (Figure 4.28).

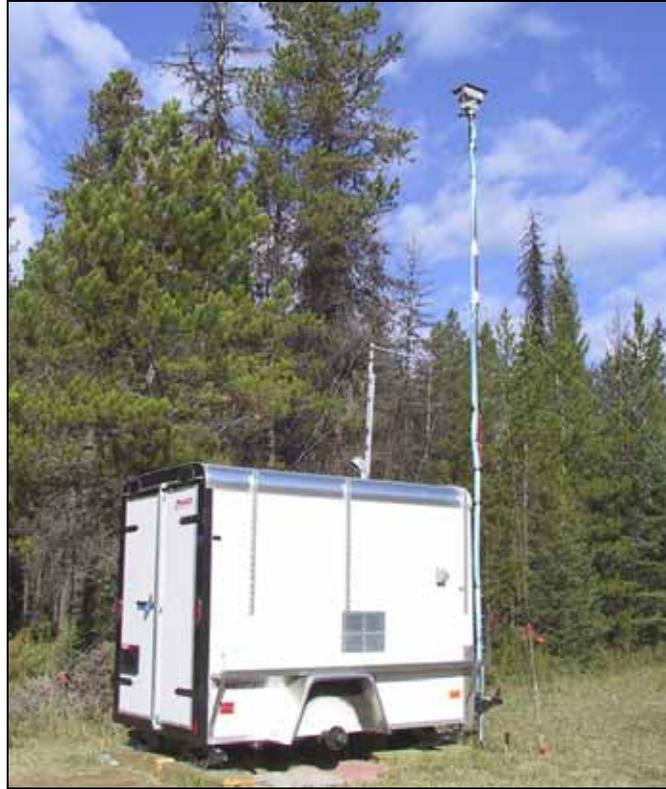
Figure 4.29: Trailer and camera in Kootenay, British Columbia, Canada (Photo: Tim McAllister)

Two infrared cameras that detect heat, as well as additional equipment, were installed in the right of way (Figure 4.29). The software uses a combination of motion, speed and size to determine whether the warning system should indeed be triggered.

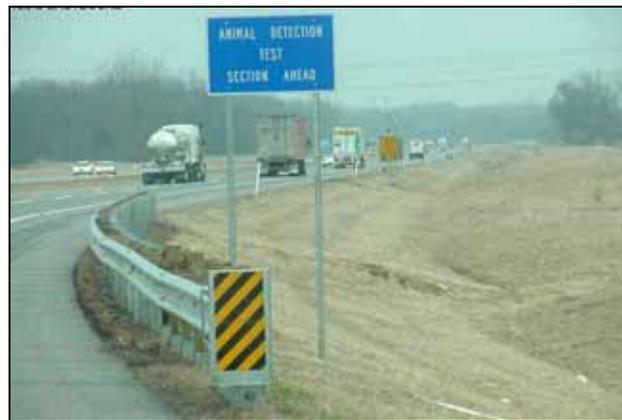
Figure 4.30: Sign indicating test section on the Indiana Toll Road, Indiana, USA (Photo: Indiana Department of Transportation, Toll Road District)

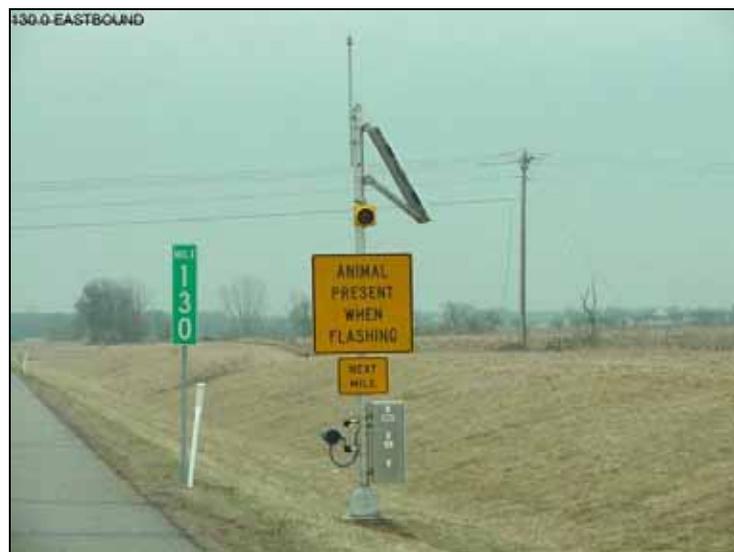
Figure 4.31: Warning signal and sign on the Indiana Toll Road, Indiana, USA (Photo: Indiana Department of Transportation, Toll Road District)

Transportation, personal communication; Lloyd Salsman, STS, personal communication). The system was designed and integrated by Sensor Technologies and Systems, Scottsdale, Arizona. Michiana Contracting Inc., Plymouth, Indiana, installed the system. The total length covered by the system was 9,654 m (6 mi), but the system was split up in 6 sections of 1,609 m (1 mi) each (IDOT 2003; Sedat Gulen, Research Division, Indiana Department of Transportation, personal communication). A 1,609 m (1 m) long control section follows each 1,609 m (1 mi) section with sensors. Sections with sensors are at mileposts 130-131, 132-133, 134-135, 137-138, 139-140, and 141-142 (Lloyd Salsman, STS, personal communication). The drivers are presented with a flashing beacon and a sign that says “ANIMAL PRESENT WHEN FLASHING” (Figure 4.31).

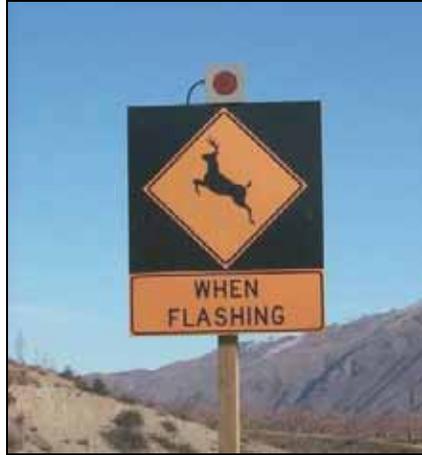
Figure 4.34: Warning signal and sign in Wenatchee, Washington, USA (Photo: WSDOT, NorthCentral Region)

In October 2002 an animal detection system was installed along US 97A (mile post 206), near Wenatchee, Washington (Figures 4.34 and 4.35). The system was designed and built by Parks Gribble (Battelle Laboratories). The system was installed by Parks Gribble and WSDOT. When the far infrared laser beams (wavelength 1500 nano m) were broken along a 213 m (232.2 yd) long road section, yellow flashing beacons on 1.5 by 1.8 m (5 by 6 ft) black on yellow warning signs with a deer profile were activated (*WSDOT 2003a*; *WSDOT 2003b*) (Figure 4.34). Other signs that said “WHEN FLASHING” accompanied the deer signs. When the system was triggered the lights flashed for one minute.

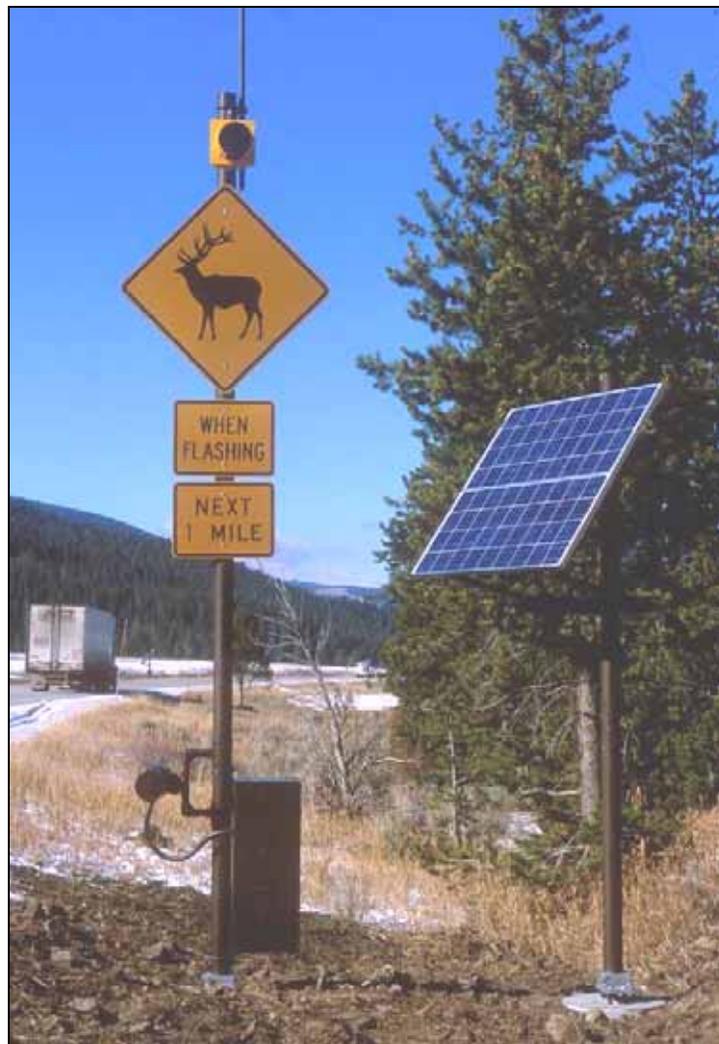
Figure 4.36: Original warning signal and sign in Yellowstone National Park, Montana, USA. A sensor is attached on the left side of the post; a cabinet with circuit boards and batteries is attached to the right side of the post. (Photo: Marcel Huijser, WTI-MSU)

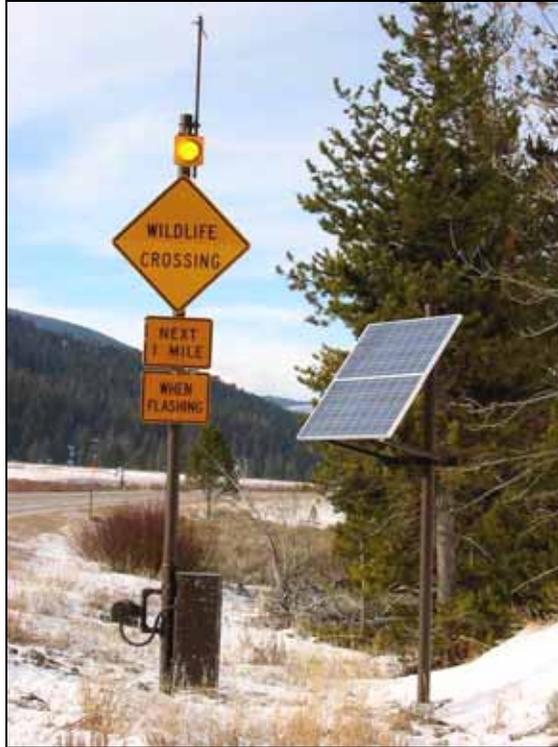
Figure 4.37: Activated warning signal and sign with new text sign “WILDLIFE CROSSING” and solar panel in Yellowstone National Park, Montana, USA (Photo: Marcel Huijser, WTI-MSU)

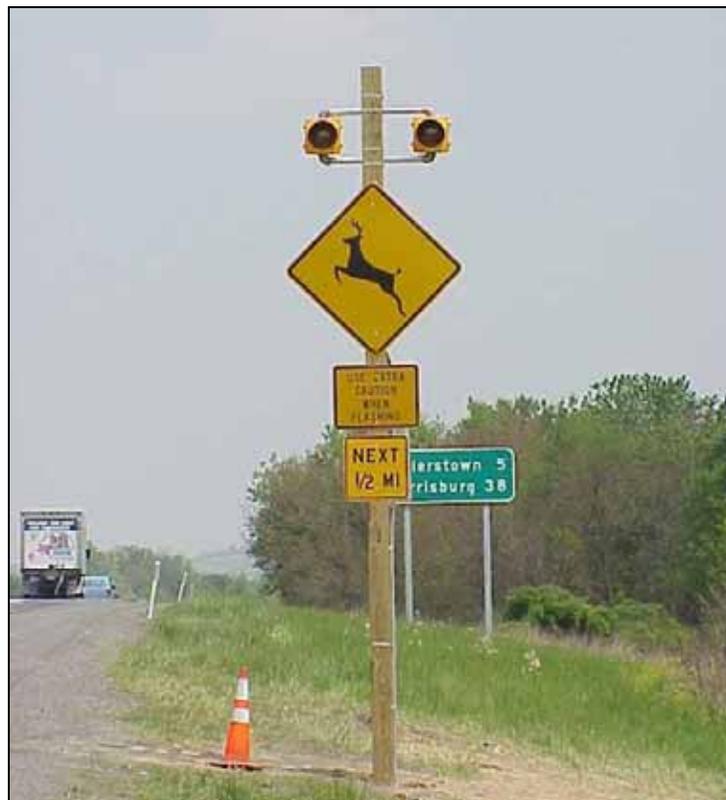
Figure 4.38: Warning signal and sign in Thompsontown, Pennsylvania, USA (Photo: Rhonda Stankavich, PENNDOT)

Standard deer crossing signs (black on yellow) were combined with yellow flashing lights and additional signs that say “USE EXTRA CAUTION WHEN FLASHING” and “NEXT ½ MI” (Figure 4.38). Signs that say “ANIMAL DETECTION TEST AREA AHEAD” and “END TEST AREA” were installed before and after the sensors. The system suffered from integration problems between the animal detection system part and the driver warning part of the system, problems with the power supply and radios, and difficulties distinguishing between moving vehicles and deer or similar sized animals. The system was removed on 31 January 2005.

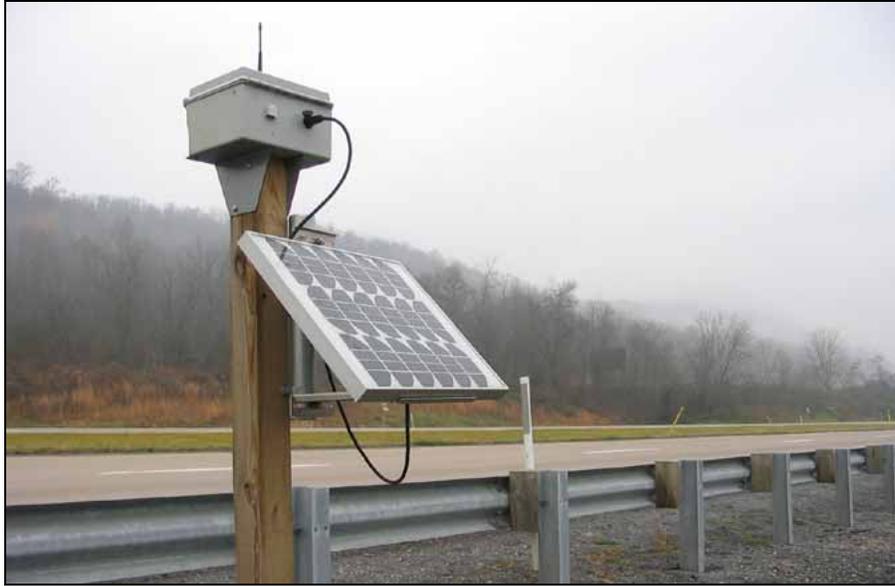
Figure 4.39: Pole with sensors and solar panel in Thompsontown, Pennsylvania, USA (Photo: Marcel Huijser, WTI-MSU)

The Pennsylvania Department of Transportation (PENNDOT) and the vendor installed the system. As opposed to a “break-the-beam-system,” the microwave detectors (Figure 4.39) covered the entire right-of-way and were designed to detect white-tailed deer in an area and filter out moving vehicles, swaying branches, rain and snow. The 17 posts (each with 2 sensor units) were placed at approximately 91 m (99.2 yd) intervals along the side of the road, and they operated on solar power. Hardwiring was calculated to cost more than \$50,000; while the cost for solar panels was estimated at \$7,500 (*Edwards and Kelcey 2003*).

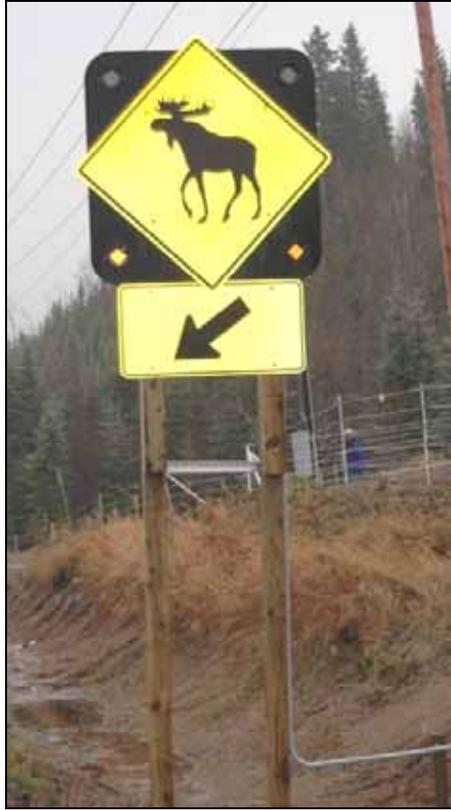
Figure 4.40: Warning sign and signals in Herbertville, Quebec, Canada (Photo: Ministère des Transports du Québec)

The system became operational in the spring of 2005. Large black on yellow warning signs – 1.2 x 1.2 m (3.9 x 3.9 ft) – with a moose silhouette and a flashing light in each of the four corners were installed for both travel directions, approximately 75 m (246 ft) before the gap in the fence (Figure 4.40).

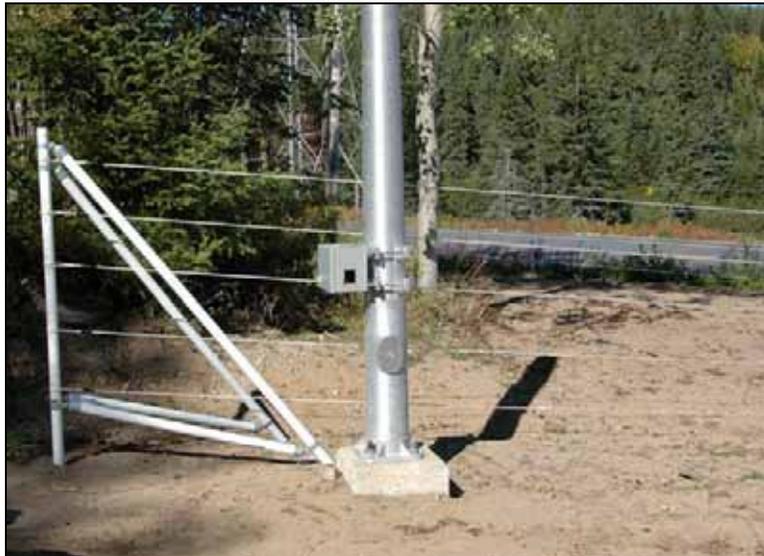
Figure 4.41: Sensor and electric fence in Herbertville, Quebec, Canada (Photo: Ministère des Transports du Québec)

The laser break-the-beam system was replaced by an active infrared system that also consisted of a transmitter and a receiver (Figure 4.41). The systems were installed on both sides of the road, and the sensors were placed on metal posts (about 1.3 m (4.3 ft) above the ground) on either side of the two gaps. The system was designed to detect moose, and to a lesser extent white-tailed deer and black bear. The infrared system was custom made by an electronic consultant (Service Camera Pro, Quebec City).

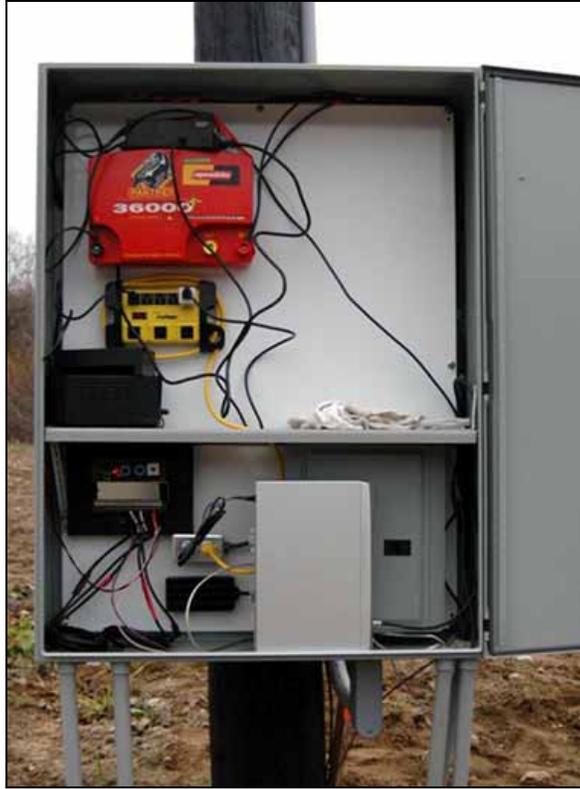
Figure 4.42: Control cabinet in Herbertville, Quebec, Canada. The upper section of the control cabinet contains the electronics for the electric fence; the lower section contains the electronics for the sensors and warning signals. (Photo: Ministère des Transports du Québec)

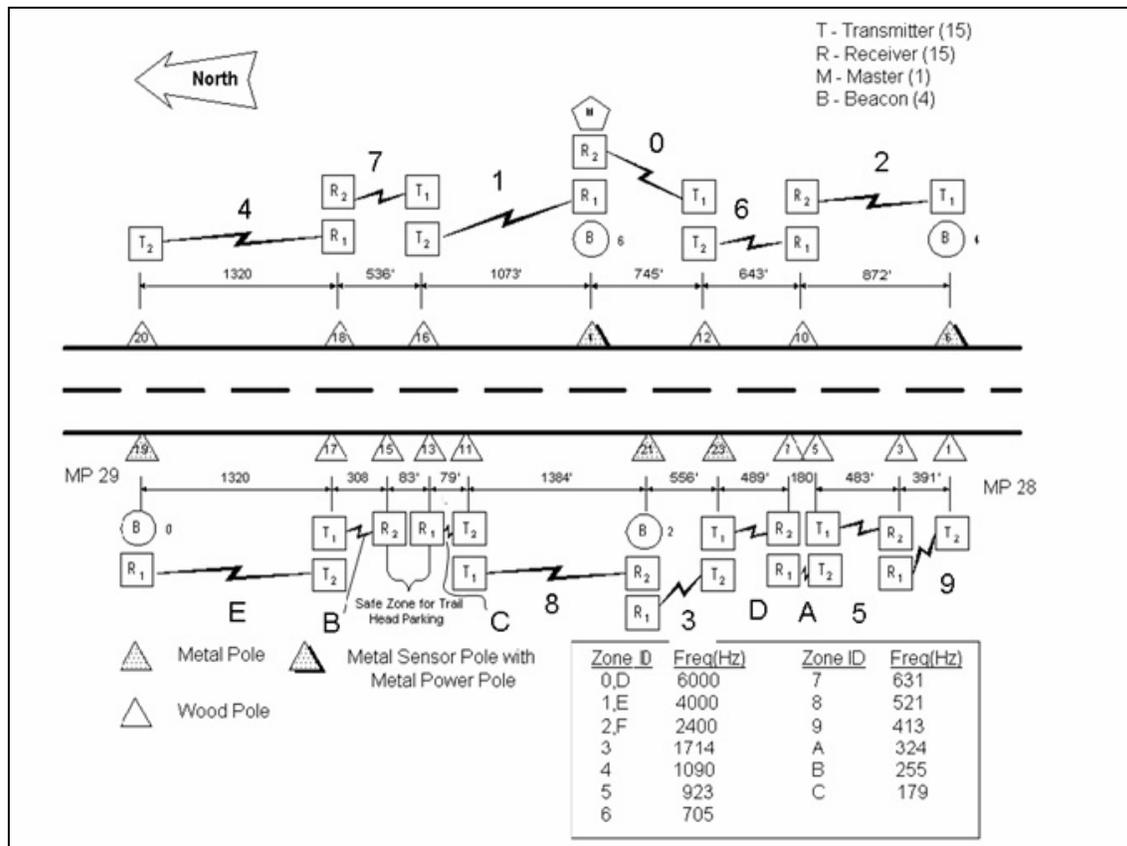
Figure 5.7: Layout of animal detection system US Hwy 191 (Source: STS)

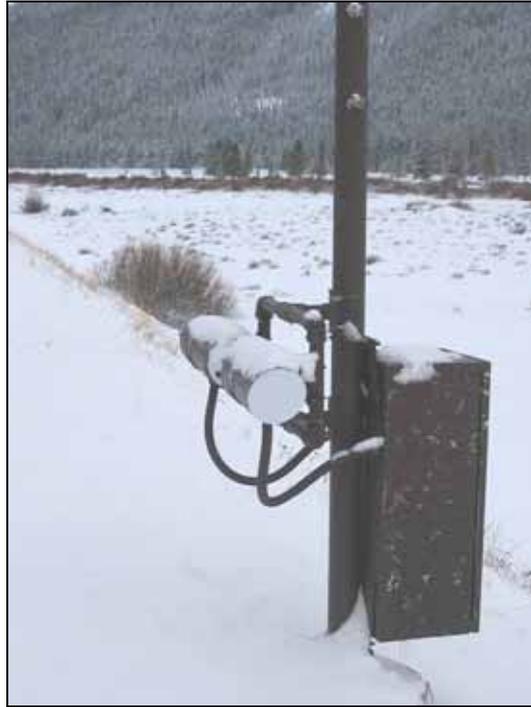
Figure 5.8: The sensors at one of the stations at the MT site. The cabinet contains a circuit board and batteries. (Photo: Marcel Huijser, WTI-MSU)

Poles with sensors are referred to as “stations.” A station typically has either two transmitters or two receivers, facing in opposite directions (Figure 5.8). There are nine transmitter stations, and
