**ANIMAL VEHICLE CRASH  
MITIGATION USING  
ADVANCED TECHNOLOGY  
PHASE I: REVIEW, DESIGN AND  
IMPLEMENTATION**

**Final Report**

**SPR-3(076)**

**August 2006**

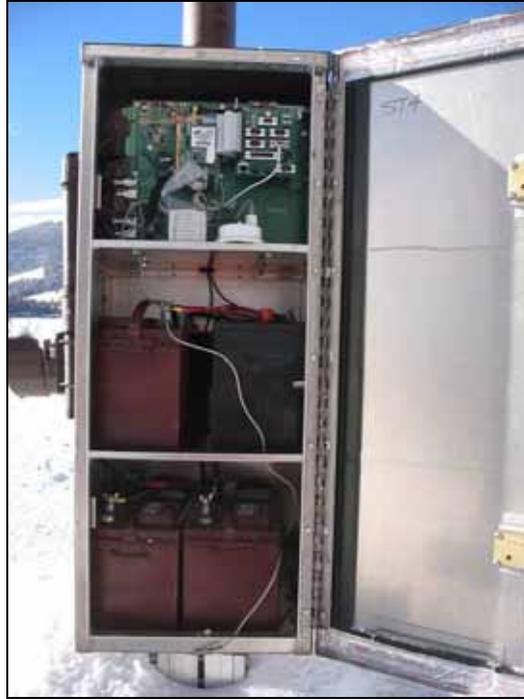
Figure 5.9: The master station at the MT site (Photo: Marcel Huijser, WTI-MSU)

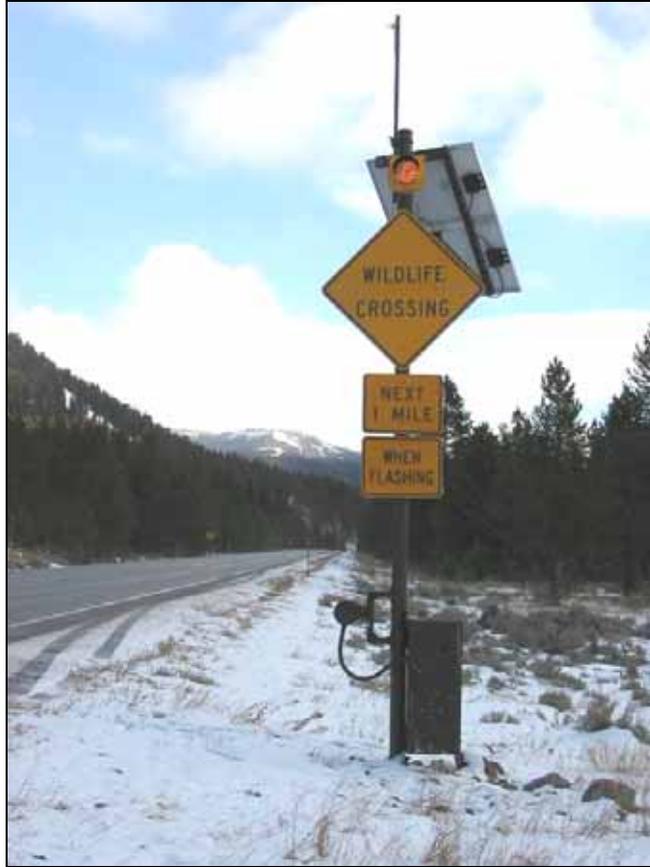
Figure 5.10: Activated warning signal, text sign “wildlife crossing” and solar panel at the MT site (Photo: Marcel Huijser, WTI-MSU)

When activated the flashing lights alert the drivers that a large animal may be on or near the road at that time. There are four stations with warning lights: station 19 and 21 for southbound traffic and station 6 and 4 for northbound traffic (see diagram Figure 5.7). The warning lights are accompanied by black on yellow warning signs that say “WILDLIFE CROSSING,” “NEXT 1 MILE” (or “NEXT ½ MILE”), “WHEN FLASHING” (Figure 5.10).

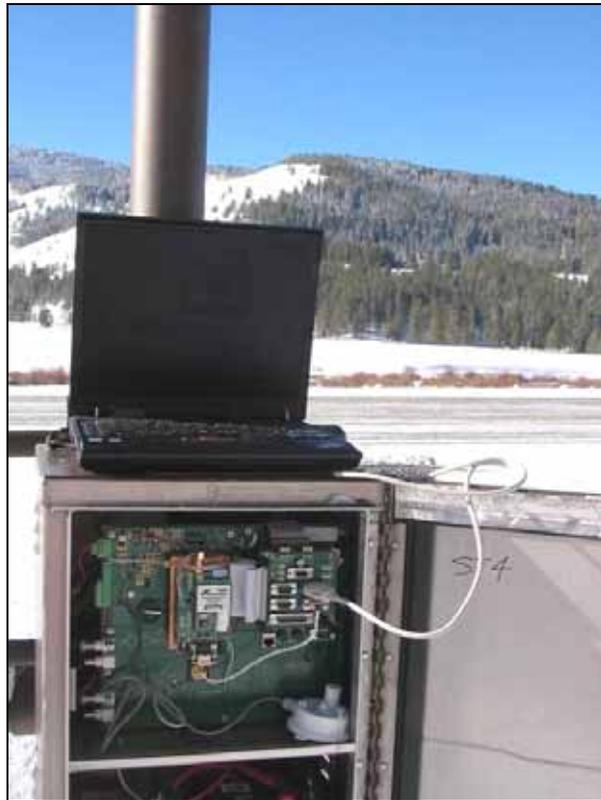
Figure 5.13: Data can be downloaded from the master station at the MT site through a direct connection or a radio link (Photo: Marcel Huijser, WTI-MSU)

The system records all detections and saves them at the master station. Detection events are broadcast using the UHF radio system, in real-time, so that the animal detection system operation can be monitored on site using a portable data radio connected to a laptop computer. The system also saves the date and time for each change in beam status (i.e., the beginning and end of a break-of-the-beam are recorded as two changes in beam status), the zone in which the detection occurred, and a code for the activation of the flashing warning signals. In addition, the logging system maintains and reports statistics associated with the operation of individual elements of the system. These statistics include radio link failures, radio link signal levels, beam break summaries, and logging memory status. The data can be downloaded on-site (memory card, direct physical link to laptop, or radio link to laptop) or from a remote location through a modem and land-based phone line (Figure 5.13).

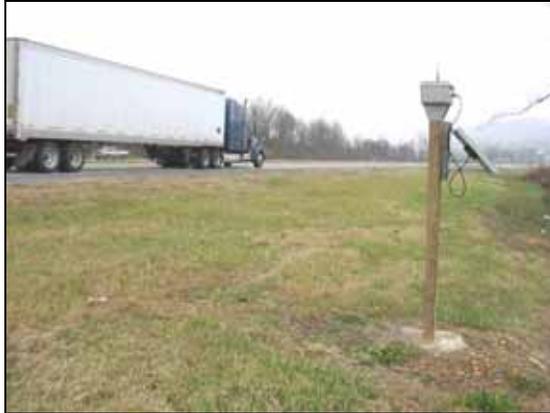
Figure 5.15: A station at the PA site. The sensors and battery are located inside the grey box on top of the pole. The solar panel is attached to the side of the pole. (Photo: Marcel Huijser, WTI-MSU)

The wooden posts were set in concrete. The poles with signs were inside the clear zone and had two holes just above the ground as a break-away system. Each station was powered by solar panels that were attached to the same pole. Batteries covered periods of darkness or instances with snow on the solar panels and were recharged by the solar panels (Figures 5.15 and 5.16). The control station was connected to a 110 V power source (Figure 5.17).

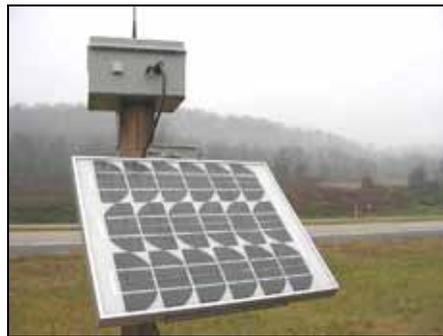
Figure 5.16: A closer view of the box with sensors, battery and the solar panel (Photo: Marcel Huijser, WTI-MSU)

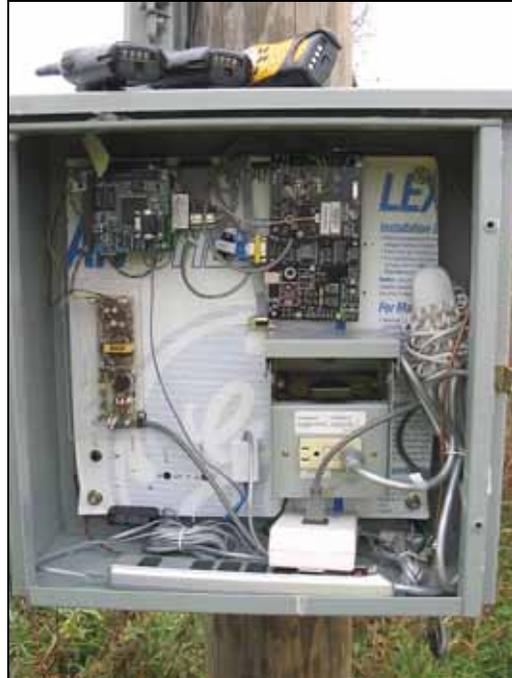
Figure 5.17: The control cabinet at the PA site (Photo: Marcel Huijser, WTI-MSU)

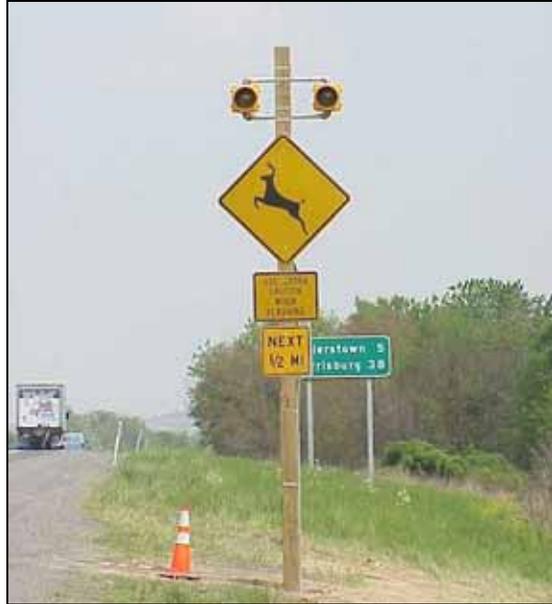
Figure 5.18: Warning signs and signals at the PA site (Photo: Rhonda Stankavich, PENNDOT)

Once the controller station has determined that it is a valid deer detection, a “beacons on” radio signal is sent that activates two alternating flashing amber warning lights, one pair on one location for each travel direction. For eastbound traffic the warning lights were located 425 m (1400 ft) before the first station with sensors. For west bound traffic the warning lights were located about 259 m (850 ft) from the station because of the clear zone for the off-ramp and limited sight distance. The warning lights were accompanied by standard black on yellow deer crossing warning, plus signs that say “USE EXTRA CAUTION WHEN FLASHING” and “NEXT ½ MI” (Figure 5.18). If no new detections occur the warning lights are turned off after three minutes.

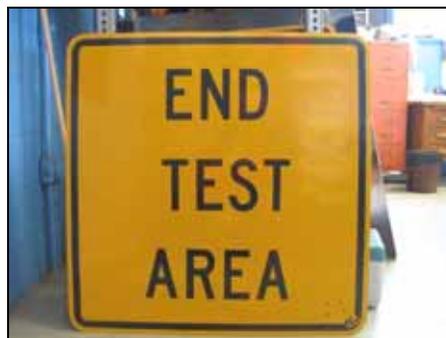
Figure 5.20: Sign marking the end of the test area at the PA site while still at the maintenance office (Photo: Marcel Huijser/WTI-MSU)

Drivers were informed of the presence and function of the system by two black on yellow signs, one for each travel direction, about 800 m (2,630 ft) before the first station with sensors. The signs said “ANIMAL DETECTION TEST AREA AHEAD” (Figure 5.19). In addition, there was another black on yellow sign for each travel direction that said “END TEST AREA” about 45.6 m (150 ft) past the last station (Figure 5.20).

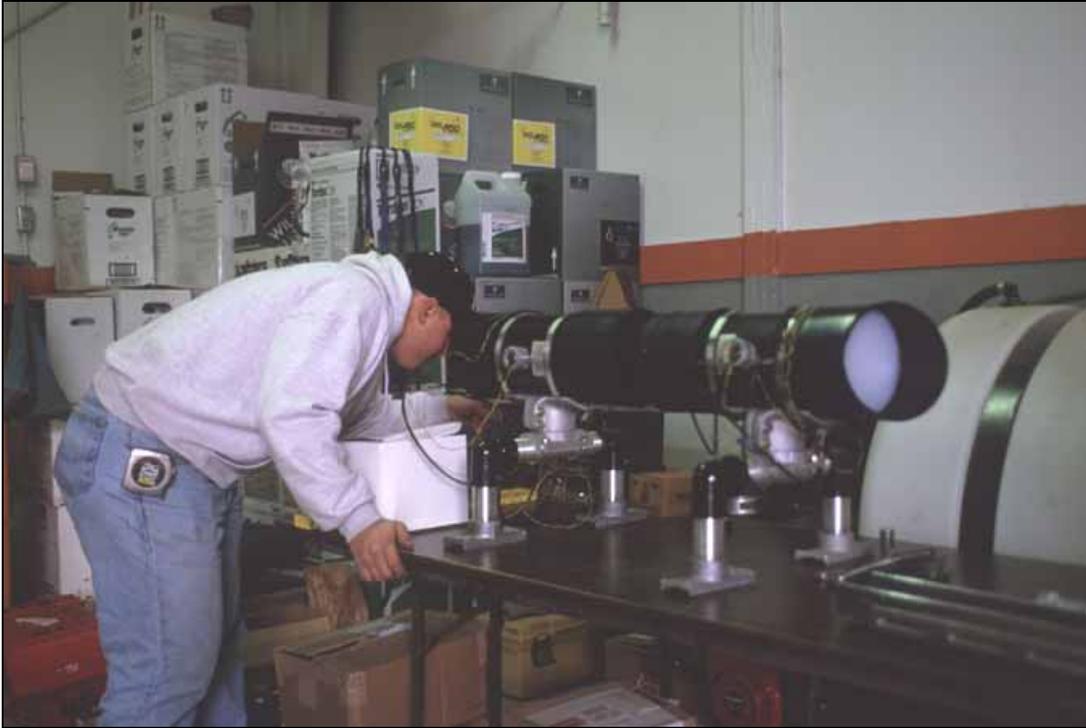
Figure 5.21: Michiana Contracting, Inc. assembled the animal detection system at the MDT maintenance yard in Bozeman, MT (Photo: Marcel Huijser, WTI-MSU)

Michiana Contracting Inc. and their subcontractors Eagle Rock Timber Inc. and Dependable Paint and Drywall Inc.: Assembled, painted and installed the sensors, poles, foundations, cabinets, solar panels, batteries and wiring in October/November 2002 (Figures 5.21-5.24). The work had to meet the requirements and specifications listed in the Request for Proposals, the contract between WTI-MSU and STS, and federal and state regulations. In addition, the work had to meet the requirements of Yellowstone National Park for topsoil and vegetation preservation and paint. After installation, Michiana Contracting Inc. and Eagle Rock Timber Inc. corrected problems with some of the concrete foundations and break-away systems.

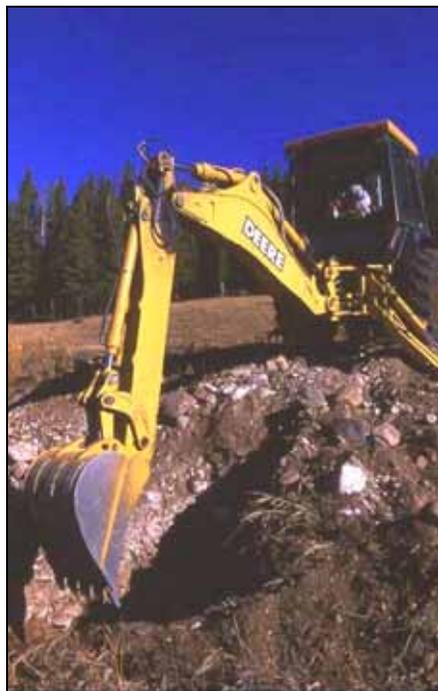
Figure 5.22: Eagle Rock Timber installed the poles and foundations at the MT site (Photo: Marcel Huijser, WTI-MSU)

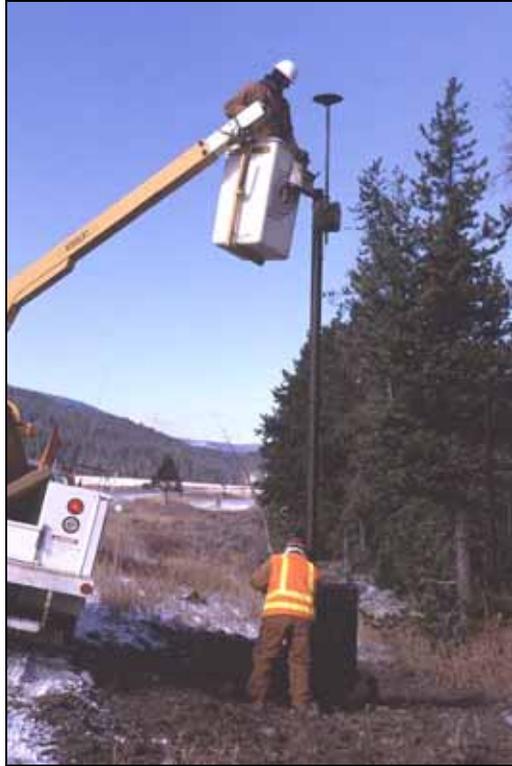
Figure 5.23: Installation of the antennas, beacons, signs and solar panels at the MT site required the use of a bucket truck (Photo: Marcel Huijser, WTI-MSU)

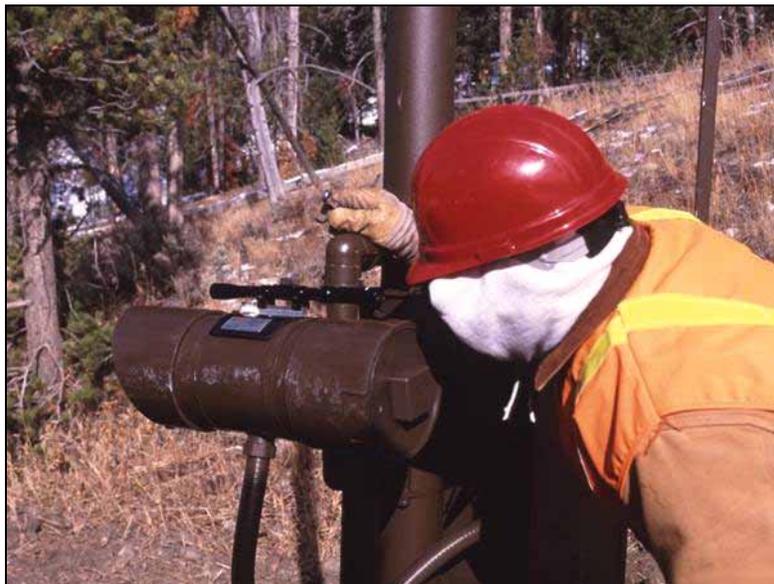
Figure 5.24: Sensors at the MT site were aligned by using a scope (Photo: Marcel Huijser, WTI-MSU)

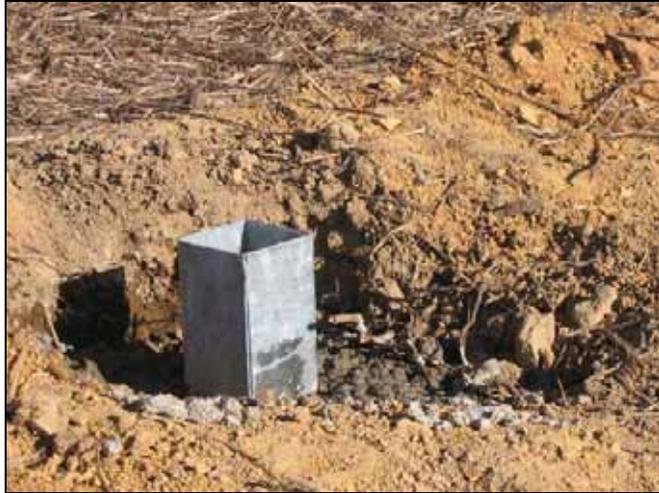
Figure 5.26: The wooden poles were fitted with a concrete foundation at the PA site (Photo: Marcel Huijser, WTI-MSU)

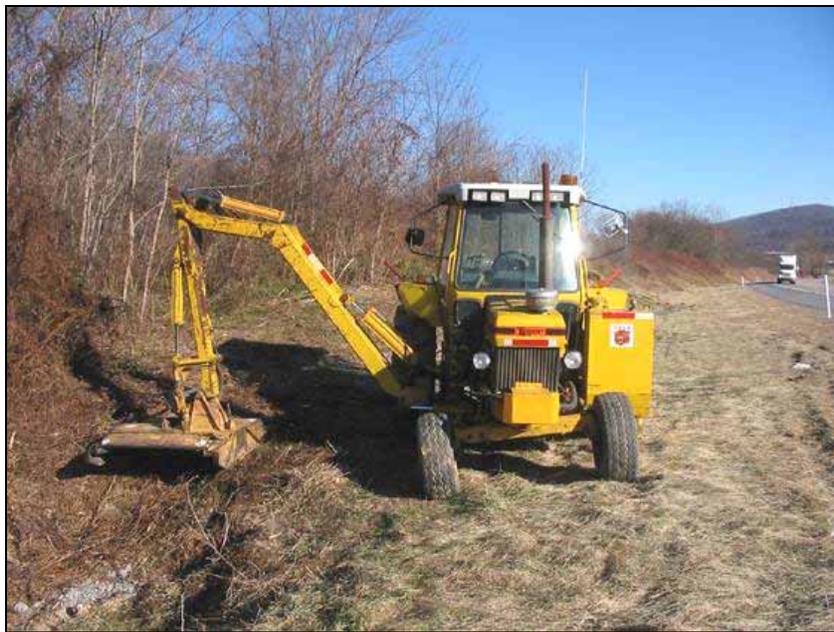
Figure 5.27: Before installation the high shrubs and weeds were cut and branches of trees were removed at the PA site. (Photo: Marcel Huijser, WTI-MSU)

Pennsylvania Department of Transportation (PennDOT): Hosted the system; installed foundations and posts; provided traffic control during post installation; cleared bushes, branches and other vegetation (Figures 5.26 and 5.27); contracted and coordinated the engineering plans, signing plan and "as-builts" with Edwards and Kelcey; coordinated sign manufacturing and delivery; installed the signs; coordinated the installation of 110 V power and a land-based phone line for the control station; and coordinated system installation with Oh DEER, Inc. PennDOT will assume ownership of the system and responsibility for operation and maintenance once the system meets the requirements listed in the RFP, the contract between WTI-MSU and Oh DEER, Inc., and federal and state regulations. PennDOT also paid for the electricity and phone service and coordinated contacts with the media. PennDOT also collected road kill monitoring data.

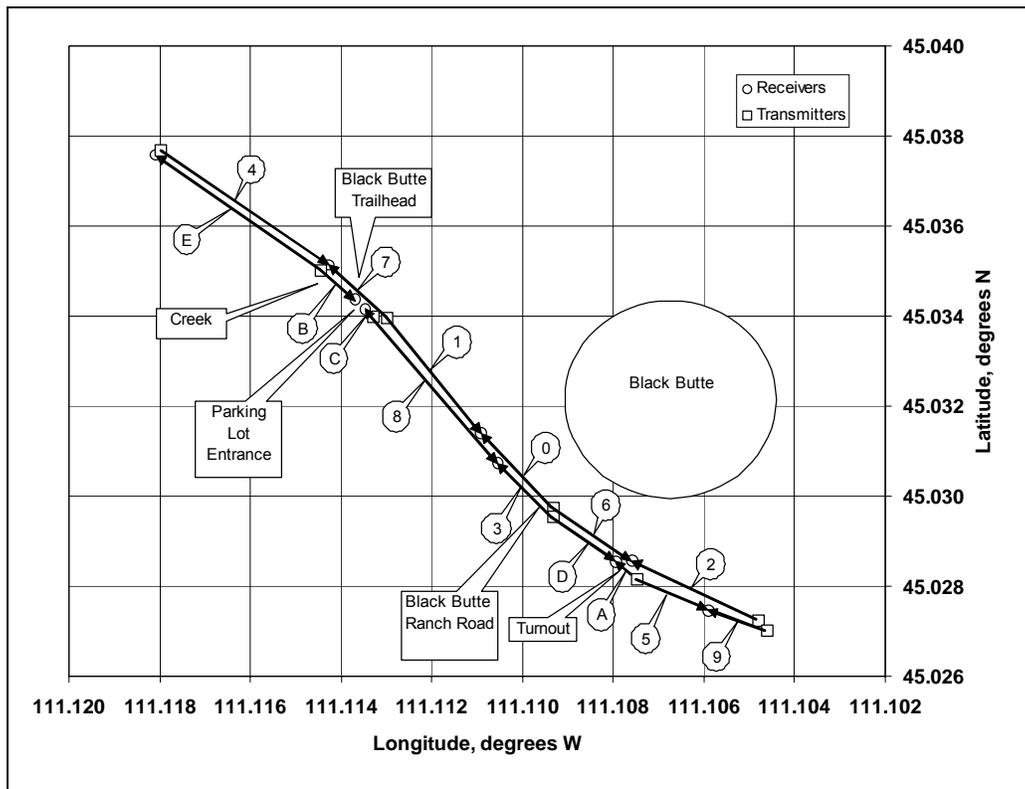
Figure 6.1: RADS layout showing station locations, receivers, transmitters, and codes for the detection zones

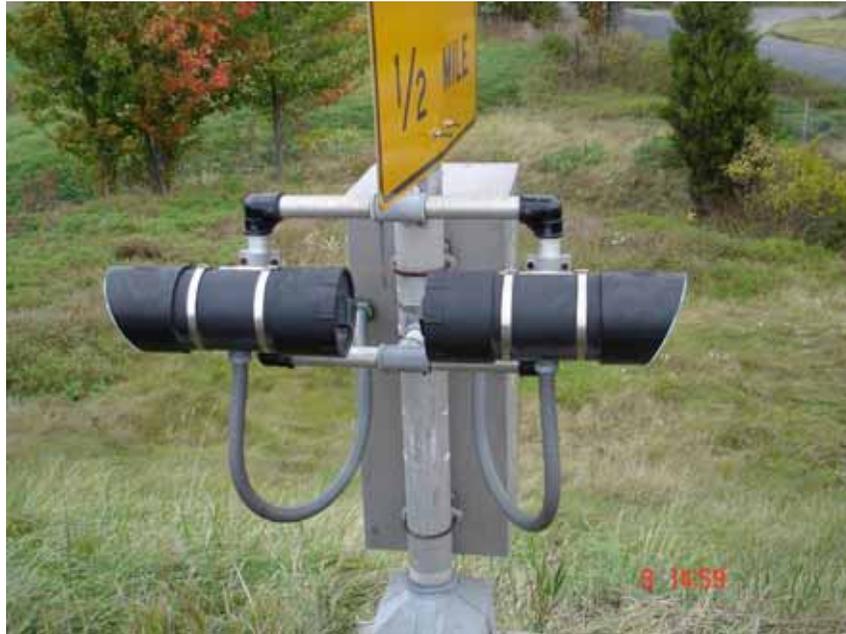
Figure 6.2: Typical receiver/transmitter station showing beam tubes and mounts at an Indiana site (see Chapter 4 for details on the Indiana site) (Photo: Lloyd N. Salsman, STS)

RADS is composed of three station types: transmitter, receiver, and master. An optional traffic warning beacon can be installed on any station type. Figure 6.2 shows a typical station with

mounted beam tubes. The RADS Montana site consists of one master station, nine transmitter stations, and eight receiver stations (see also Chapter 5, Figure 5.7).

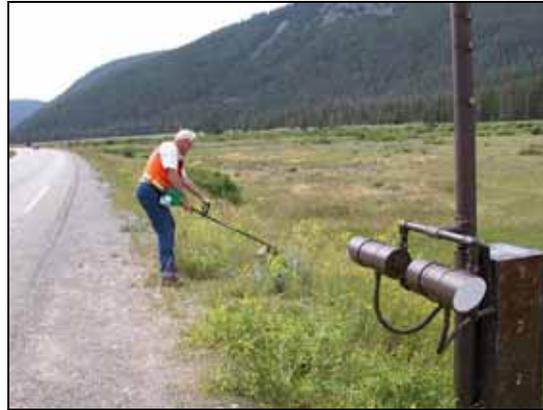
Figure 6.3: Randy Moore mows vegetation in front of one of the sensors to evaluate the effect of high, moving, broad-leafed, and wet vegetation on the occurrence of false positives (Photo: Lloyd N. Salsman/STS)

Several beams were overcome by vegetation in the beam path. Some vegetation removal was allowed by Yellowstone National Park to alleviate this problem. Figure 6.3 shows a vegetation removal operation in the beam path in August 2004.

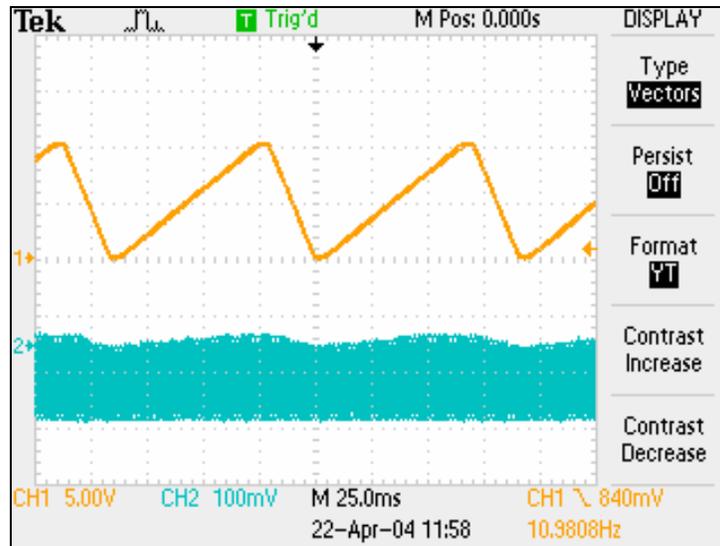
Figure 6.4: Detector output under frequency sweep showing nearly constant sensitivity (bottom) versus frequency (top).

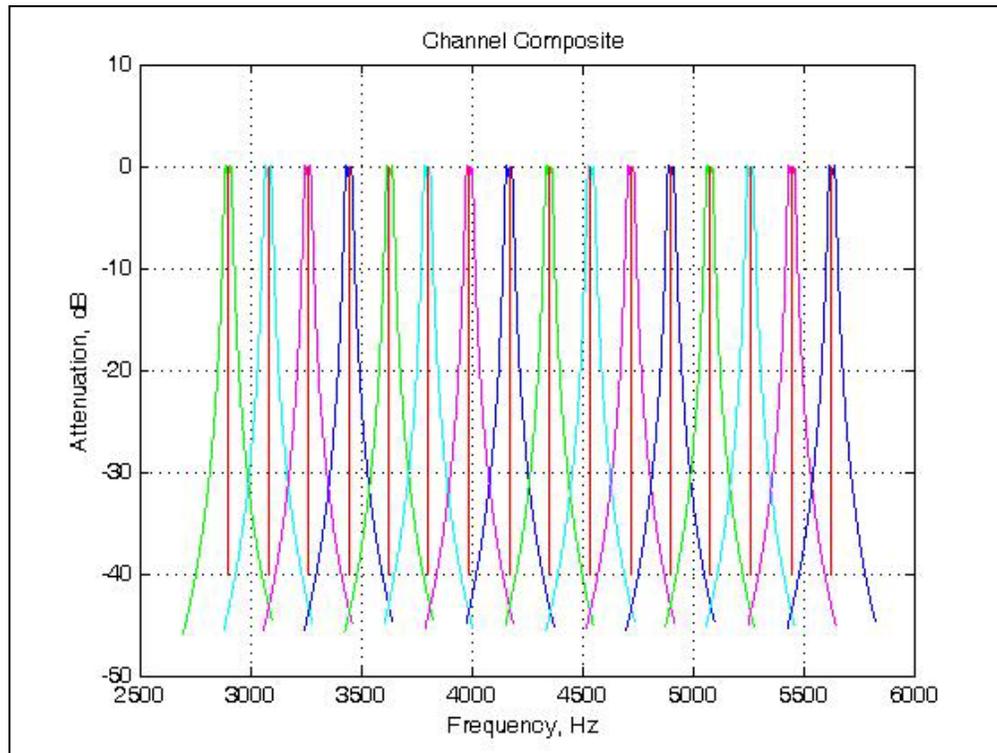
Figure 6.5: Center modulation for each of the 16 RADS Channels. The center modulation is used to distinguish between the individual detection beams (channels).

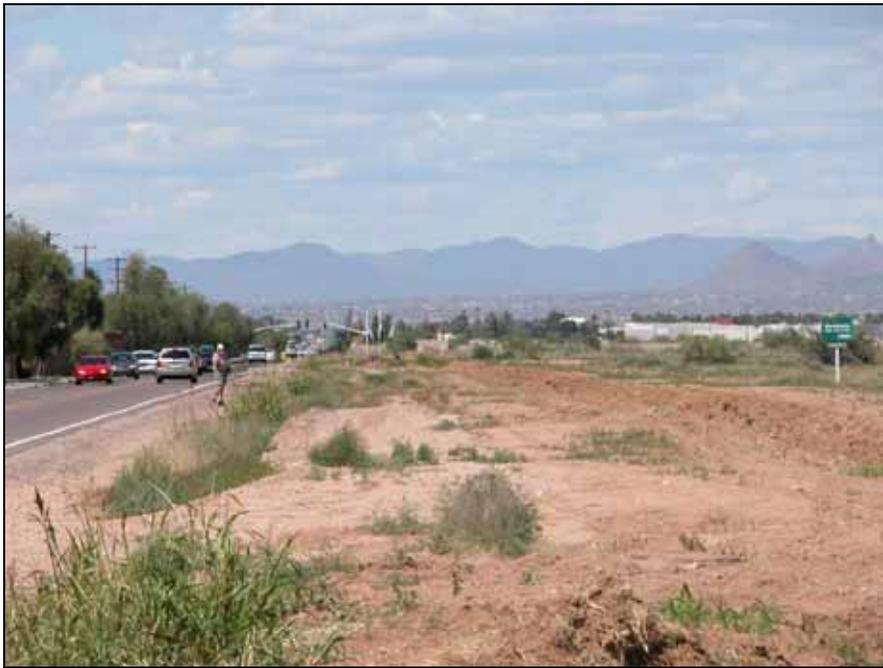
Figure 6.6: Pima Road test site, Scottsdale (Photo: Lloyd N. Salsman, STS)

The system was triggered using various targets, including humans, horses, and birds. The target signatures (receiver levels) were investigated. The results of this study were used to minimize detections not caused by large animals. The effect of road traffic on the signal was investigated by moving the system parallel to Pima Road near Scottsdale. Rotating the polarization of the beams was also studied. Figure 6.6 shows the test site used to evaluate traffic interference. The polarization of the receiver and transmitter beams was changed to minimize reflections from passing vehicles.

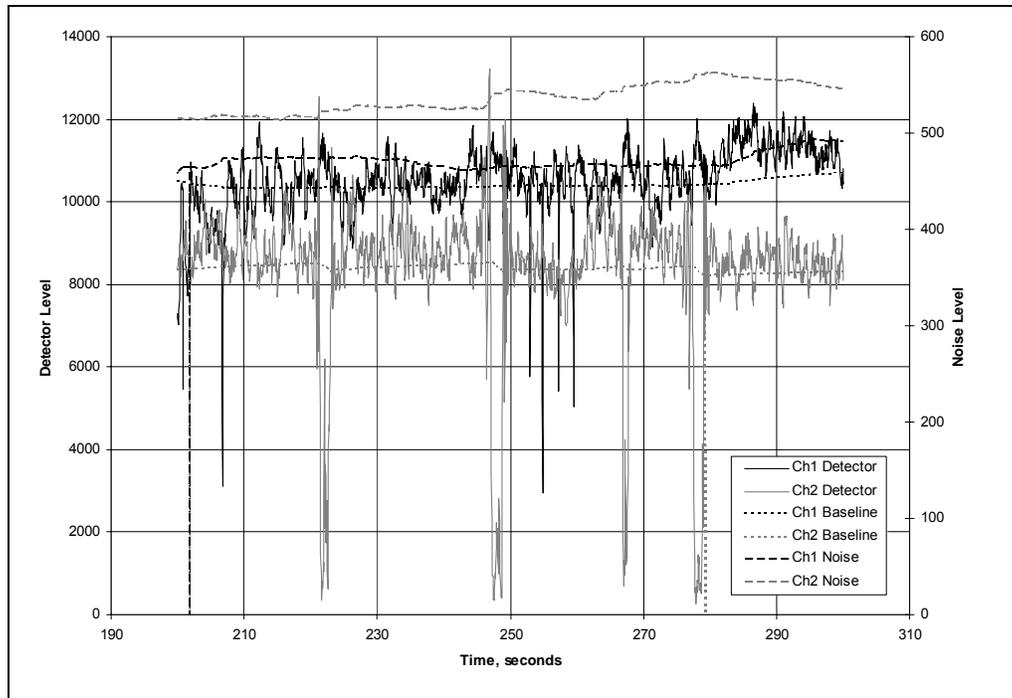
Figure 6.7: Detector recordings from the horse test at the site along US Hwy 191 in Yellowstone National Park, ST18.

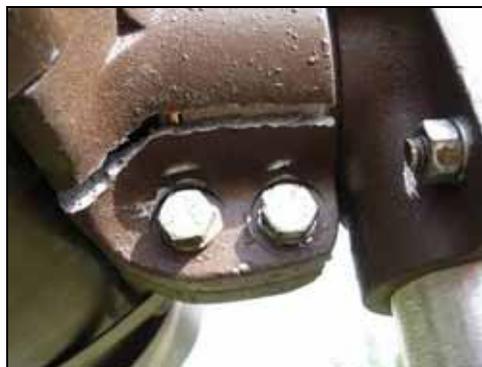
Figure 6.8: The brackets holding the sensors cracked as a result of extreme temperature fluctuations at the MT site  
(Photo: Marcel Huijser, WTI-MSU)

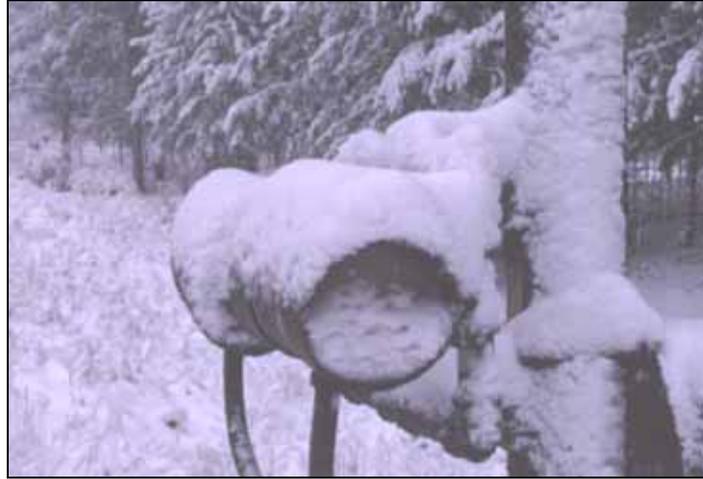
Figure 6.9: Snow and ice build-up on the sensors caused false positives at the MT site (Photo: Marcel Huijser, WTI-MSU)

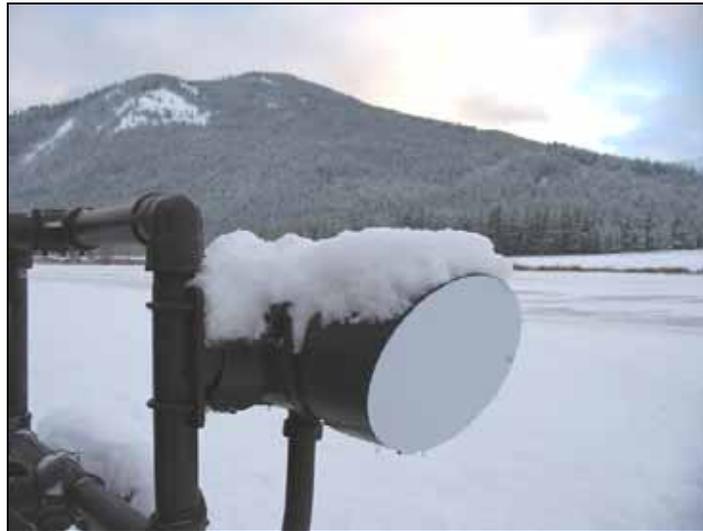
Figure 6.10: Placing a smooth surface at an angle in front of the sensors prevented snow and ice build-up on the sensors at the MT site (Photo: Marcel Huijser, WTI-MSU)

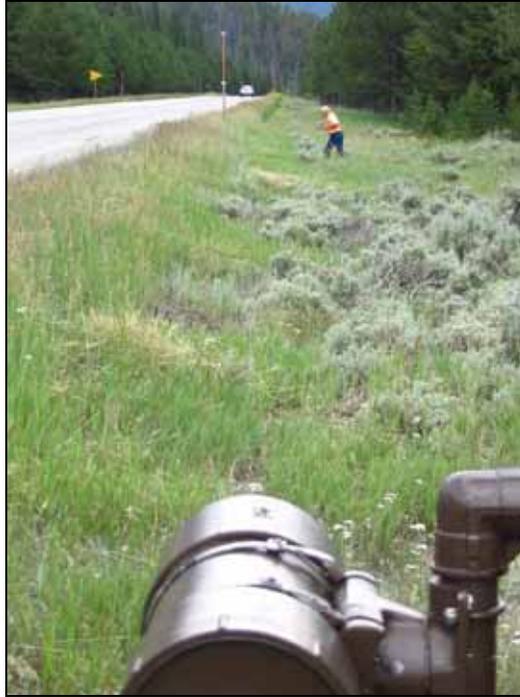
Figure 6.11: Randy Moore (STS) triggers the system at the MT site (Photo: Marcel Huijser, WTI-MSU)

A second visit to the Montana site was conducted during August, 2004. The software for the receiver digital signal processor was modified to incorporate a new adaptive detector algorithm. The beams were triggered using a human as a model for wildlife (Figure 6.11, Figure 6.12). A portable master station was used to operate the RADS installation. The master station software failed to function.

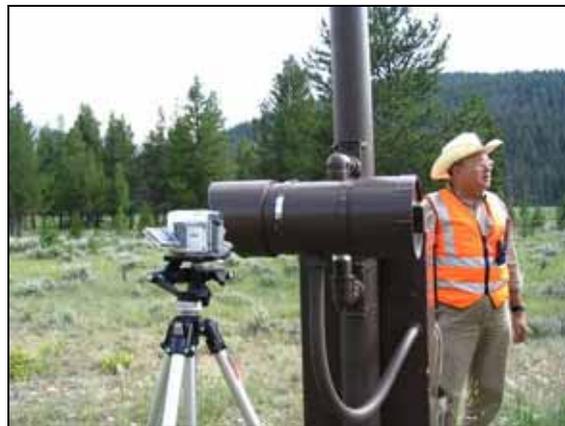
Figure 6.12: Lloyd Salsman (STS) investigating signal signatures at one of the stations at the MT site (Photo: Marcel Huijser, WTI-MSU)

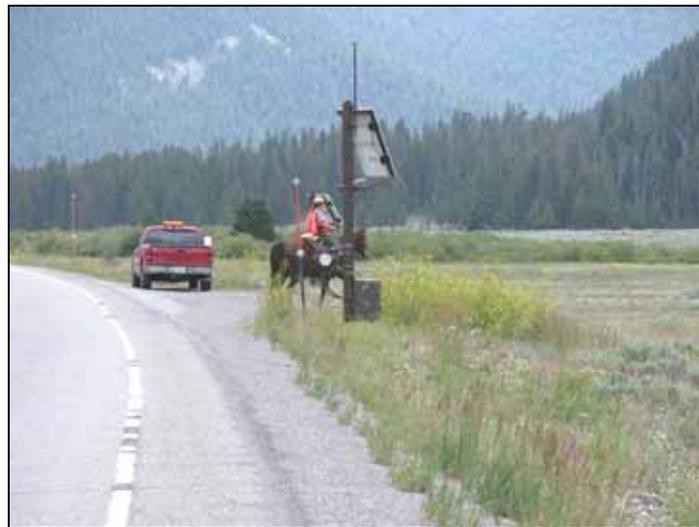
Figure 6.13: Tests with Ranger Gafney and her horse Buster, Yellowstone National Park, Montana (Photo: Lloyd N. Salsman, STS)

During the August 2004 visit a comprehensive test of the detection algorithm was conducted using a horse and rider (see Figure 6.13). The horse and rider were filmed while recording detector outputs under different conditions of speed and aspect.

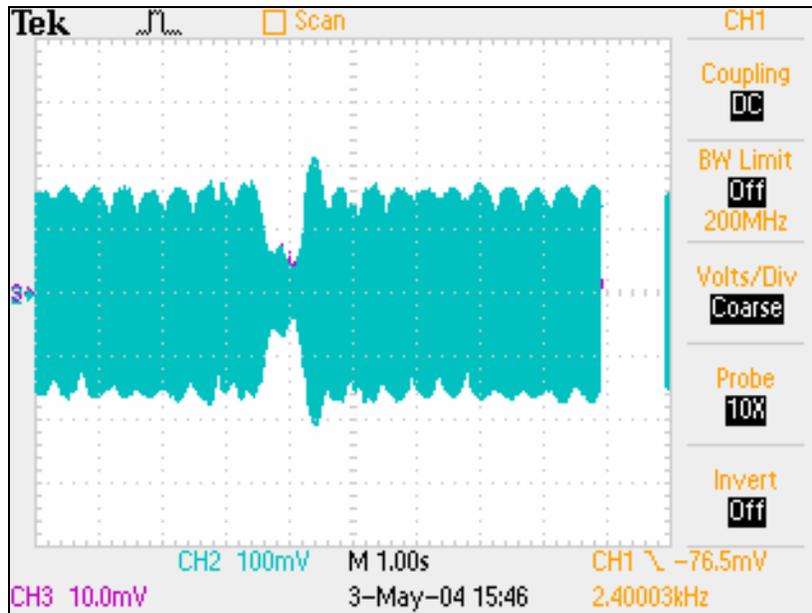
Figure 6.14: Beam break signature for an animal crossing

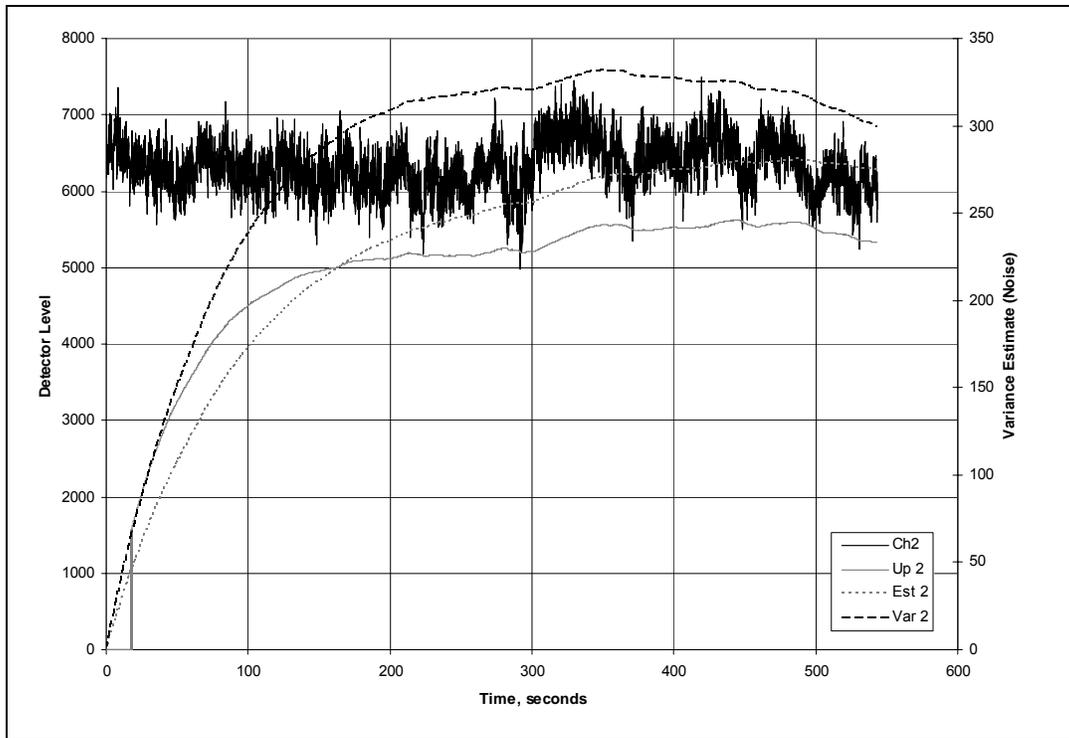
Figure 6.15: RADS “good performance” in a clear path with little vegetation interference. ST12 (3/6) – 20 June 2004, detector - Ch2

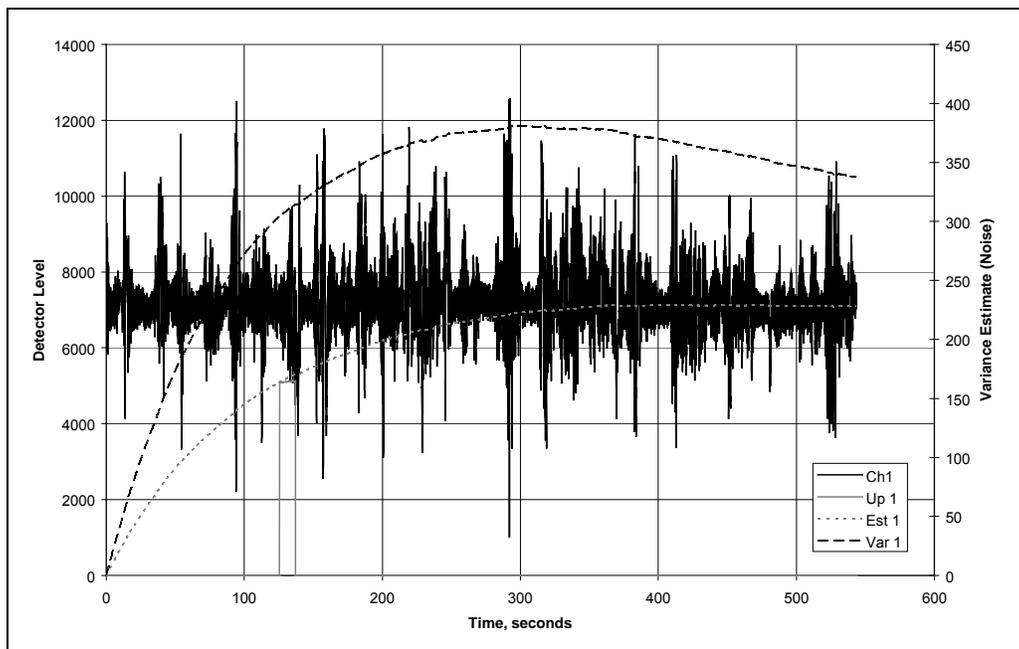
Figure 6.16: RADS “bad performance” for a beam located over a guardrail showing vehicle multipath interference. ST12 (3/6) – 20 June 2004 Detector - Ch1

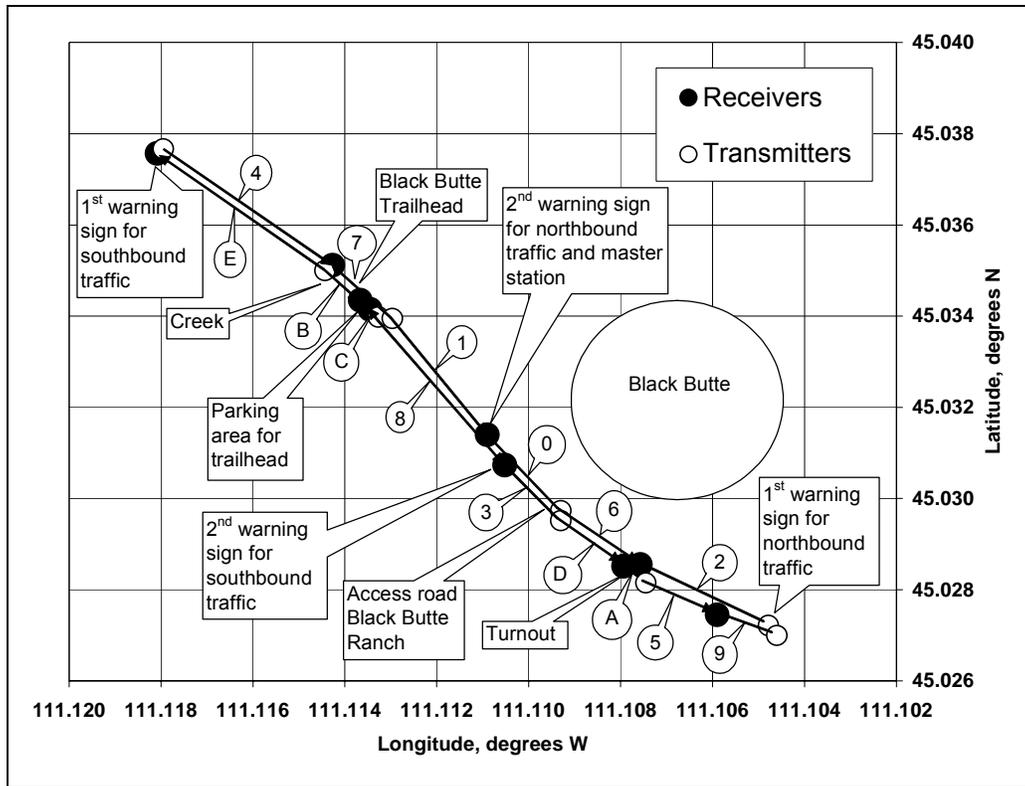
Figure 7.1: Schematic layout of the animal detection system and major road and landscape features at the study site (Source: STS). The numbers and letters represent the codes of the individual detection zones.

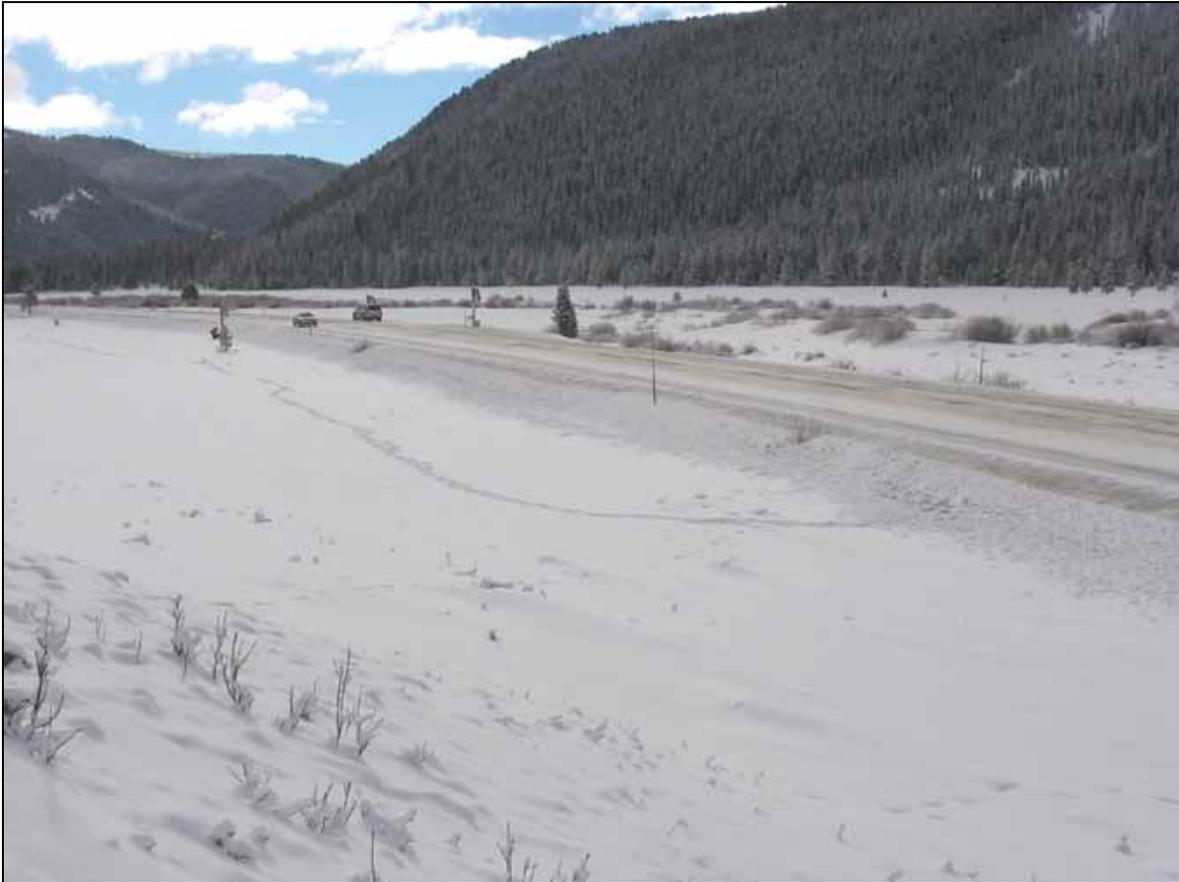
Figure 7.2: Elk tracks in the right-of-way, paralleling the road at the MT site. These movements in the right-of-way may classify as "unclear" detections when interpreting the detection data of the system. (Photo: Marcel Huijser, WTI-MSU)

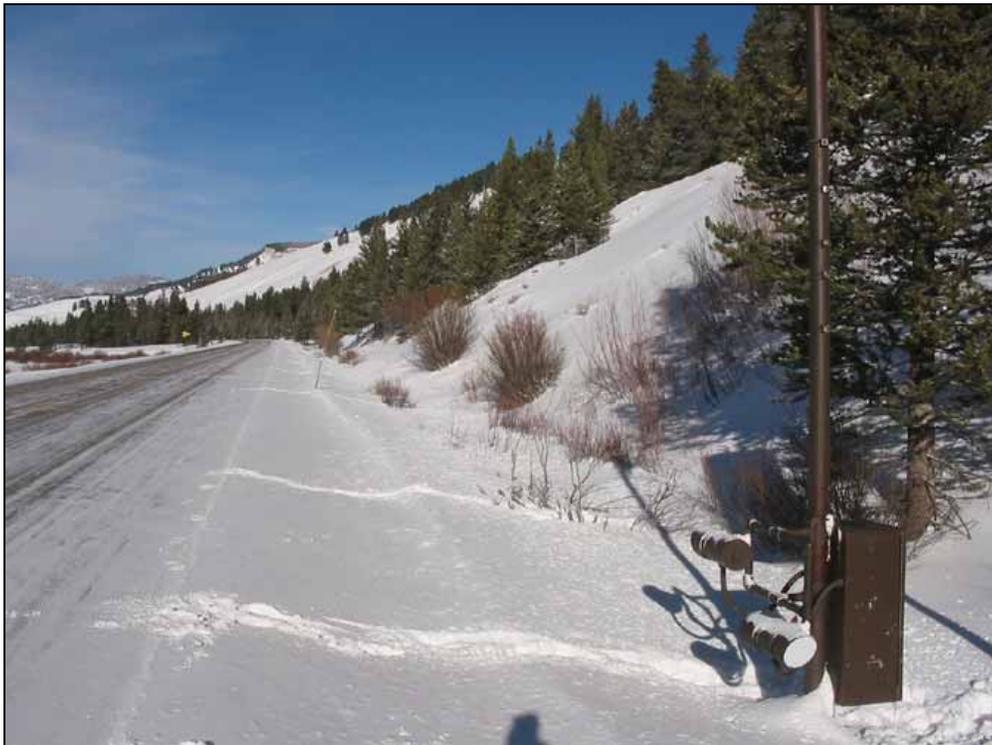
Figure 7.6: Investigation for potential blind spots. The tracks indicate where human models passed through the beam. (Photo: Marcel Huijser, WTI-MSU)

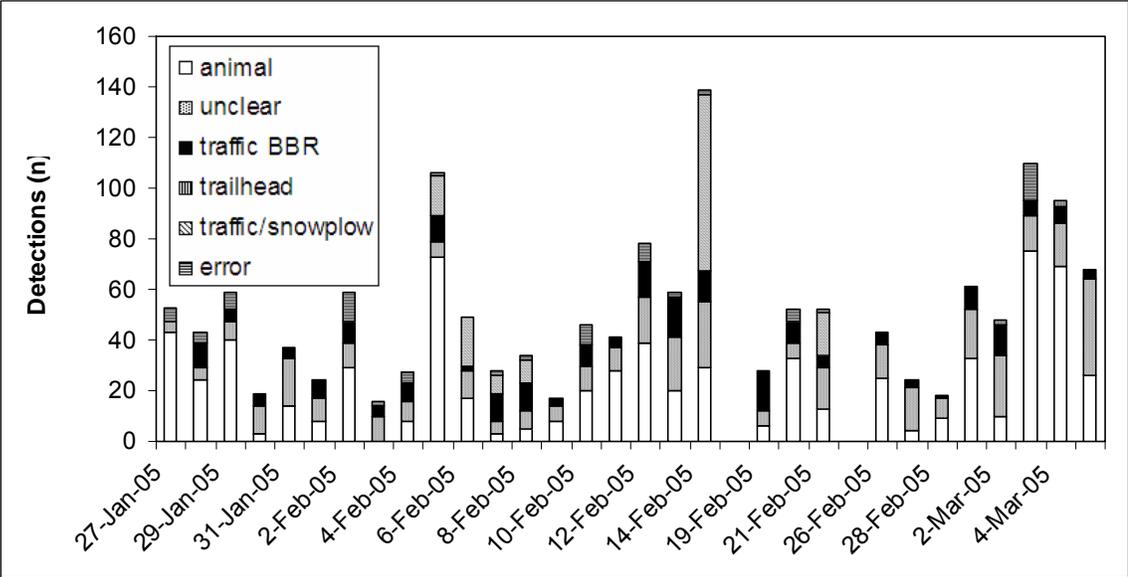
Figure 7.7: Number of detections per day between 26 January and 5 March 2005

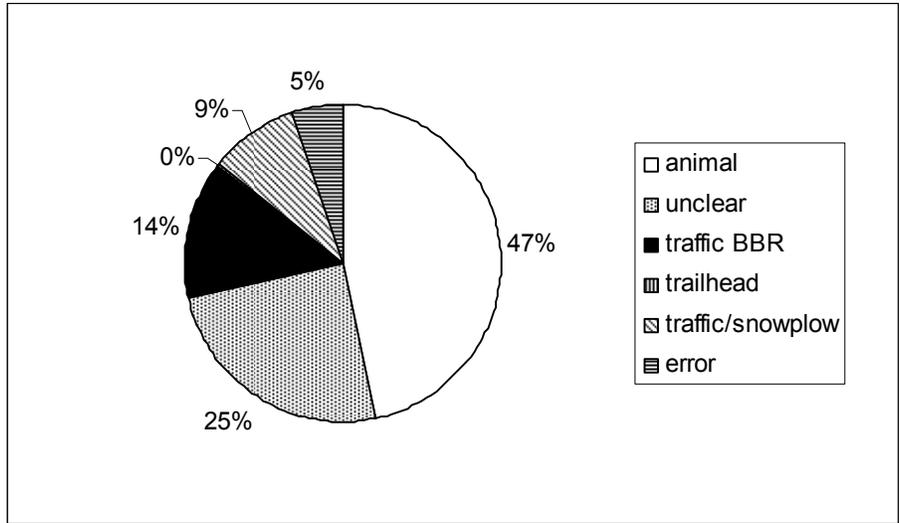
Figure 7.8: Percentage of detections per category (n = 1533) between 26 January and 5 March 2005

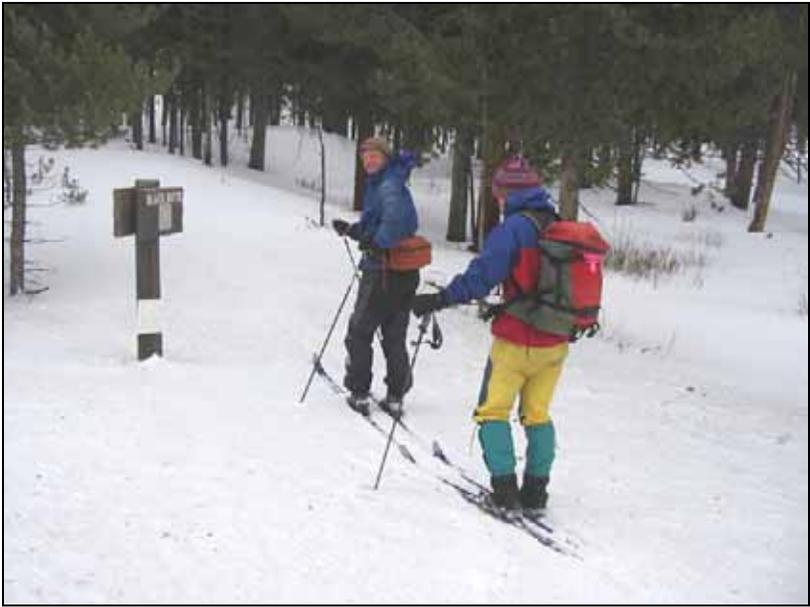
Figure 7.9: Hikers and cross-country skiers at the Black Butte trailhead triggered the system as well (Photo: Marcel Huijser, WTI-MSU)

Almost 47% of all detections were classified as crossings, 25% were classified as unclear, and 14% were classified as traffic on the Black Butte Ranch access road (Figure 7.8). A small number of the detections (0.3%) seemed to be related to hikers or skiers at the trailhead in detection Zone 7 (Figure 7.9). During the periods investigated, 9% of all detections were classified as caused by snow plows or other traffic (Figure 7.10), and 5% of all detections were classified as errors.

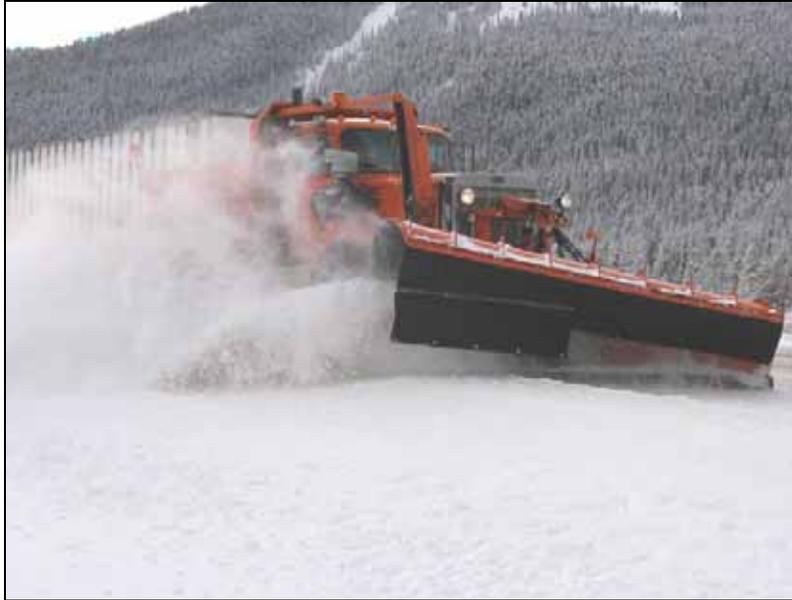
Figure 7.10: Snow spray from a snow plow at the MT site. Depending on the amount of snow spray, how far the snow is thrown into the right-of-way, and the location of the beam, snow spray can trigger the system. (Photo: Marcel Huijser, WTI-MSU)

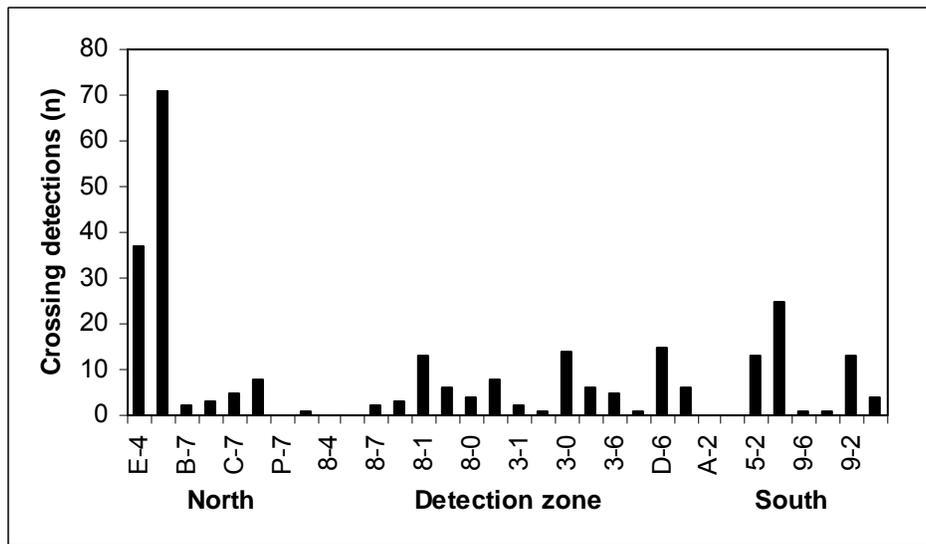
Figure 7.17: Number of crossings based on interpretation of the detection data between 26 January 2005 and 28 February 2005. (See Figure 7.1 for the exact location of the detection zones.)

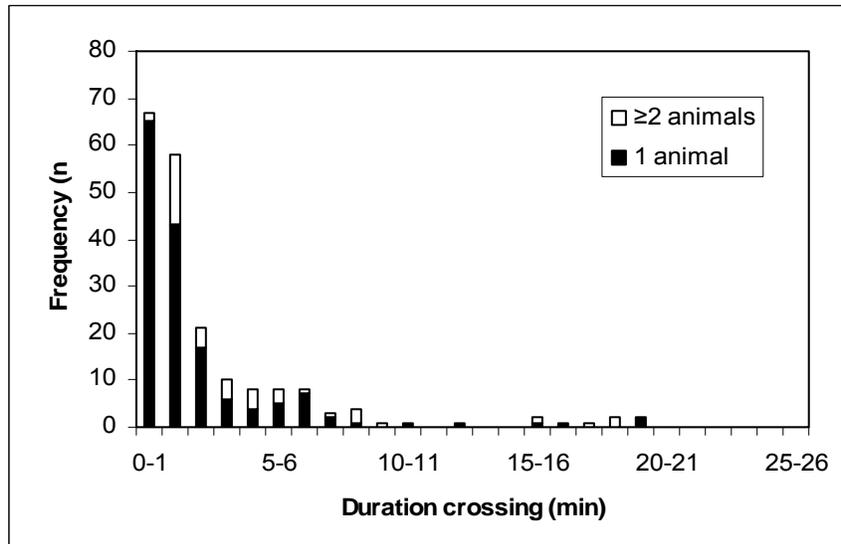
Figure 7.21: Frequency distribution of the duration of crossing events between 27 Jan. 2005 and 5 Mar. 2005
