**ANIMAL VEHICLE CRASH  
MITIGATION USING  
ADVANCED TECHNOLOGY  
PHASE I: REVIEW, DESIGN AND  
IMPLEMENTATION**

**Final Report**

**SPR-3(076)**

**August 2006**

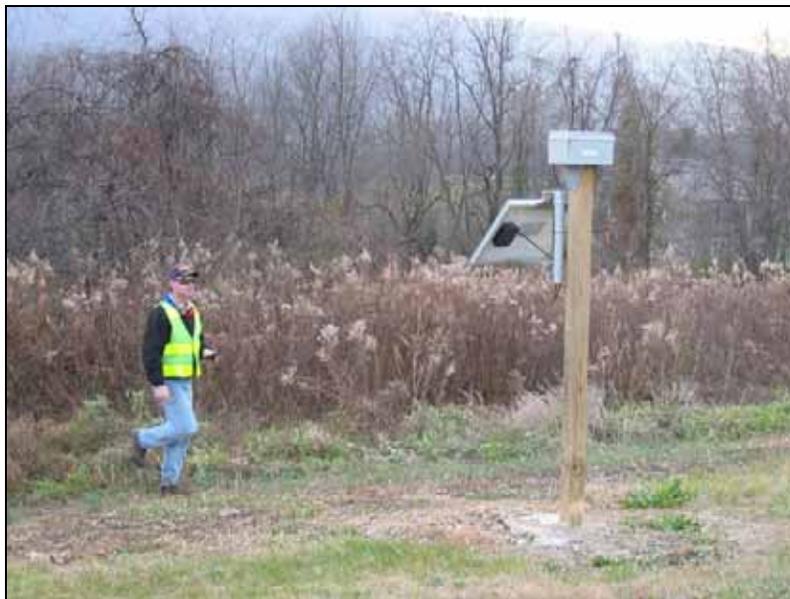
Figure 7.24: Jon Fleming (PennDOT) approaching one of the stations at the PA site to test the reliability of the system (Photo: Marcel Huijser, WTI-MSU)

The system was installed in May 2004 (see also Chapter 4). The system suffered from a range of technological challenges (see Chapter 8 and Appendix C). A reliability test was done on 18 November 2004. PennDOT and WTI-MSU staff triggered the system with human models at known times and at known locations and recorded whether the flashing lights were activated (Figure 7.24) (see Appendix H). The system should have been triggered almost constantly during the 42 min 15 sec testing period. However, the system was only activated 20 times (for 1-2 seconds at a time, based on the current settings for the beacons). The system was usually not activated when human models ran 10-25 m in front of and around multiple sensors.

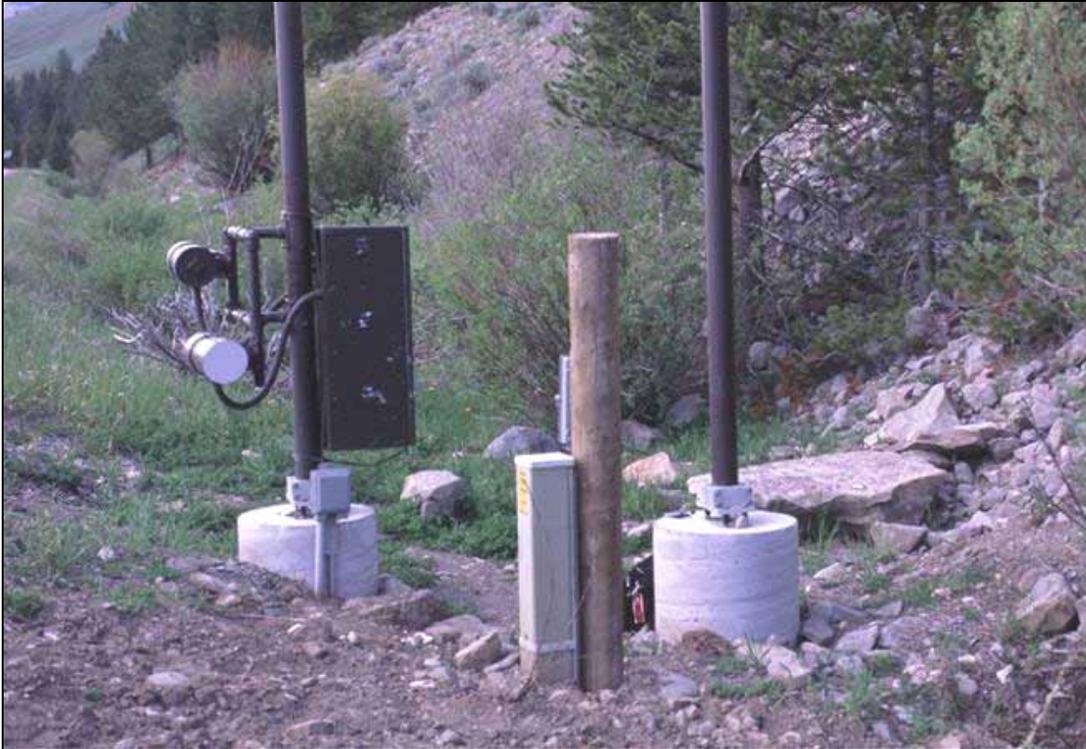
Figure 8.1: Some of the concrete foundations were in the clear zone and too high above the ground. This is the master station. The wooden post on the foreground is for the link to the land-based phone line. (Photo: Marcel Huijser, WTI-MSU)

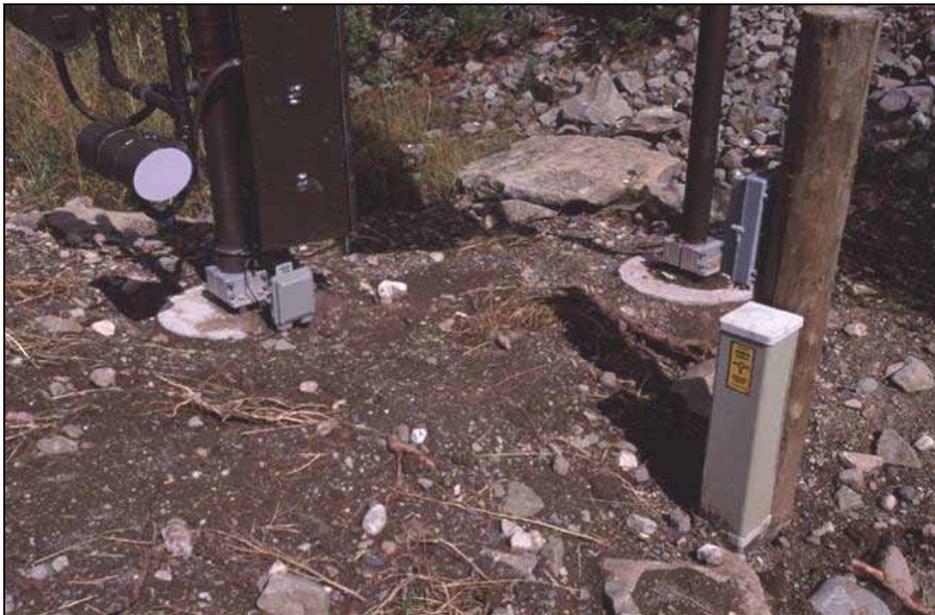
Figure 8.2: The problem with some of the concrete foundations was addressed by putting weed free soil around the posts while not blocking the drainage from the road. (Photo: Marcel Huijser, WTI-MSU)

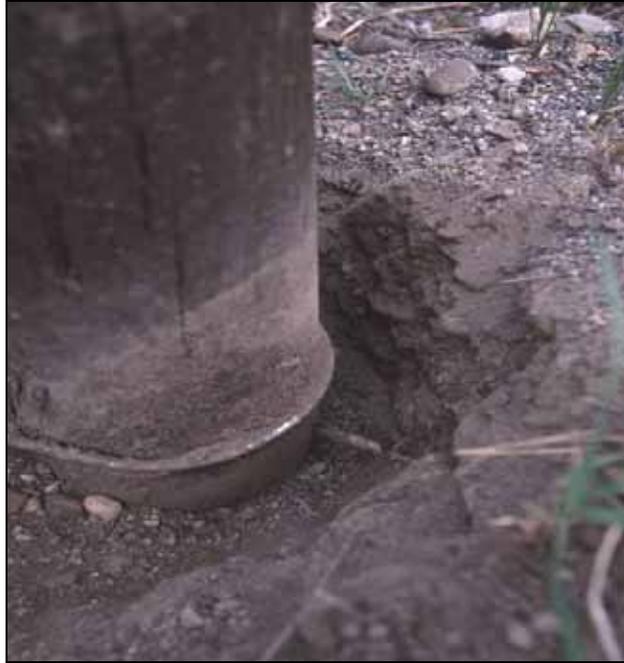
Figure 8.3: Some of the wooden poles were buried too deep. The stick indicates the upper of the three holes that serve as a break-away in case of a collision. All three holes should have been above the ground level. (Photo: Marcel Huijser, WTI-MSU)

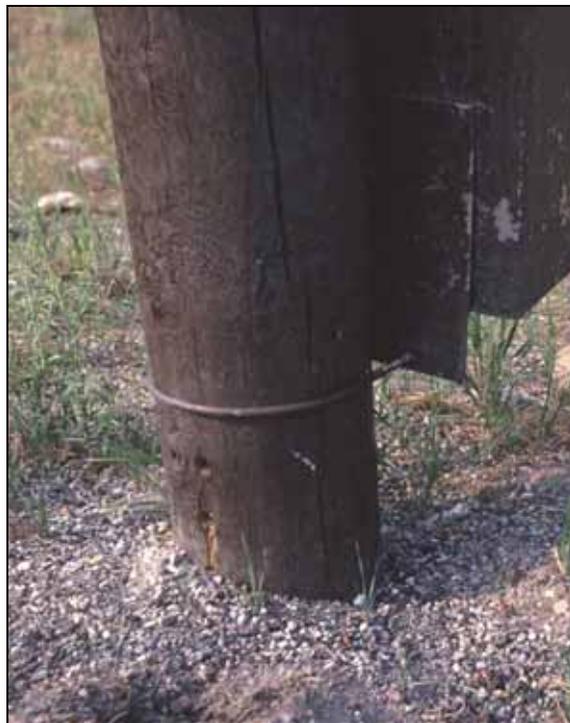
Figure 8.4: The problem with some of the break-away constructions for the wooden poles was addressed by drilling new holes at the appropriate height above the ground level. (Photo: Marcel Huijser, WTI-MSU)

Generally the installation contractor performed well, but one aspect of the work was not inspected. The top of some of the concrete foundations was too high above the ground level; they did not meet the requirements for the clear zone (Figure 8.1). This required additional ground work and the transport of weed free soil to the site (Figure 8.2). In addition, some of the wooden poles were buried too deep in the ground; the holes in the poles that serve as a break away construction in case of a collision were buried (Figure 8.3). This was simply addressed by drilling additional holes in the wooden poles at the appropriate level (Figure 8.4).

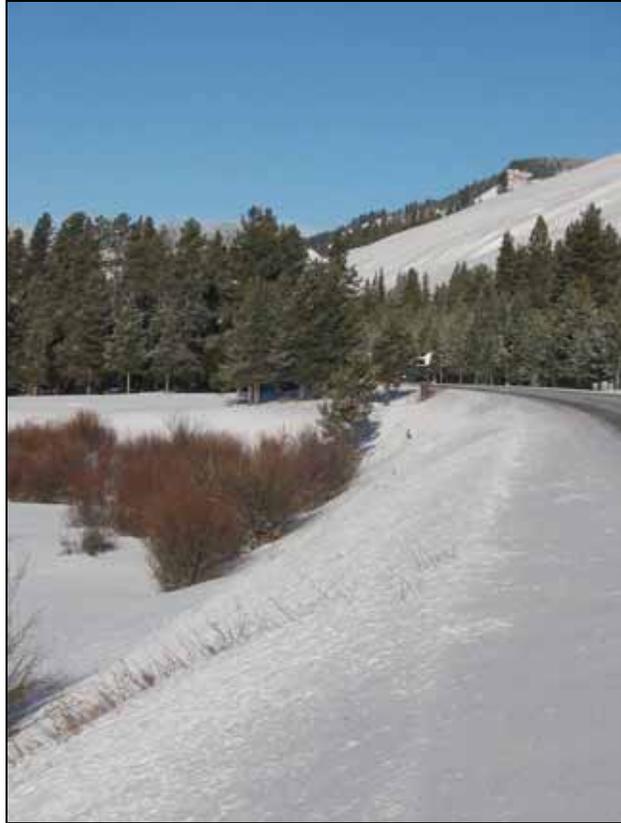
Figure 8.5: Curves and slopes caused the beam to shoot too high in some locations at the MT site, causing blind spots. Shown here is detection Zone 8 (see Figure 5.7 for exact location). (Photo: Marcel Huijser, WTI-MSU)

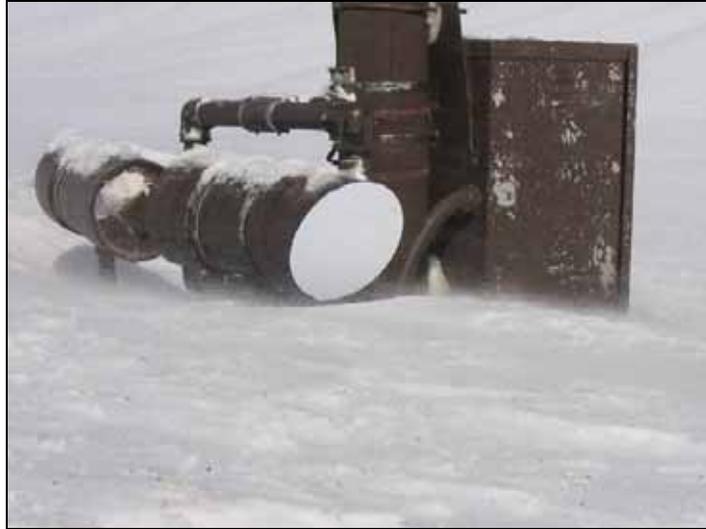
Figure 8.6: Snow accumulation at the MT site. Snow accumulation may bury the sensors, potentially causing downtime for the system. (Photo: Marcel Huijser, WTI-MSU)

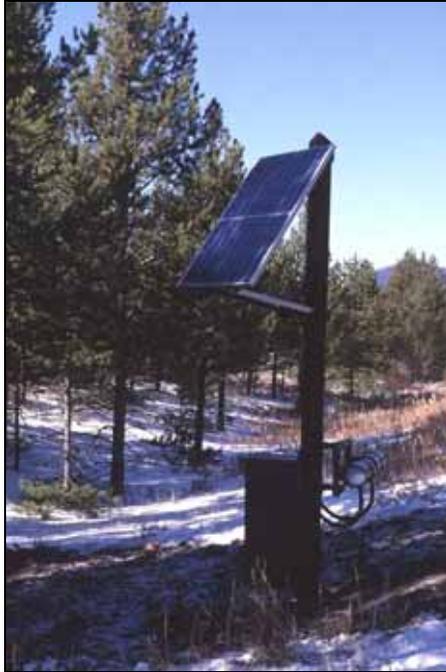
Figure 8.7: Care should be taken that solar panels are not placed in the shade of trees or other objects, including steep slopes. The angles of the sun should be calculated during winter, as daylight is scarce and the sun is low on the horizon. (Photo: Marcel Huijser, WTI-MSU)

Most animal detection systems are located in remote areas where 110 V or 220 V is not readily available. Even if such a power source is available it may be relatively expensive to bring power to the individual stations with the sensors. Edwards and Kelcey (2003) calculated that it would cost a minimum of \$52,893 for trenching and conduit for 2 times ½ mi (both sides of the road) for the PA site. This estimate was based on a cost of \$32.87/m (\$10/ft), not including electricity costs. Solar power can be a cost effective alternative. The total costs for solar power for the PA site were estimated at approximately \$7,500. Solar panels should be positioned such that shadows are taken into account, especially during winter when the sun is low on the horizon and shadows are long (Figure 8.7). Battery storage should also be designed to cope with long nights, dark days, and potential snow cover (Figure 8.8). Fuel cell technology may be an option for areas that do not receive enough sunlight (e.g., in the arctic or in deep canyons).

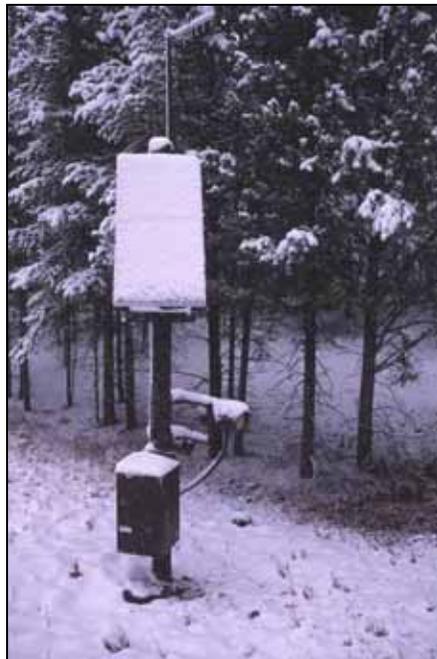
Figure 8.8: Snow may temporarily cover the solar panels. The batteries should have enough power storage to accommodate for such events. (Photo: Marcel Huijser, WTI-MSU)

Snow cover on solar panels usually disappears quickly when the sun is out, even if the temperature remains well below freezing. Snow and ice should not be removed from the solar panels, as that may damage the solar panels in the process. Some of the solar panels

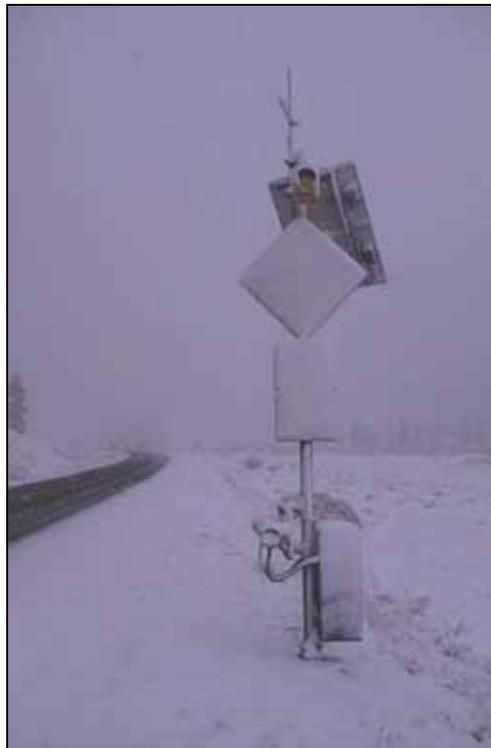
Figure 8.9: Snow may temporarily cover warning signs and signals (Photo: Marcel Huijser, WTI-MSU)

As more animal detection systems are installed and become operational, it becomes more important to standardize the warning signals and signs. However, there remains much to be learned about how different signs may contribute to the effectiveness of an animal detection system (see Chapter 3), and regulations for traffic signs sometimes differ between states. Note: Graphic warning signs (e.g., a black silhouette of an elk or a moose on a yellow background) are often stolen, as experienced at the MT site (see Section 8.3.3.5). This may be a reason to use text messages only, e.g., “wildlife crossing” on a yellow background. Furthermore, some states may need to modify the regulations regarding ITS signage to allow for signs that stimulate the drivers to use “extra” caution when the warning signs and signals are activated (see later). Finally, snow may temporarily obscure the signs (Figure 8.9).

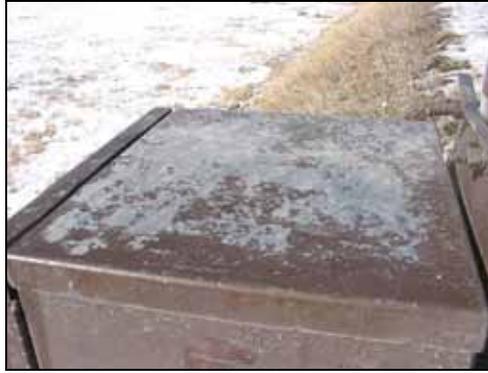
Figure 8.10: The elements can be hard on the equipment and the paint (Photo: Marcel Huijser, WTI-MSU)

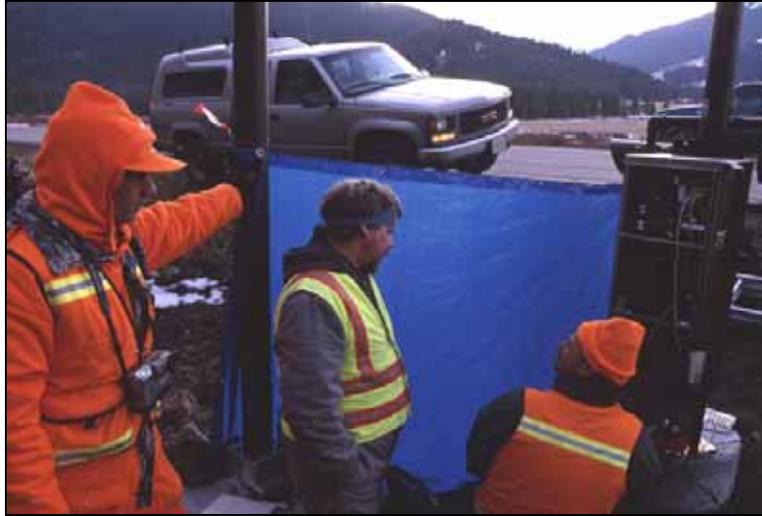
Figure 8.12: STS and MDT representatives at the MT site. After installation the system suffered from a range of technological challenges which required problem identification, problem solving and evaluation (Photo: Marcel Huijser, WTI-MSU).

Since animal detection systems are likely to suffer from various problems after installation, it is advisable to have the vendor monitor the system at the site immediately after installation, perhaps for two to four weeks initially. The vendor must have appropriate tools, spare parts and other materials on site, as this effort is likely to include modifications and repairs. If problems are not identified or solved on site (Figure 8.12) further delays can occur.

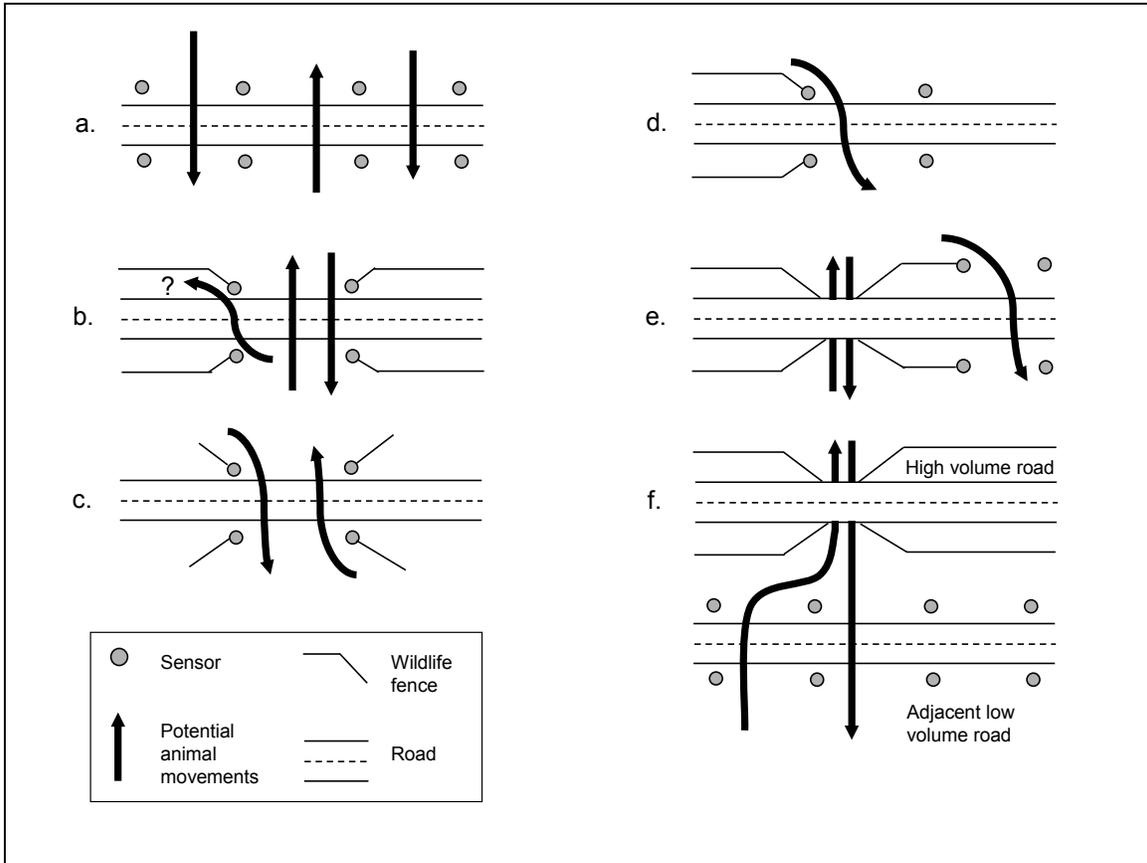
Figure 10.1: Potential applications of animal detection systems

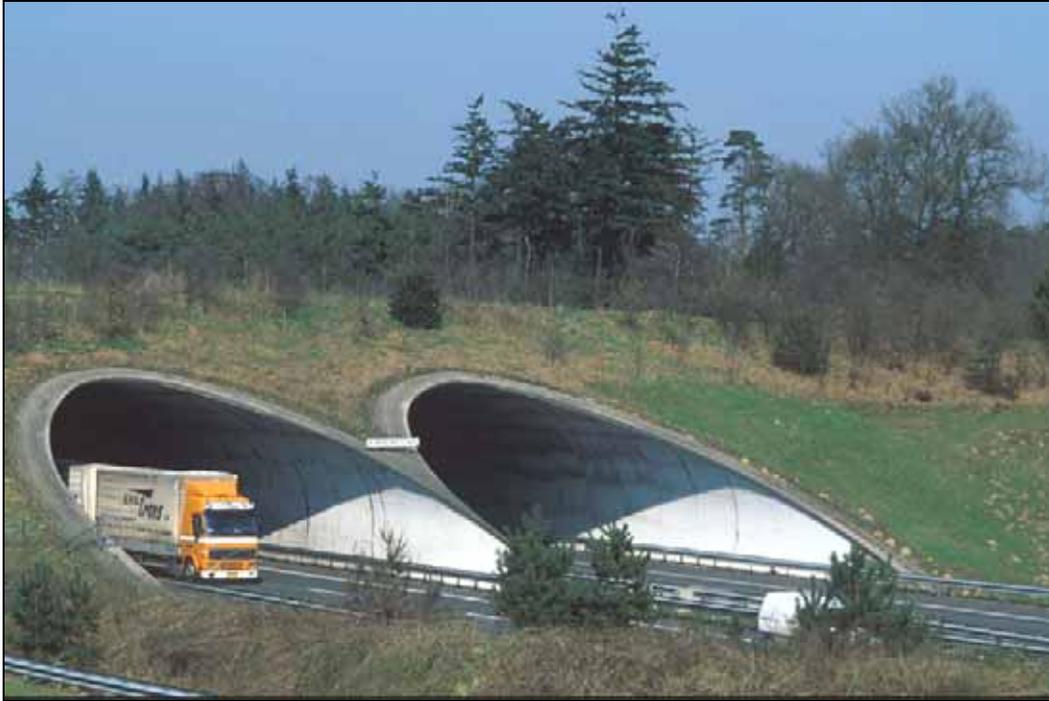
Figure 10.2: Wildlife crossing structures are often combined with wildlife fencing to guide the animals towards the crossing structure. Since some animals may walk the other way and cross the road where the fence ends, an animal detection system may be applied also. (Photo: Marcel Huijser, WTI-MSU)

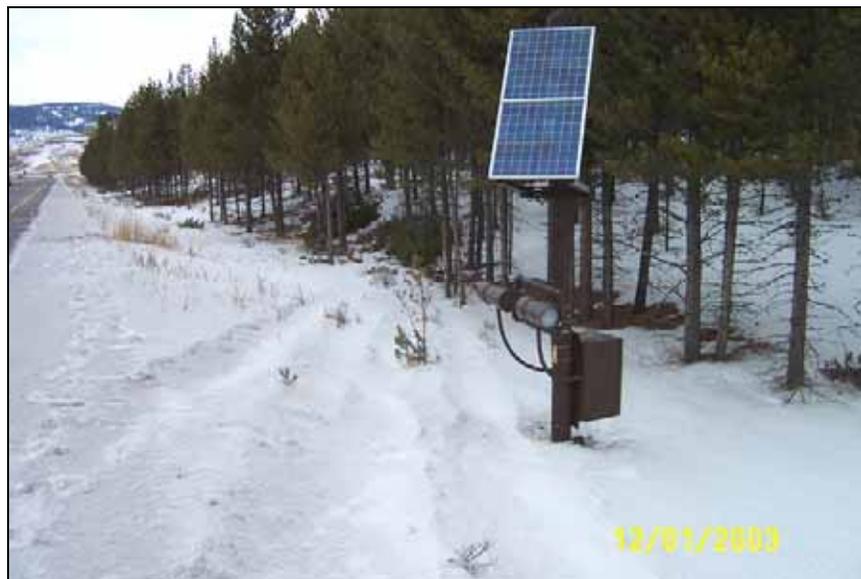
Figure 10.3: Animal detections may reduce or prevent animal-vehicle collisions, but the poles and equipment in the right-of-way form a hazard of their own. Here a car went off the road at the MT site and just missed the pole. However, the damage to one of the sensors was about \$2000. (Photo: Jason Norman, MDT)

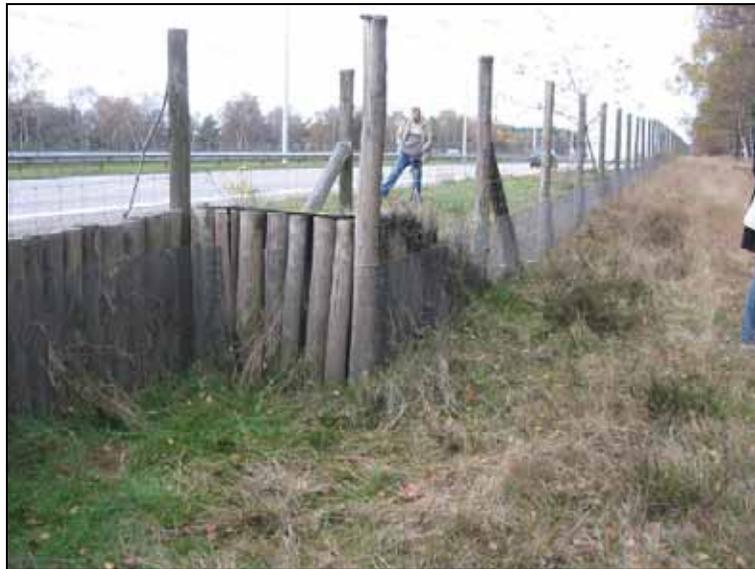
Figure 10.4: Wildlife fences guide large animals towards the crossing area with the animal detection system. Long fence sections should have jump-outs however, to provide an escape for animals that might end up in between the fences in the right-of-way. (Photo: Bethanie Walder)

Animal detections systems may be combined with wildlife fencing (Figure 10.1 and Figure 10.4). Extensive or limited wildlife fencing on both road sides and on either side of an animal detection system may help funnel the animals towards a road section with an animal detection system (Figure 10.1.b and c). This increases the length of the mitigated road section, and it may
