**EXPLORATION OF WILDLIFE MITIGATION  
MEASURES FOR THE ROADS THROUGH AND  
AROUND FISHERMAN ISLAND AND CHINCOTEAGUE  
NATIONAL WILDLIFE REFUGES, VIRGINIA**

FINAL REPORT

Western Transportation Institute  
College of Engineering, Montana State University, P.O. Box 174250. Bozeman, MT 59717-4250

February, 2019

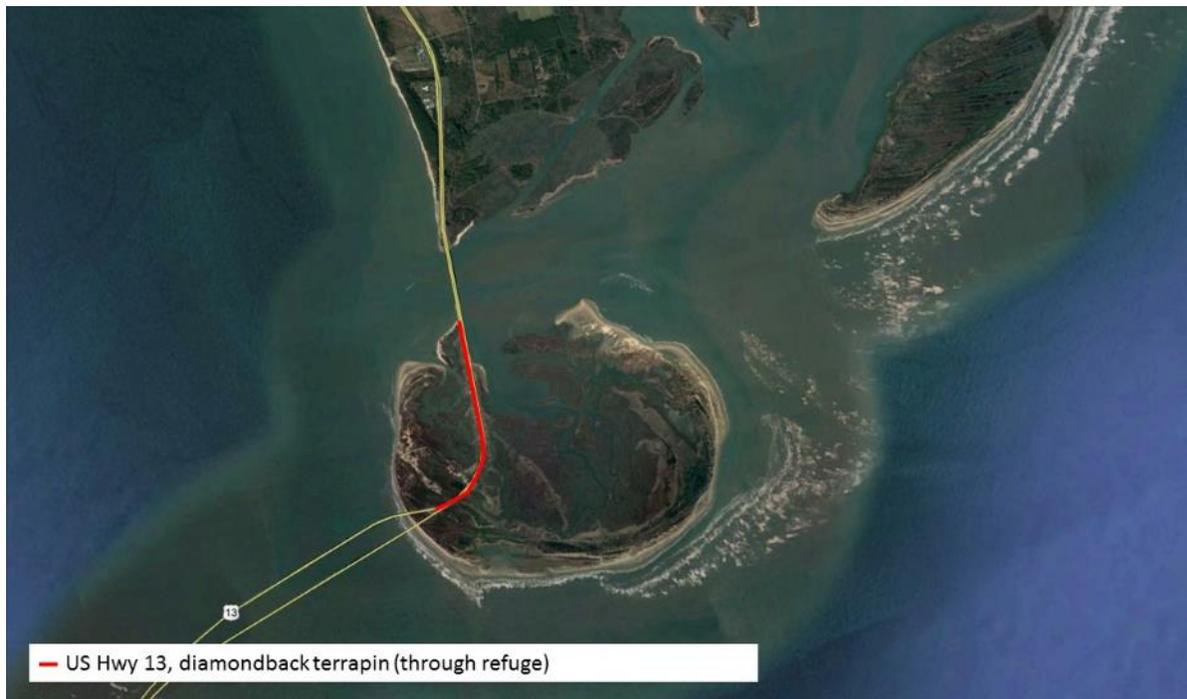
Figure 3: US Hwy 13 on Fisherman Island National Wildlife Refuge, Virginia, USA.

Road mortality of northern diamondback terrapin (*Malaclemys terrapin terrapin*) along US Hwy 13 through the refuge, is a major concern (Figure 3). The northern diamondback terrapin lives in brackish saltwater marshes, coastal bays, and lagoons, and is impacted by habitat loss, mortalities in crab pots, and road mortality. Nesting females appear especially vulnerable to road mortality when they move to higher nesting areas. The species is considered “Near Threatened” on an international level (IUCN, 2018), not listed on a USA Federal level, and is a species with a “Very High Conservation Need” on the state level (Virginia Department of Game and Inland Fisheries, 2015). Some people swerve or stop their vehicle along US Hwy 13 when they see a turtle on or near the road to save it (Holloway, 2016). Given the safety risks associated with swerving or stopping a vehicle along a high traffic volume (Average Annual Daily Traffic was 10,956 in 2017) and high-speed highway (posted speed limit 55 MPH), it is desirable to prevent turtles from accessing the road surface altogether and replace and lengthen the existing barrier (Holloway, 2016; Pers. com. Timothy R. Holloway, Chesapeake Bay Bridge-Tunnel).

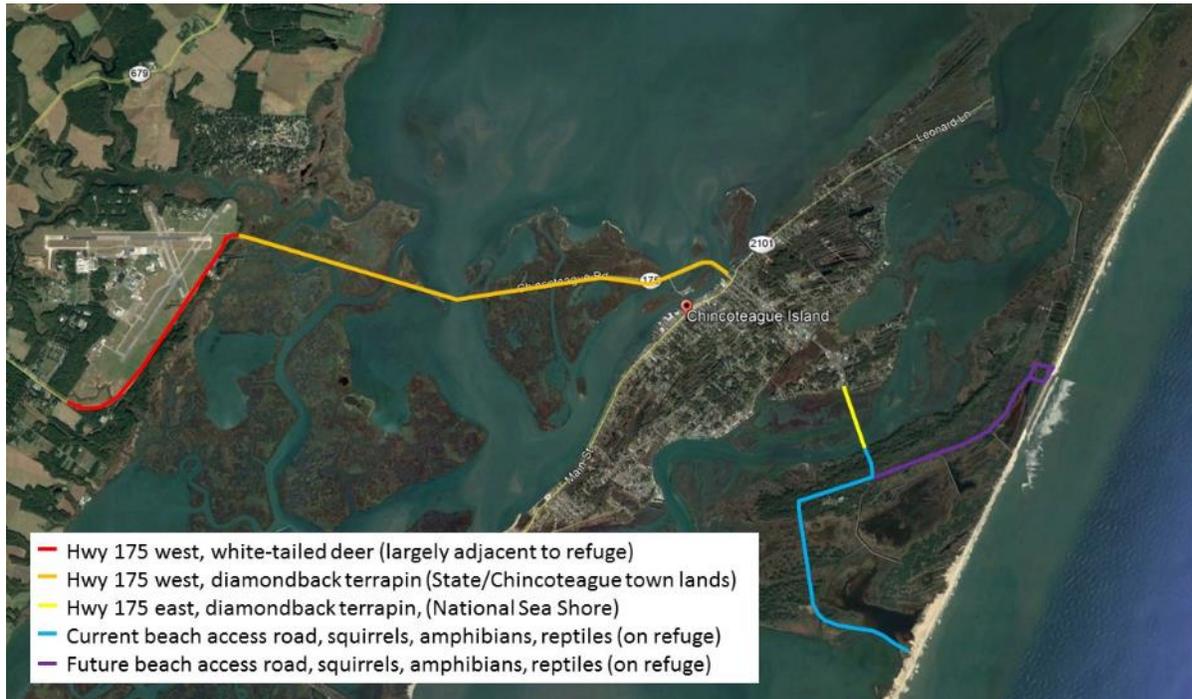
**Figure 4: The roads on and around Chincoteague National Wildlife Refuge, Virginia, USA. Note that the road sections are based on ecological issues rather than land ownership.**

Hwy 175 west (red in Figure 4) is located between Wallops Island National Wildlife Refuge (WINWR) and the National Aeronautics and Space Administration’s Wallops Flight Facility (NASA-WFF). It has a relatively high concentration of white-tailed deer-vehicle collisions (Pers. comm. Nancy Finley, Kevin Holcomb and Robert Leffel, USFWS). The refuge lands are mostly forested, whereas Hwy 175 has wide grassy shoulders. Note that there is a fence on the north-west side of the highway, keeping people, deer, and other wildlife species from entering the airport.

Another section of Hwy 175 west (orange in Figure 4) bisects Chincoteague Bay and salt marshes. Hwy 175 is a causeway with bridges across the major channels. The surrounding lands are managed by the NASA-WFF, Virginia Marine Resources Commission (VMRC), and the town of Chincoteague. Here, road mortality of northern diamondback terrapin is a major concern (Pers. comm. Nancy Finley, Kevin Holcomb and Robert Leffel, USFWS).

Hwy 175 west (red in Figure 4) is located between Wallops Island NWR and NASA Wallops Flight Facility. It has a relatively high concentration of white-tailed deer-vehicle collisions (Pers. comm. Nancy Finley, Kevin Holcomb and Robert Leffel, USFWS). The refuge lands are mostly forested, whereas Hwy 175 has wide grassy shoulders. Note that there is a fence on the north-west side of the highway, keeping people, deer, and other species from entering the airport (Figure 35).

Another section of Hwy 175 west (orange in Figure 4) bisects Chincoteague Bay and saltmarshes. Here Hwy 175 is a causeway with bridges across the major channels (Figure 40, 41). The surrounding lands are managed by the NASA-WFF, Virginia Marine Resources Commission, and the town of Chincoteague. Here, road mortality of northern diamondback terrapin is a major concern (Pers. comm. Nancy Finley, Kevin Holcomb and Robert Leffel, USFWS). The northern diamondback terrapin mortality primarily occurs during the nesting season between the end of May and mid-July (Pers. comm. Nancy Finley, Kevin Holcomb and Robert Leffel, USFWS). It is suspected that adult females are attracted to the higher and drier soil of the roadbed to lay their eggs (Pers. comm. Nancy Finley, Kevin Holcomb and Robert Leffel, USFWS).

Hwy 175 east (yellow in Figure 4) connects the town of Chincoteague on Chincoteague Island with Chincoteague NWR on Assateague Island. It crosses a saltmarsh and the Assateague Channel and is within the boundaries of the town of Chincoteague and Assateague Island National Seashore. Road mortality of northern diamondback terrapin is a concern here too (Pers. comm. Nancy Finley, Kevin Holcomb and Robert Leffel, USFWS).

The current beach access road (blue in Figure 4) is located within Chincoteague. The forested sections of this road have road mortality of the recently delisted Delmarva Peninsula fox squirrel (*Sciurus niger cinereus*) (Pers. com. Nancy Finley, Kevin Holcomb and Robert Leffel, USFWS) (Figure 43). Mortality and connectivity for frogs and toads, salamanders, snakes and turtles are a concern in the wetlands (Figure 44). Common snapping turtles may be the best climbers among the amphibians and reptiles present on the refuge (tree frogs excluded).

A new beach access road (purple in Figure 4) is under construction (vegetation has largely been cut) within Chincoteague NWR and the Assateague Island National Seashore from Snow Goose Pool to just north of Pintail Pool (Figure 49, 50). Likely future road mortality of the Delmarva Peninsula fox squirrel and likely future road mortality and reduced habitat connectivity is a concern for frogs and toads, salamanders, snakes and turtles (Pers. comm. Nancy Finley, Kevin Holcomb and Robert Leffel, USFWS).

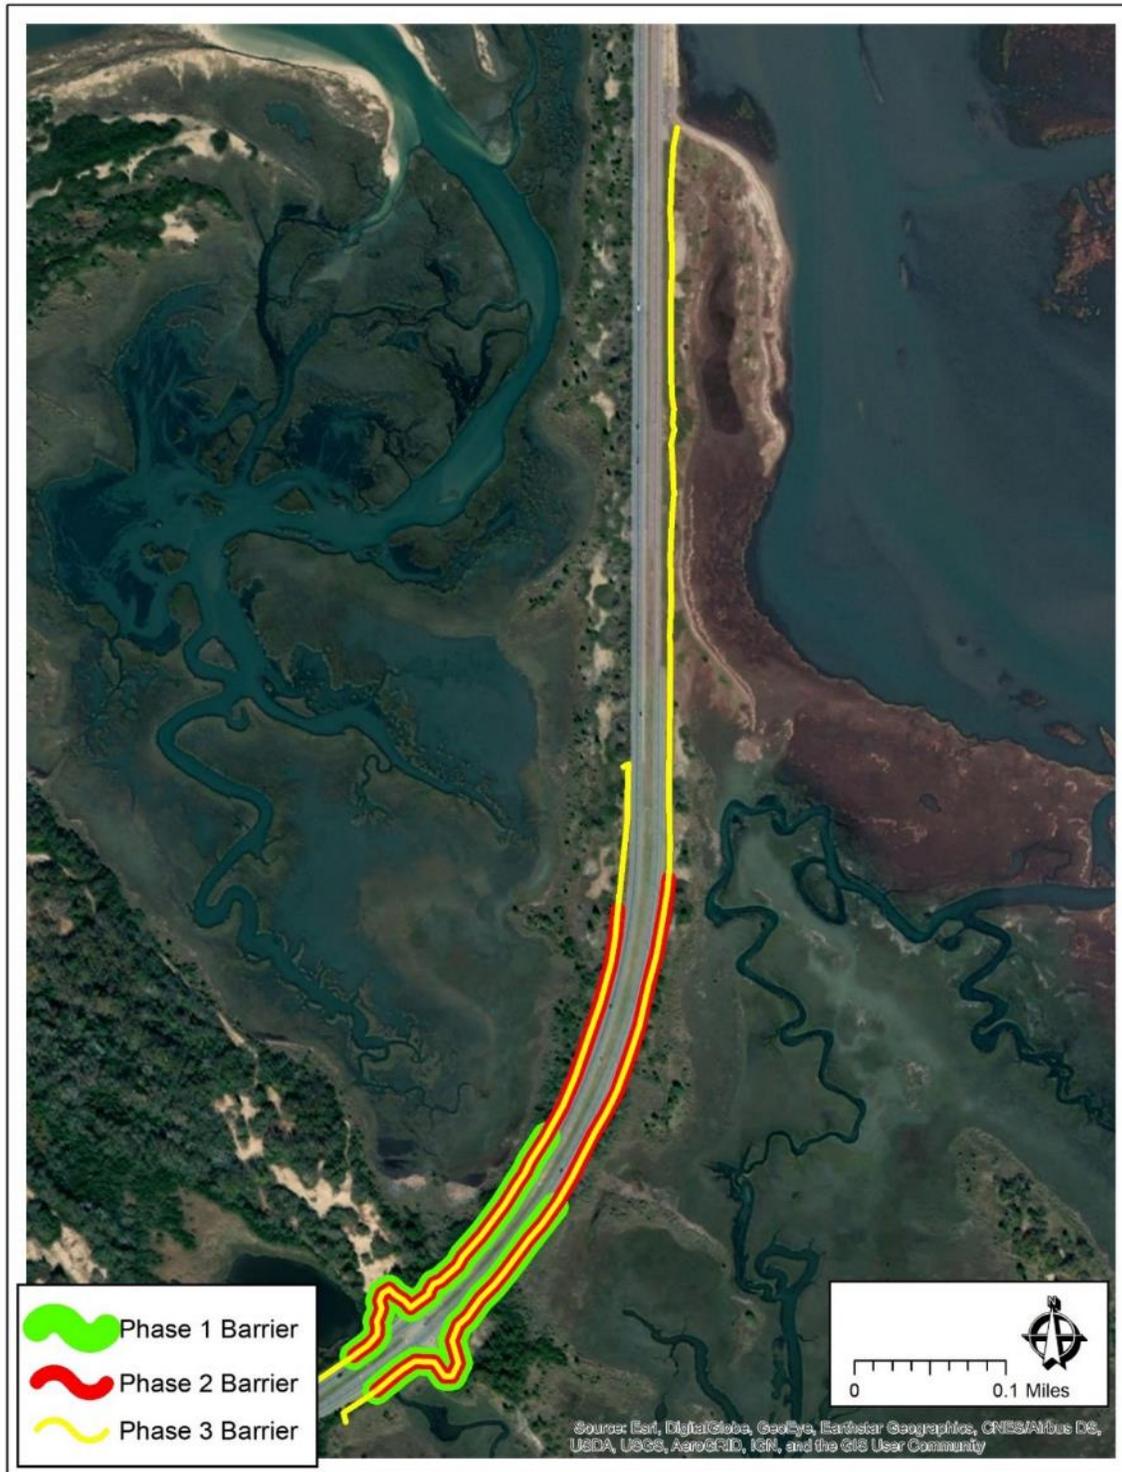
Figure 5: The three phases of the barriers along US Hwy 13 on Fisherman Island NWR. Effective barrier phase 1: 2008-2018, phase 2: 2012-2018, phase 3: expected in 2019-2020 (see also Table 2) (data provided by USFWS).

Type of barrier	Installed	Removed	Road section	Comments
Silt fence	Pre-nesting season 2007	Pre-nesting season 2008	Phase 1	This barrier was never effective. Wind, water and other erosion made it immediately permeable to northern diamondback terrapins
Plastic netting	Pre-nesting season 2008	Pre-nesting season 2010	Phase 1	This material was sensitive to damage from the sun (UV). It was repaired pre-nesting season 2009. This barrier was considered functional during the 2008 and 2009 nesting seasons. Note that open mesh fencing is no longer recommended for reptiles as they spend more time along the barrier, have more breaching attempts, and experience higher mortality rates (Peaden et al., 2017; Milburn-Rodríguez et al., 2018).
Corrugated plastic pipe (6 inch diameter)	Pre-nesting season 2010	Still present in November 2018	Phase 1	Tubing (similar to Reses et al., 2015) easily damaged by mowing. Tubing mistakenly moved to the edge of the shrubs and trees by road maintenance personnel. Tubing required more stakes over time to prevent terrapins from crawling under. This barrier was considered functional during the 2010 through 2018 nesting seasons, except for 2017 when the plastic pipe was insufficiently checked and staked down.

Extended road length corrugated plastic pipe (6 inch diameter)	Pre-nesting season 2012	Still present in November 2018	Phase 2	Length was extended compared to phase 1. The additional length of the barrier was considered functional during the 2012 through 2018 nesting seasons, except for 2017 when the plastic pipe was insufficiently checked and staked down.
Concrete beam barriers (20 ft long, height 1 ft, width 1 ft)	Scheduled to be installed post-nesting season 2019	Installation scheduled for 2019-2020	Phase 3	Design plans approved, installation permitted. Installation scheduled for 2019, and potentially 2020.

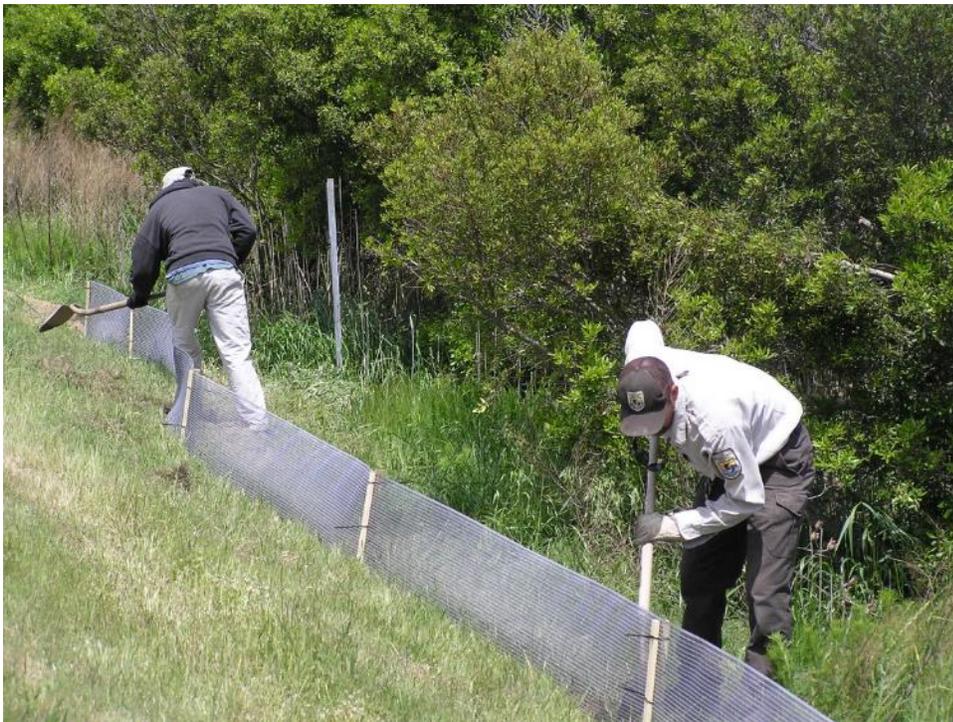
**Figure 7: The plastic netting fence, Fisherman Island NWR, Virginia, present for the 2008 and 2009 nesting seasons only (Photo credit USFWS).**

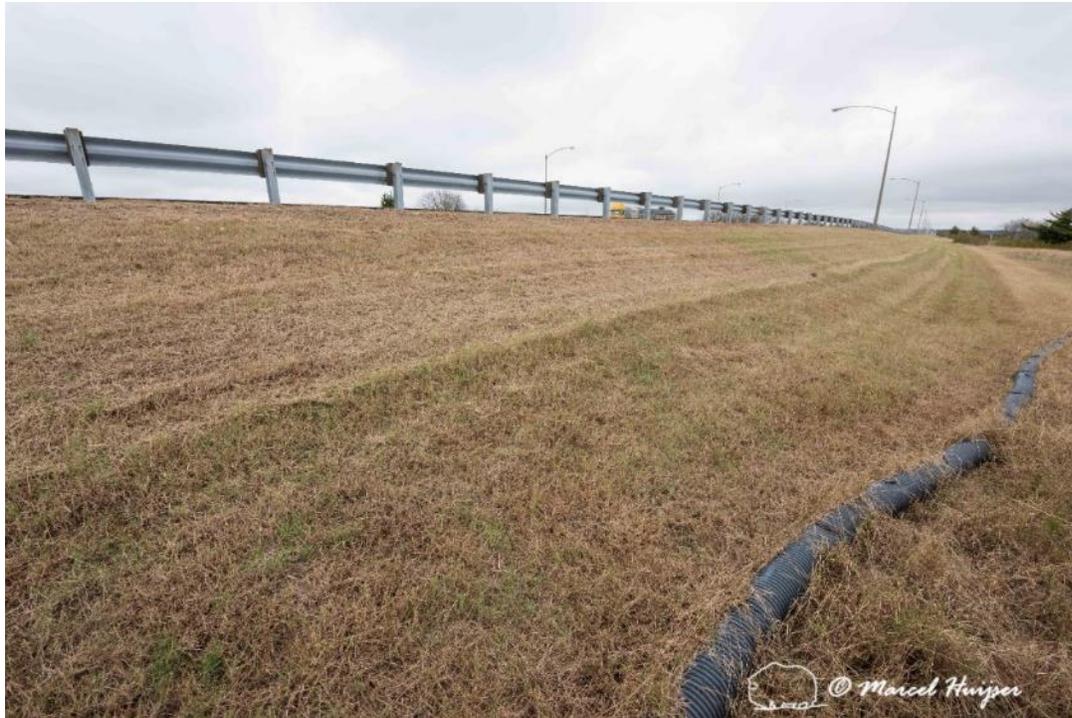
**Figure 8: The plastic corrugated pipe, Fisherman Island NWR, Virginia, present from 2010 through 2018 nesting seasons (phase 1: 2010-2011, extended road section for phase 2: 2012-2018).**

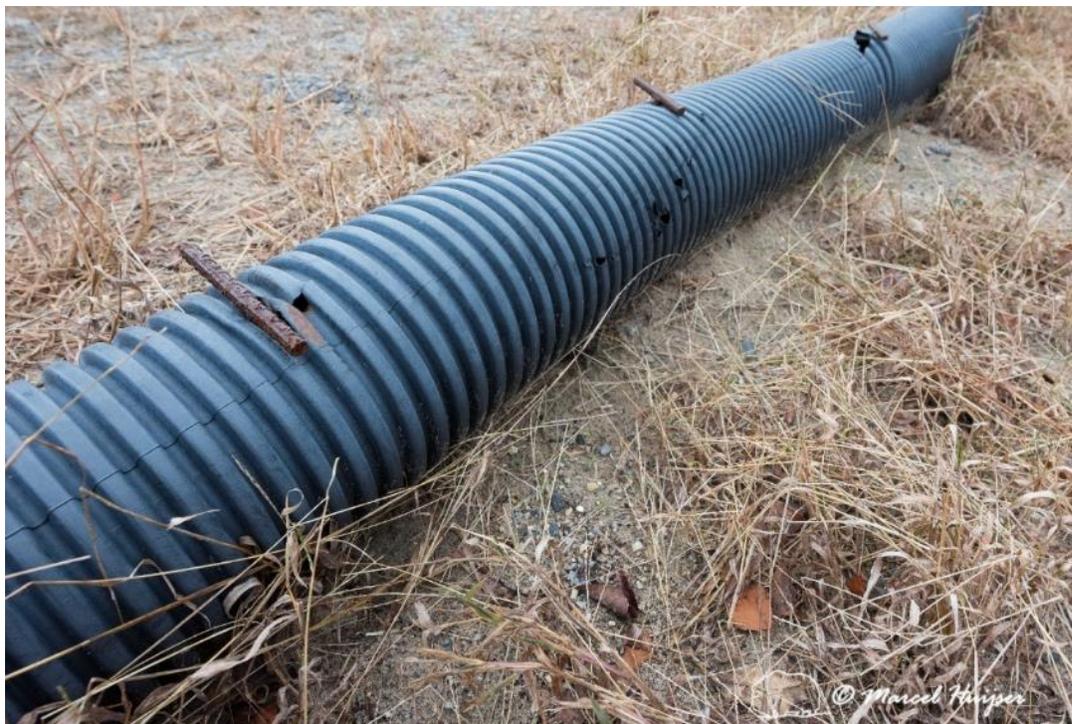
**Figure 9: The plastic corrugated pipe is staked down with rebar, pinning the pipe close to the ground to reduce the likelihood of diamondback terrapins crawling under the pipe, Fisherman Island NWR, Virginia, present 2010 through 2018 nesting seasons.**

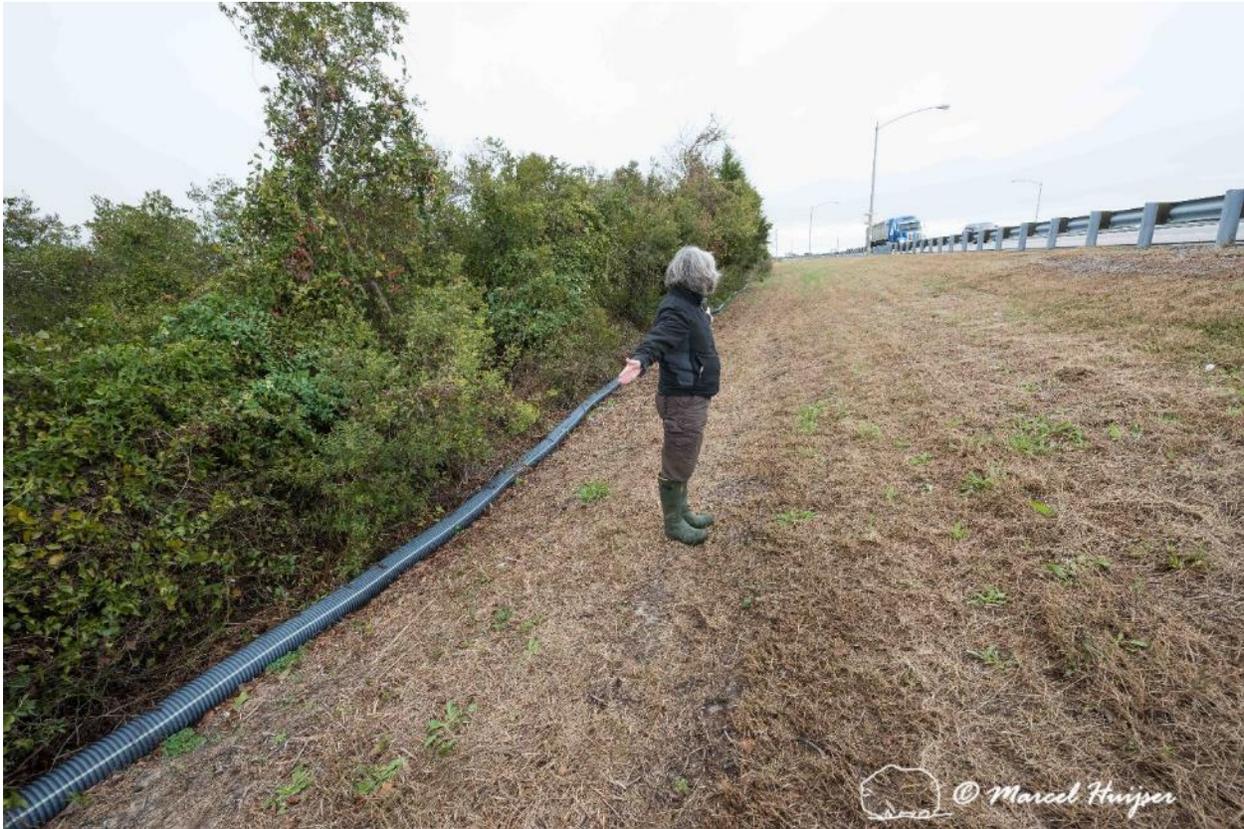
**Figure 10: Pamela Denmon (USFWS) demonstrates where the plastic corrugated pipe should be located with short vegetation on both sides. The plastic corrugated pipe should NOT be located adjacent to the shrubs as the diamondback terrapins can use the taller vegetation to climb over the pipe.**

Communication and coordination with road maintenance crews is essential. At times, the tubing was moved further back by road maintenance crews before mowing and not put back in the correct location after mowing (Figure 10). It is important that the pipes are positioned away from the shrubs and trees and have short grass-herb vegetation on both sides of the pipe; tall vegetation adjacent to the pipe allows turtles to climb over the barrier. Vegetation maintenance was needed before every nesting season; refuge personnel applied herbicides to kill the vegetation close to the tube (1-2 ft on each side of the tube). The pipe also needs to be checked regularly for potential gaps between the ground and the pipe that would allow turtles to crawl under the pipe. Mowing close to the plastic pipe can damage the plastic pipe making the barrier ineffective in these places (Figure 11).

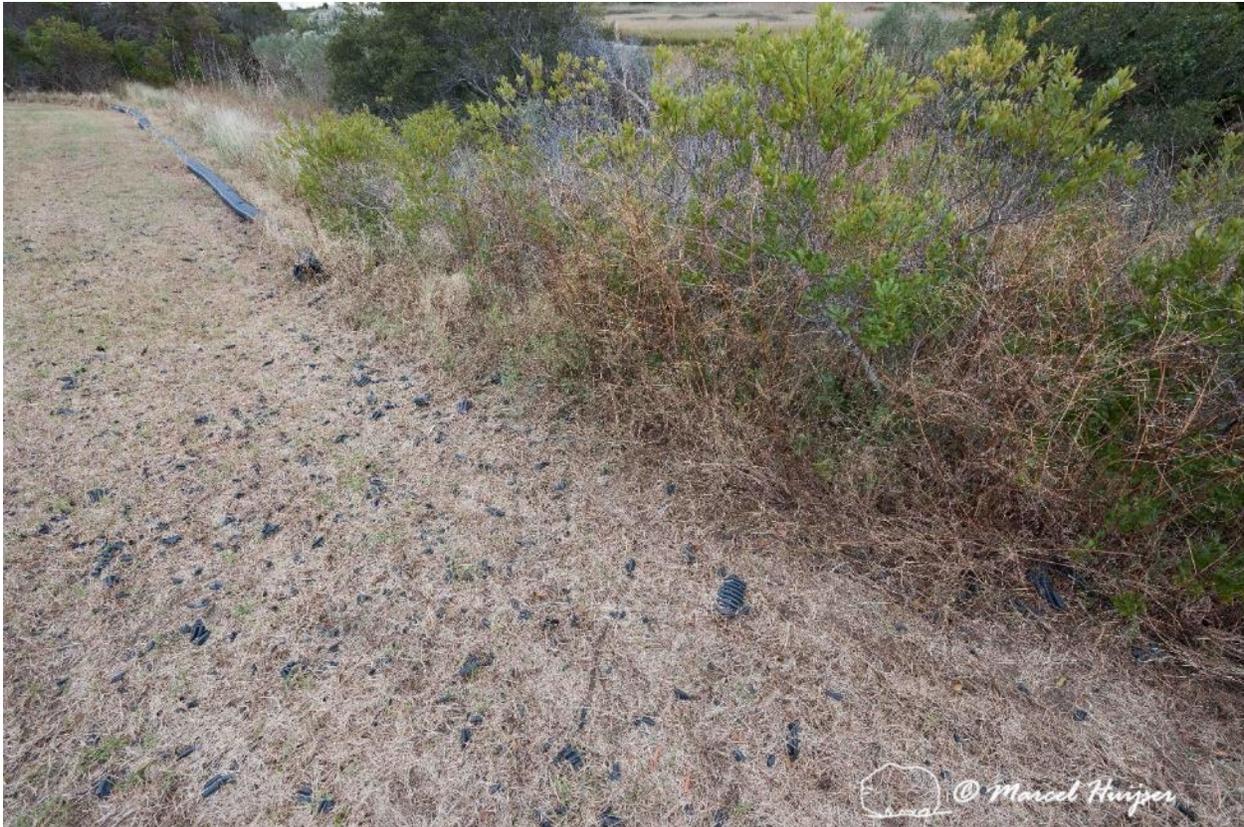
**Figure 11: The plastic corrugated pipe can be destroyed by mowing equipment, Fisherman Island NWR, Virginia, present 2010 through 2018 nesting seasons.**

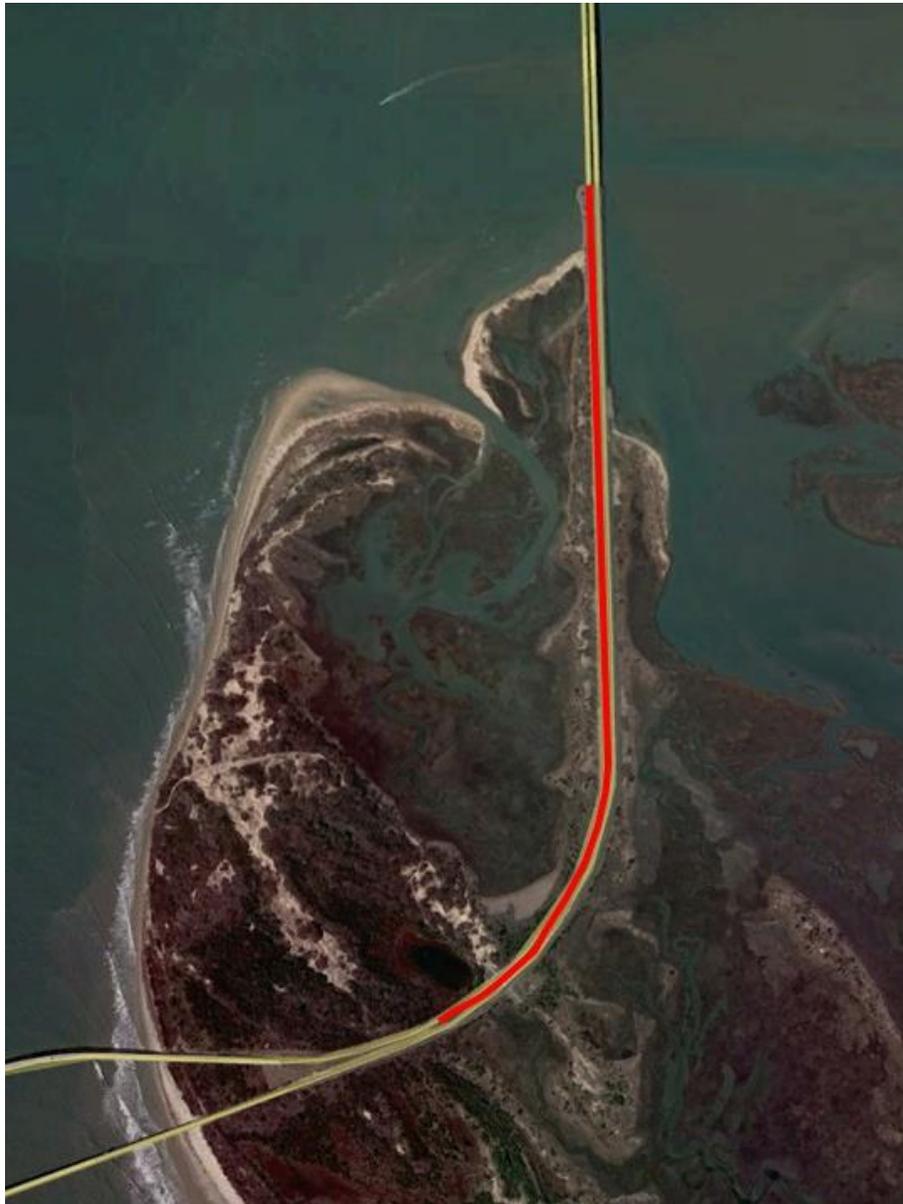
**Figure 13: The Section of U.S. Hwy 13 on Fisherman Island that was monitored 2006 through 2018 (Pers. comm. Pamela Denmon, USFWS). South end coincides with the start of the barrier, north end coincides with the start of the bridge).**

Refuge personnel and researchers inspected the road surface, shoulders and vegetated right-of-way for dead and alive diamondback terrapins during the nesting season (typically late May- mid July) between 2006 through 2018 (Pers. comm. Pamela Denmon, USFWS; Hackney et al., 2013) (Figure 13, Table 3). The road section that was inspected was from the northern edge of Fisherman Island until the southern end of the barriers just south of the parking area (Pers. comm. Pamela Denmon, USFWS) (Figure 13).

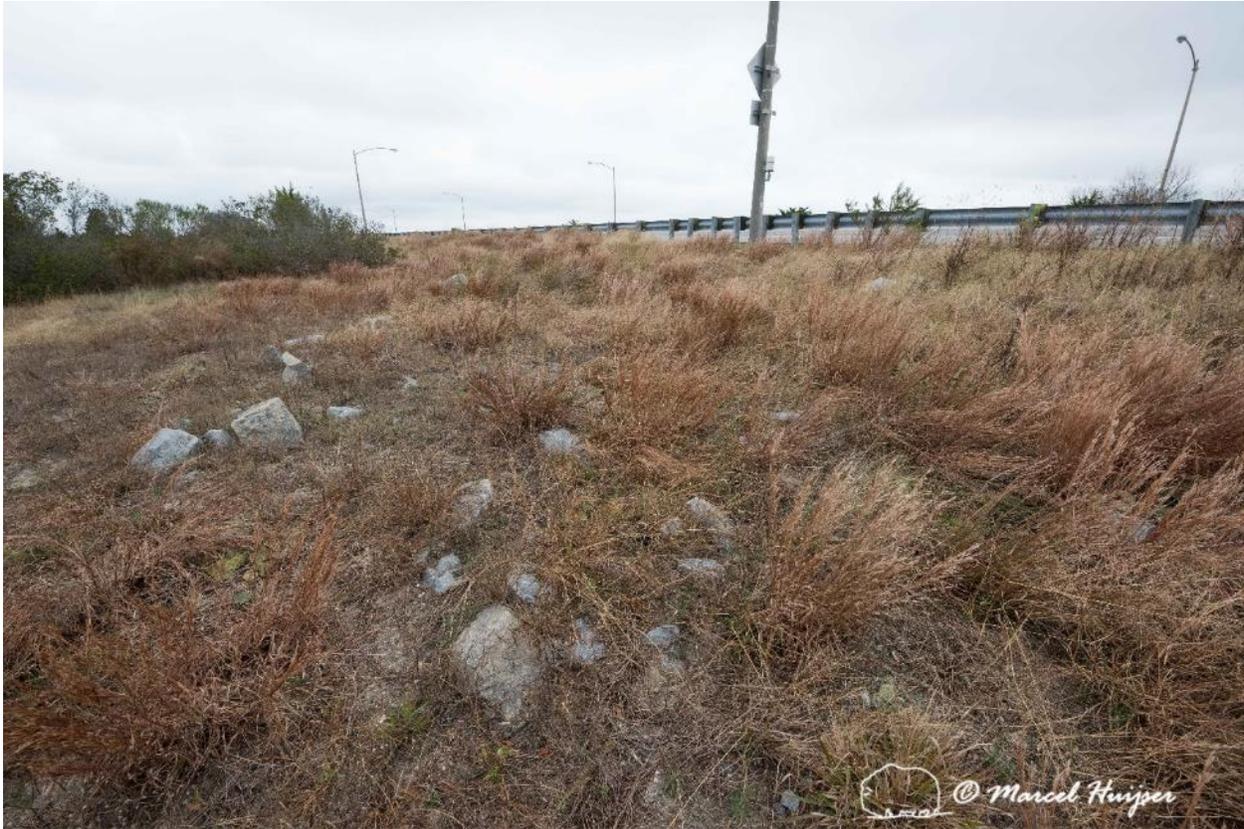
**Figure 18: Roadbed with rocks on the north side of Fisherman Island (west side of US Hwy 13), resulting in uneven surface making installation of the 20 ft long concrete barriers a challenge.**

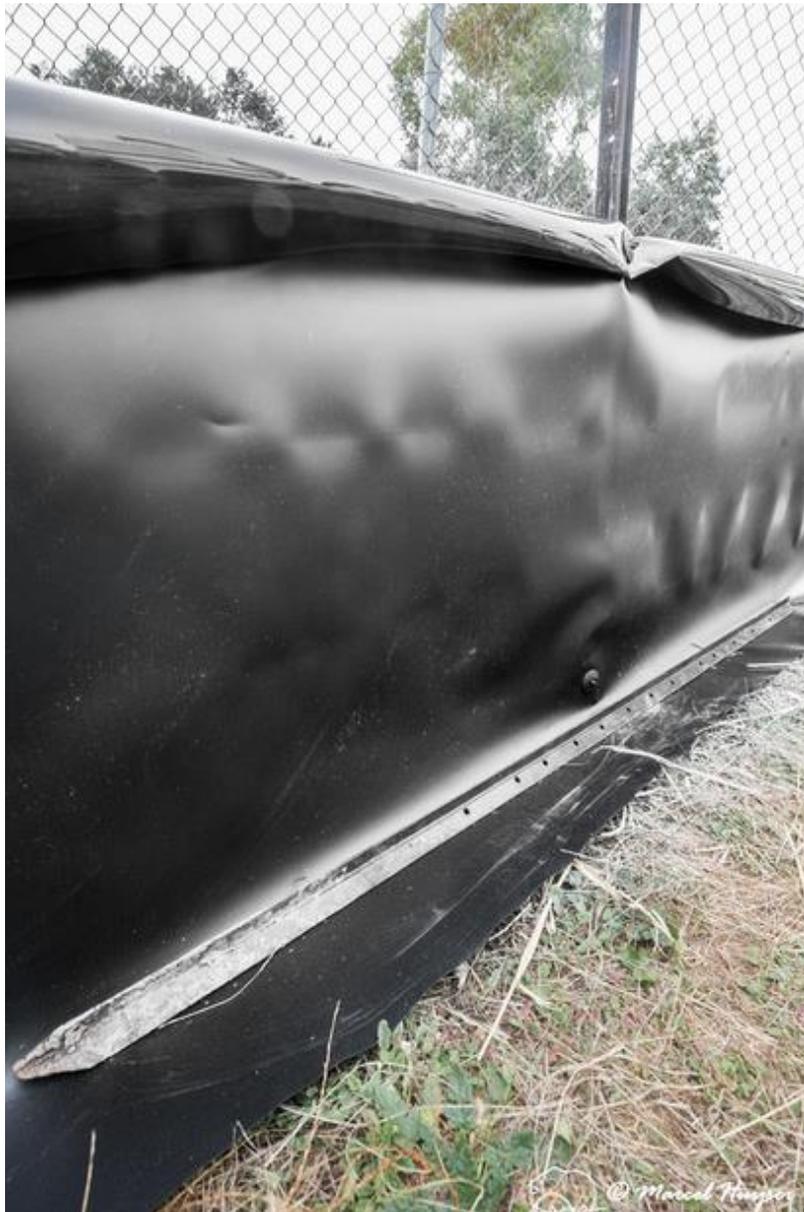
**Figure 20: Temporary demonstration installation of solid smooth plastic fence sheets (high-density polyethylene, Animex) designed as a barrier for herpetofauna, near Ballarat, Victoria, Australia.**

Silt fencing can reduce turtle road mortality by 99% (Aresco, 2005). However, as experienced on Fisherman Island, silt fencing is very vulnerable to damage (e.g. water, wind) (see also Baxter-Gilbert et al., 2015). Smooth plastic sheets (high-density polyethylene, Animex) were found to be a complete barrier to turtles in arena experiments (Milburn-Rodríguez et al., 2018). Recommended minimum height for turtles is 30 inches (Animex, 2018a) (Figure 20). These plastic sheets can be installed to existing fences or existing guard rails and should be buried into the soil.

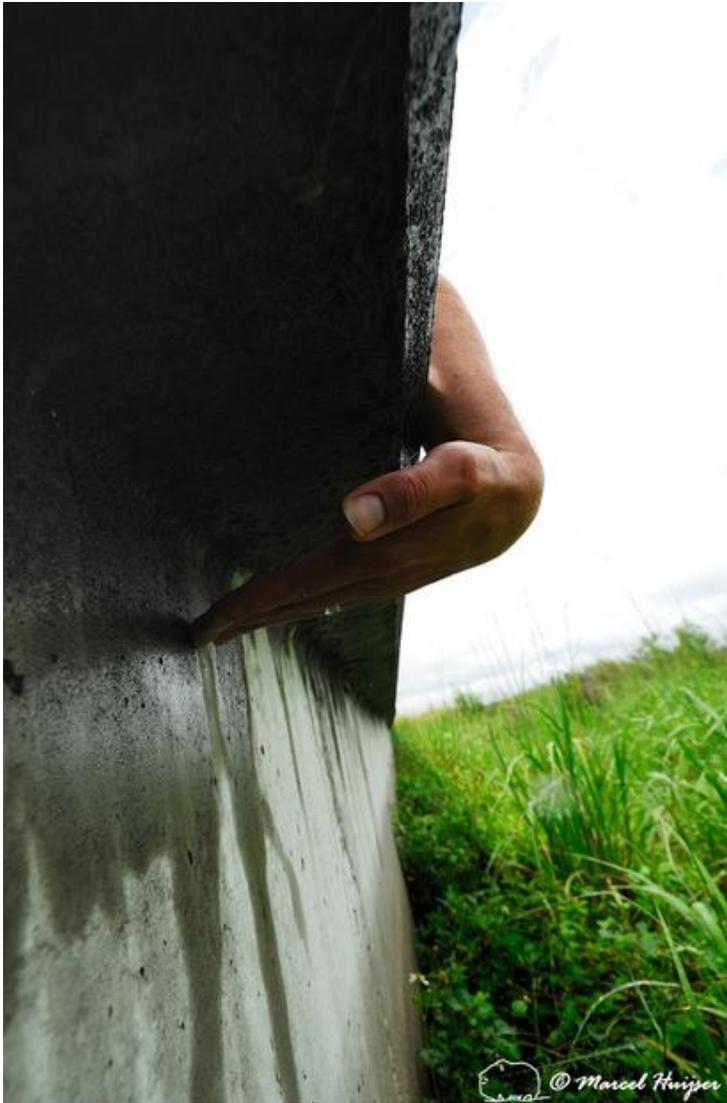
**Figure 21: Concrete barrier wall (1.1 m tall) with overhang or ‘lip’ (15.2 cm) for reptiles, amphibians and small mammals, U.S. 441, Paynes Prairie Ecopassage, south of Gainesville, Florida, USA.**

More robust barriers consist of concrete (Figure 21). This barrier is 1.1 m tall, has a 15.2 cm overhang (or ‘lip’), and was found to be 93.5% effective in reducing vertebrate mortality (including amphibians, reptiles and mammals, excluding hylid tree frogs) (Dodd et al., 2004). Snake road mortality was reduced by 88.5% and turtle road mortality was reduced by 98.1% (Dodd et al., 2004). An additional advantage of this type of barrier wall is that it can be integrated into the roadbed and that it does not affect the landscape aesthetics for people traveling on the highway.

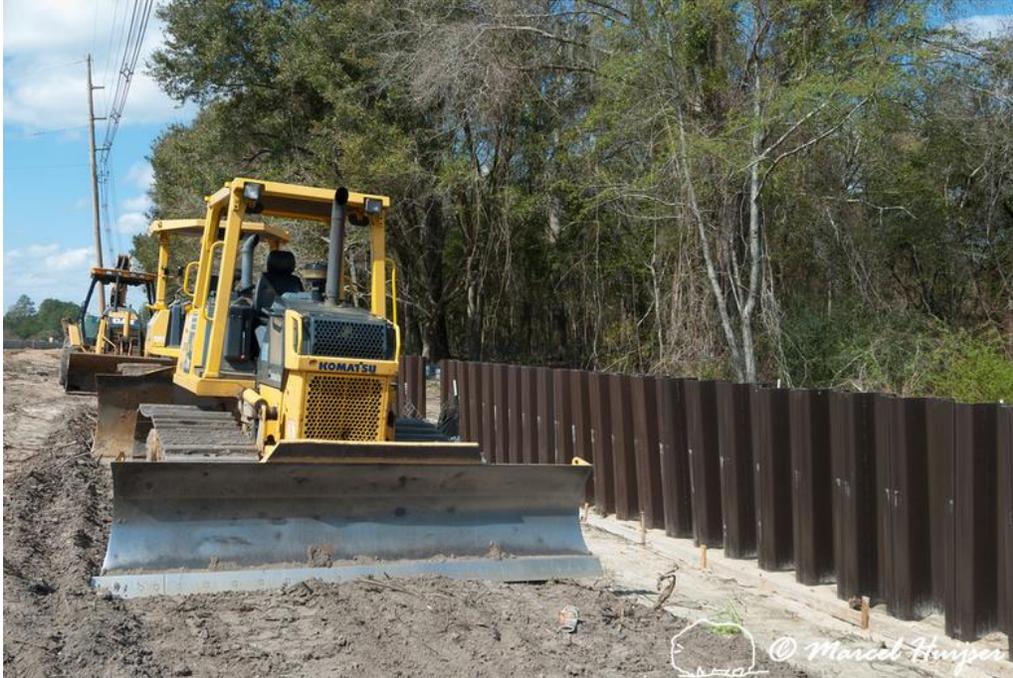
**Figure 22: Barrier wall under construction, Lake Jackson Ecopassage, U.S. Hwy 27, Tallahassee, Florida, USA. The barrier wall (height 5 ft) is designed for turtles, alligators, snakes and amphibians.**

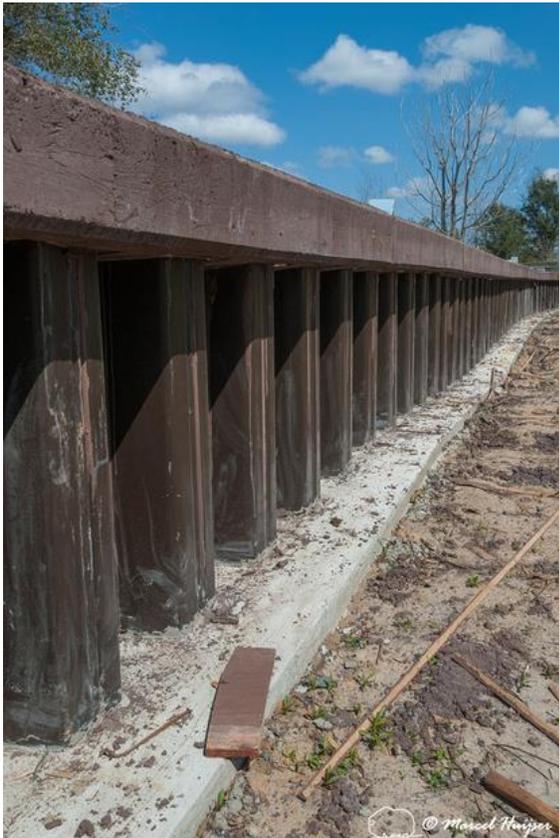
**Figure 23: Barrier wall under construction with concrete top and overhang or 'lip', Lake Jackson Ecopassage, U.S. Hwy 27, Tallahassee, Florida, USA. The barrier wall (height 5 ft) is designed for turtles, alligators, snakes and amphibians.**

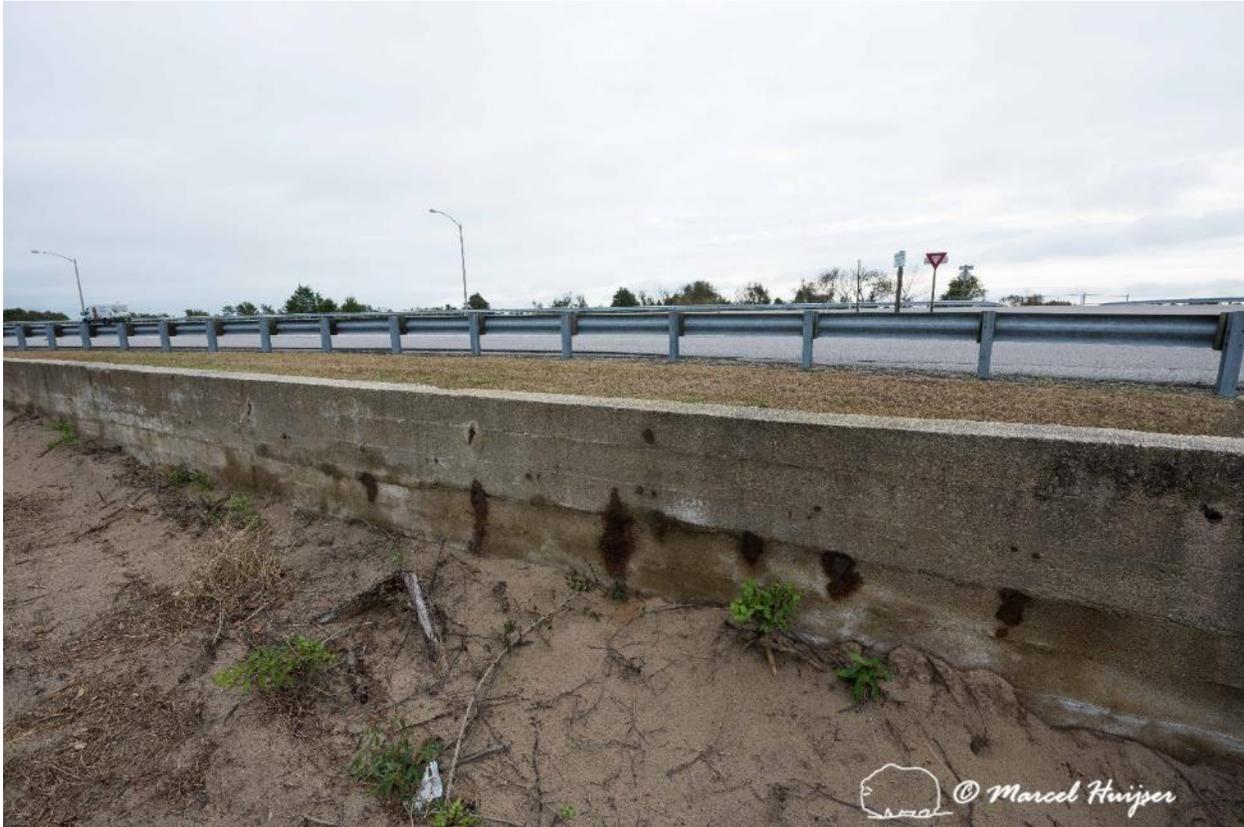
**Figure 24: Existing concrete barrier wall along west side U.S. Hwy 13, Fisherman Island National Wildlife Refuge, Virginia, USA.**

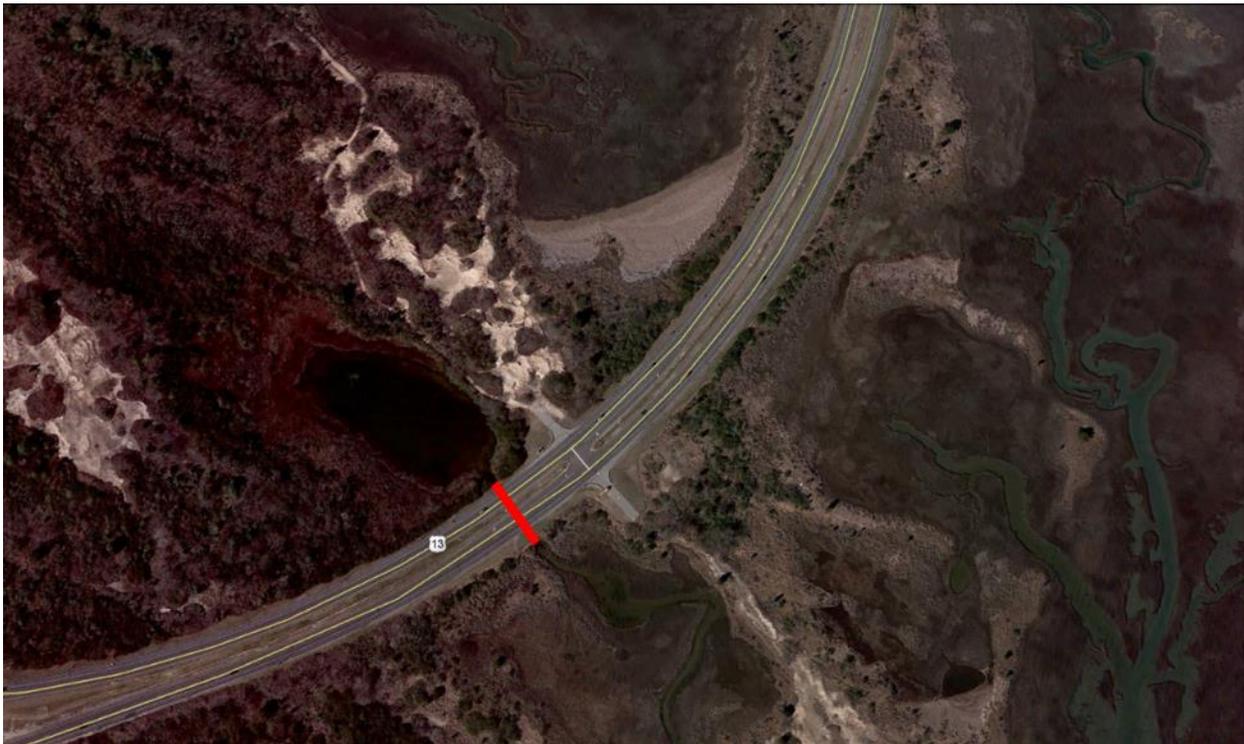
**Figure 25: The location of the existing culvert (red line), designed for hydrology, on Fisherman Island NWR.**

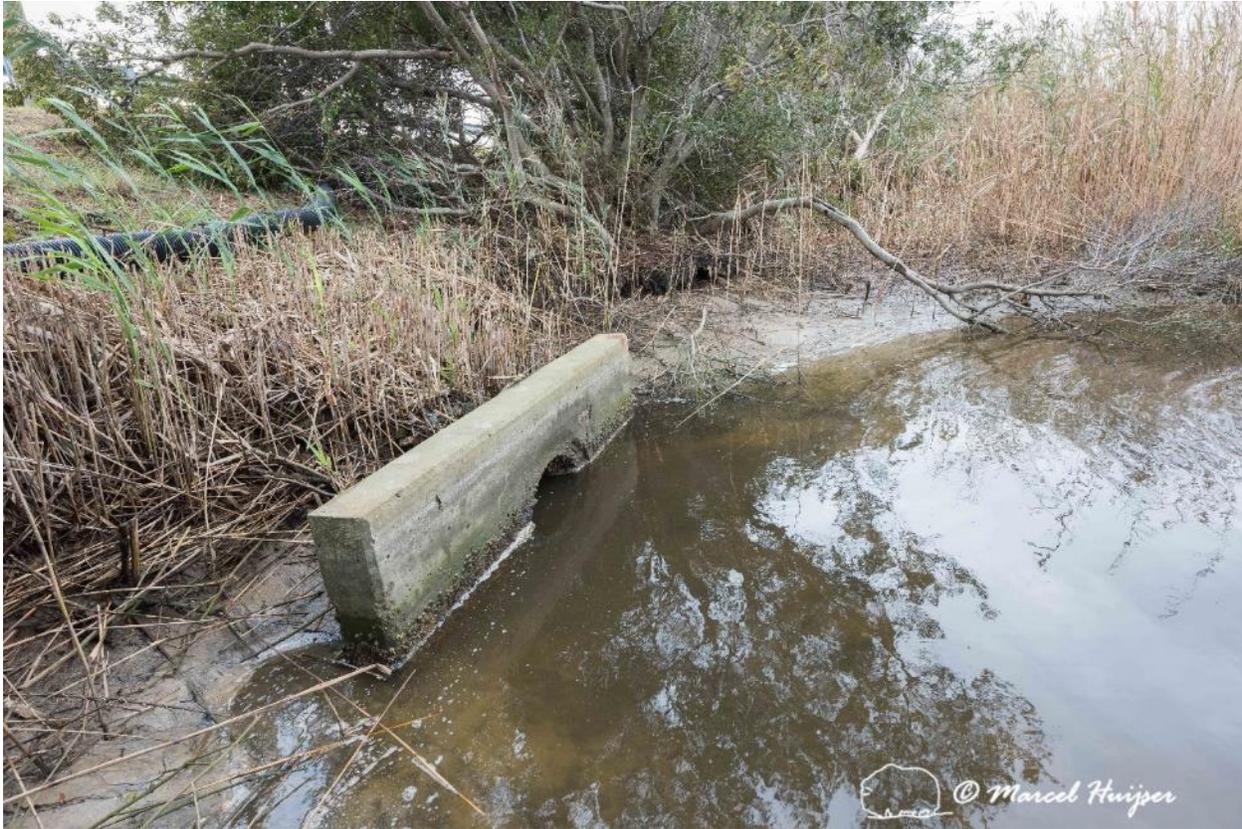
**Figure 26: The existing culvert under highway (west side) that may or may not be used by northern diamondback terrapins (*Malaclemys terrapin terrapin*), Fisherman Island National Wildlife Refuge, Virginia. It is a 24" Reinforced Concrete Pipe (RCP) (Pers. com. Timothy R. Holloway, Chesapeake Bay Bridge-Tunnel). It is subject to tidal influence.**

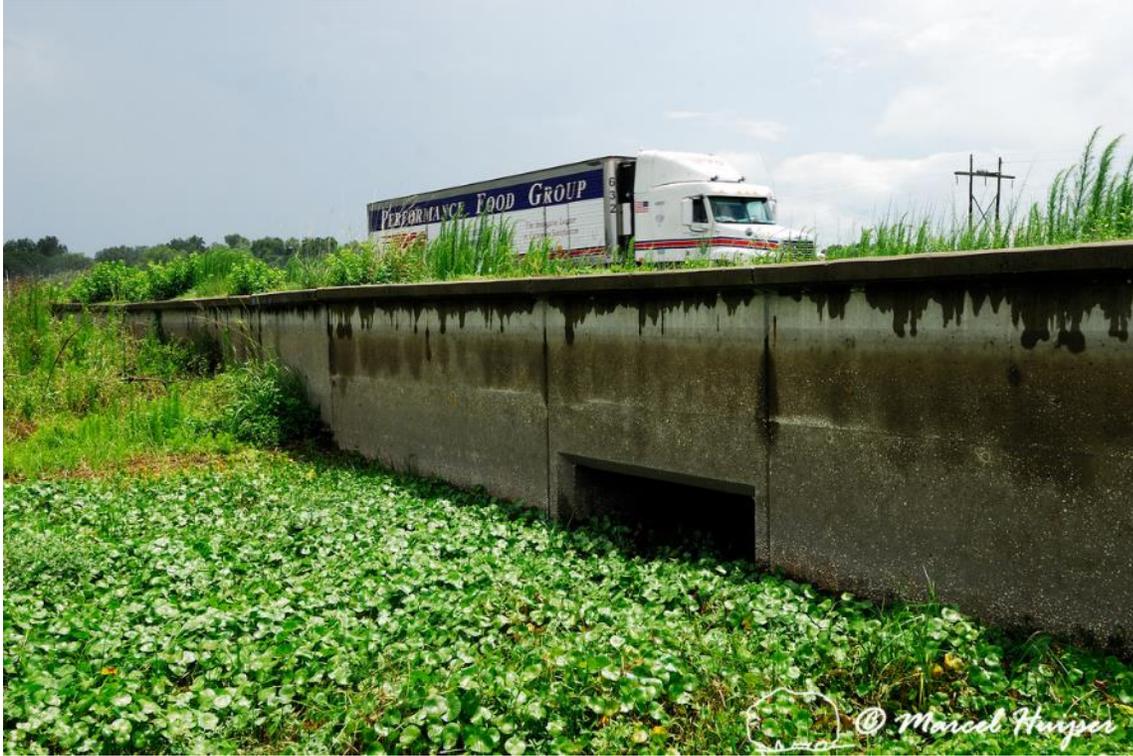
Figure 27: Example of a “wet” underpass and barrier wall for reptiles, amphibians and small mammals, U.S. Hwy 441, Paynes Prairie Ecopassage, south of Gainesville, Florida, USA.

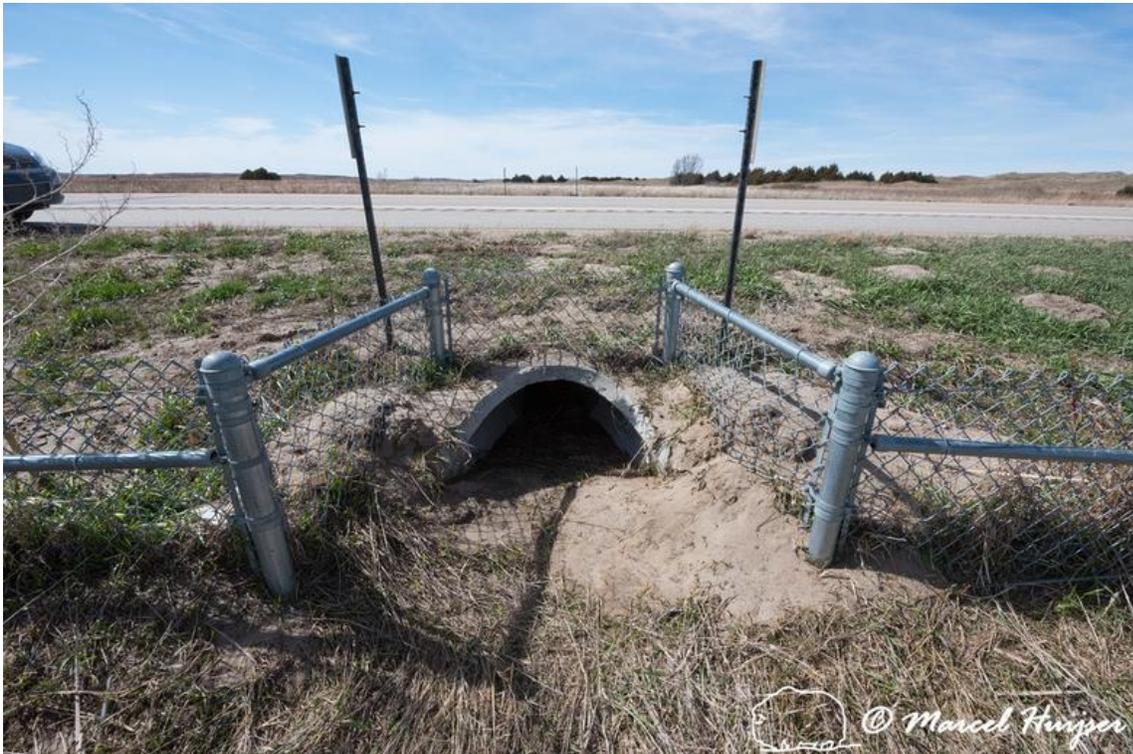
Figure 28: Example of a dry culvert (no openings in roof) used by turtles under a 2-lane road, Valentine National Wildlife Refuge, Ballard's South, Valentine, Nebraska, USA.

Culverts of about 2 ft diameter have been used by turtles under two lane roads (Huijser et al., 2017). A wider road such as US Hwy 13 (4 lanes, median) may need to have wider culverts, perhaps at least 5 ft diameter (Smith, 2003; Gunson et al., 2016), especially if it is one structure without an opening in the median. Wider culverts (at least 5 ft) are also less likely to get blocked by debris during flooding and require less maintenance. Tunnels around 1 ft in diameter are not recommended for turtles (Woltz et al., 2008). The roadbed is sufficiently high above the ground and sea water level to allow for dry culverts under US Hwy 13 (Figure 31).

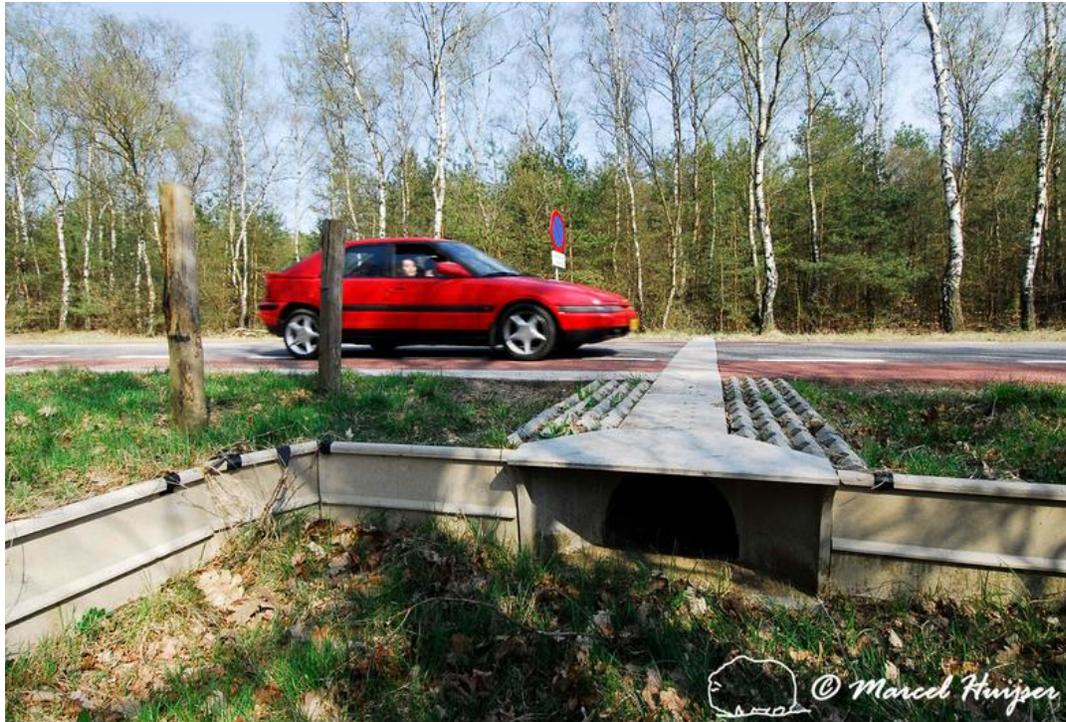
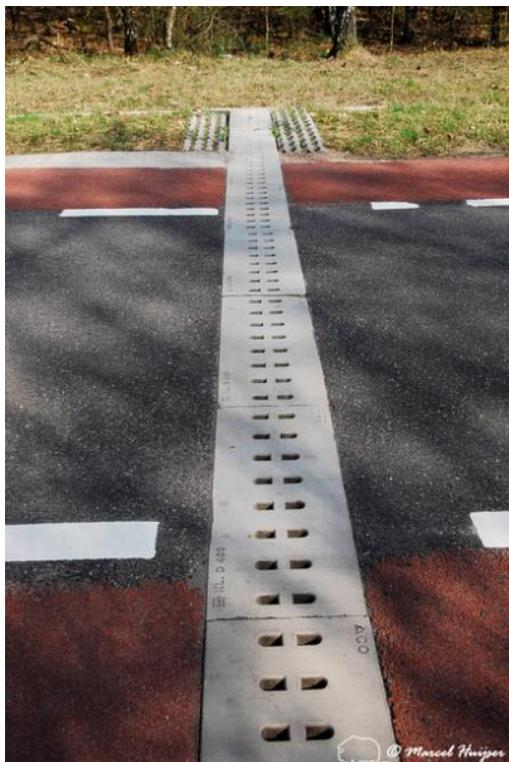
**Figure 29: Example of an amphibian barrier wall and a dry amphibian tunnel (ACO) with an open slotted roof embedded in the pavement under a 2-lane road, Deelenseweg, between Hoenderloo and Arnhem, Gelderland, The Netherlands.**

**Figure 30: Example of an amphibian tunnel (ACO) with an open slotted roof embedded in the pavement under a 2-lane road, Deelenseweg, between Hoenderloo and Arnhem, Gelderland, The Netherlands.**

3. Dry culverts with open slotted roofs (Figure 29, 30). The difference with the dry culverts with solid roofs is that dry culverts with open slotted roofs have a ceiling that is also the road surface. They are not drilled from the side, but they are situated in a trench. Construction will be associated with some traffic disruption. The open slotted roof allows for light, and air and soil temperature and humidity to be similar to the surroundings. This is especially important for amphibians (Jackson et al., 2015). The bottom of the structure should be level with the surroundings, potentially partially or seasonally inundated.
