**EXPLORATION OF WILDLIFE MITIGATION  
MEASURES FOR THE ROADS THROUGH AND  
AROUND FISHERMAN ISLAND AND CHINCOTEAGUE  
NATIONAL WILDLIFE REFUGES, VIRGINIA**

FINAL REPORT

Western Transportation Institute  
College of Engineering, Montana State University, P.O. Box 174250. Bozeman, MT 59717-4250

February, 2019

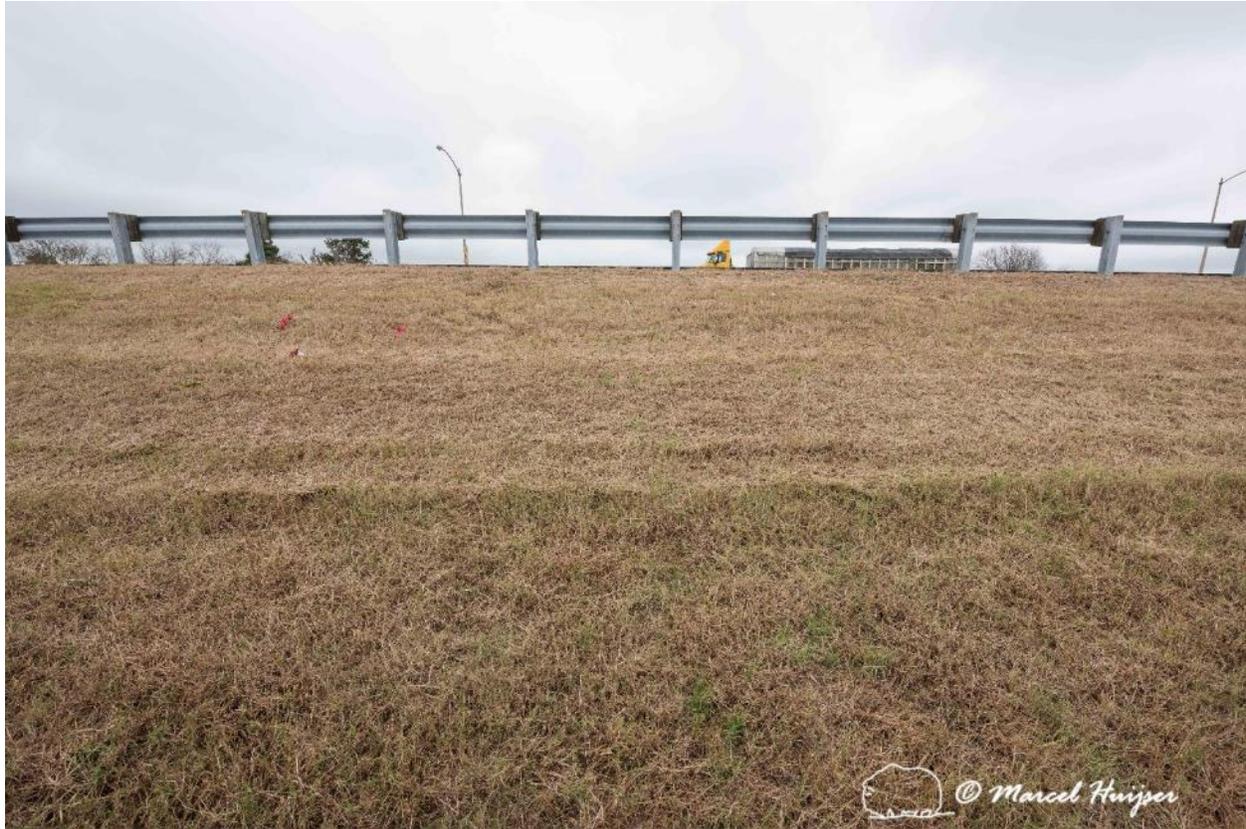
**Figure 31: The roadbed, showing the potential for drilling culverts under highway, US Hwy 13, Fisherman Island NWR.**

Culverts of about 2 ft diameter have been used by turtles under two lane roads (Huijser et al., 2017). A wider road such as US Hwy 13 (4 lanes, median) may need to have wider culverts, perhaps at least 5 ft diameter (Smith, 2003; Gunson et al., 2016), especially if it is one structure without an opening in the median. Wider culverts (at least 5 ft) are also less likely to get blocked by debris during flooding and require less maintenance. Tunnels around 1 ft in diameter are not recommended for turtles (Woltz et al., 2008). The roadbed is sufficiently high above the ground and sea water level to allow for dry culverts under US Hwy 13 (Figure 31).

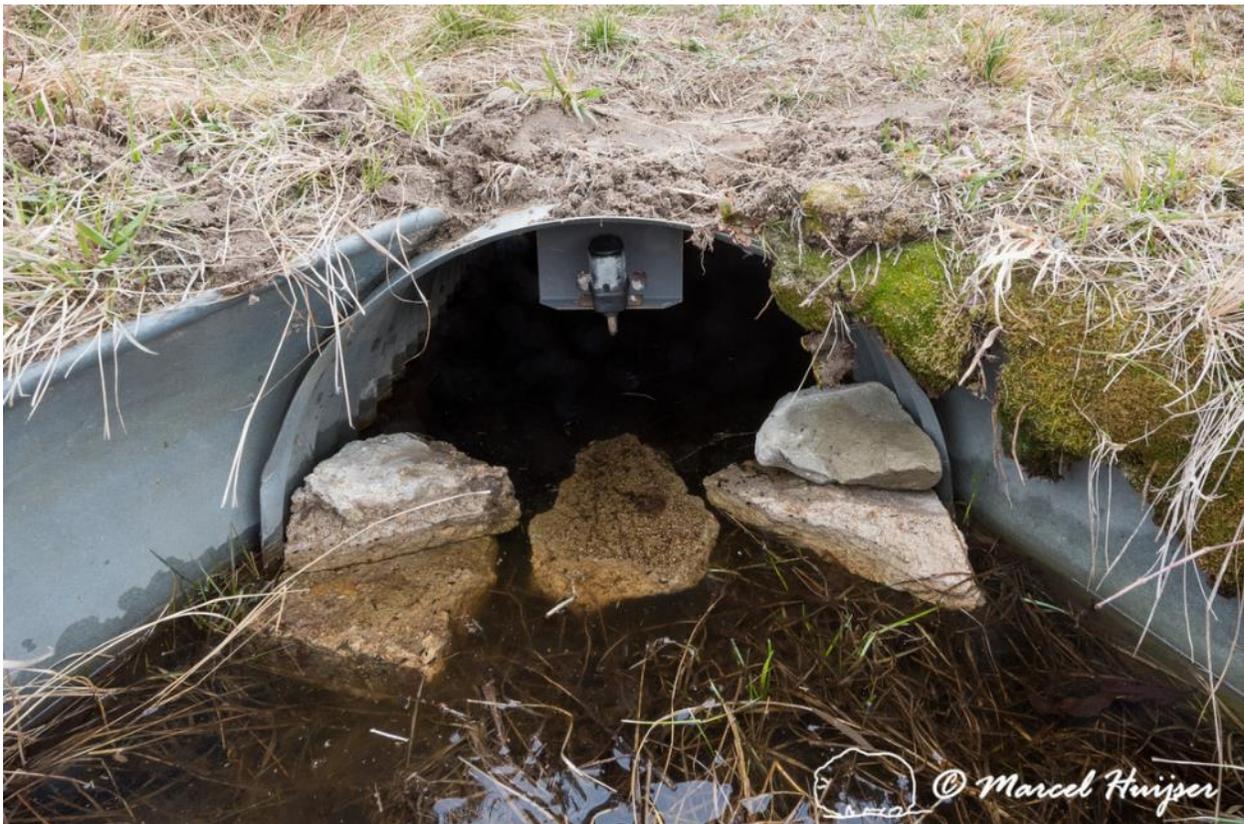
**Figure 33: Camera facing down to record turtles, and rock ramp in culvert to force turtles above the water surface when crossing through the culvert, Valentine NWR, Nebraska, USA.**

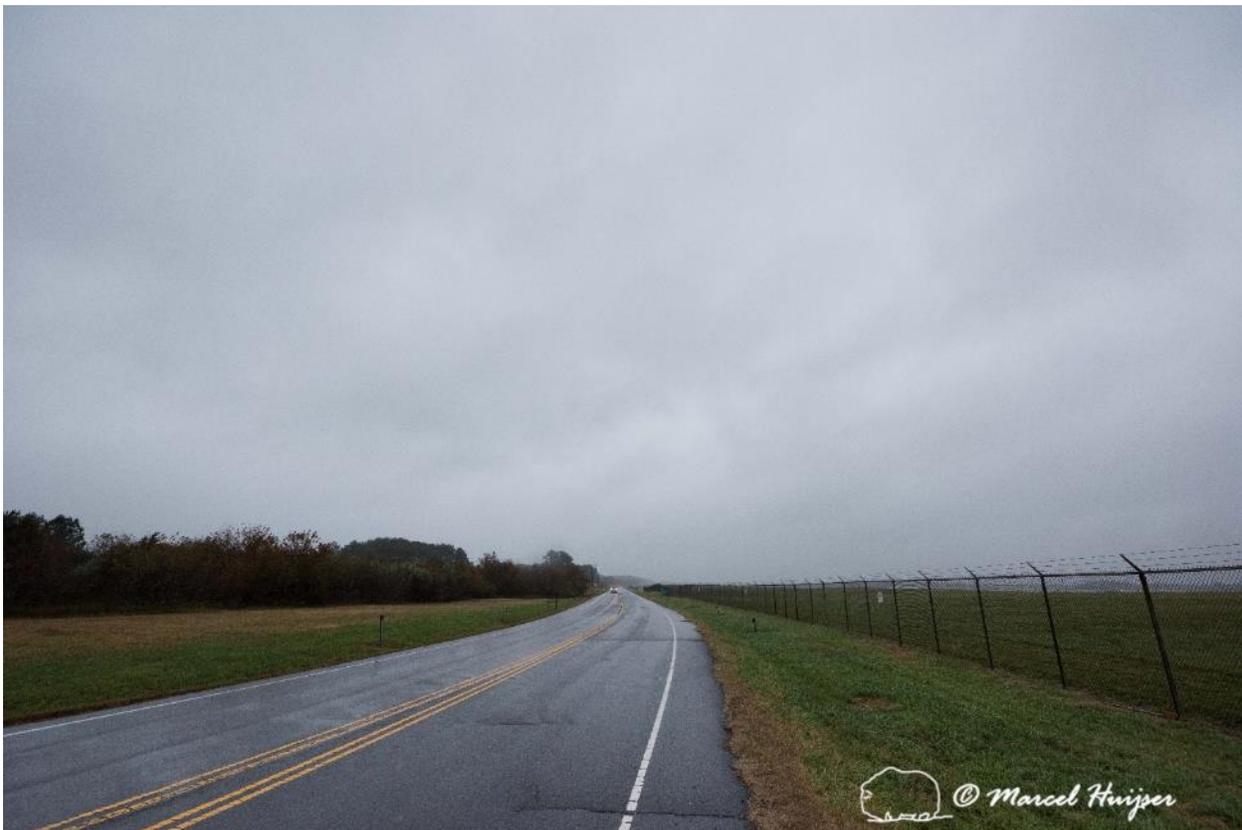
**Figure 35: Hwy 175 adjacent to Wallops Island National Wildlife Refuge and NASA Wallops Flight Facility (other side of fence), Wallops Island, Virginia, USA.**

Hwy 175 west (red in Figure 4) is located between Wallops Island NWR and NASA Wallops Flight Facility. It has a relatively high concentration of white-tailed deer-vehicle collisions (Pers. comm. Nancy Finley, Kevin Holcomb and Robert Leffel, USFWS). The refuge lands are mostly forested, whereas Hwy 175 has wide grassy shoulders. Note that there is a fence on the north-west side of the highway, keeping people, deer, and other species from entering the airport (Figure 35).

This is primarily a human safety issue as white-tailed deer are considered very numerous in the area, and there is no connectivity for large mammals to the area on the other side of the fence around the airport. The deer are likely attracted to the grass-herb vegetation in the right-of-way. We suggest making the road corridor inaccessible to white-tailed deer by also placing a fence (8 ft tall) on the other side of the highway, outside the clear-zone (Huijser et al., 2016) (Figure 36). This would make the road corridor, including most of the grass-herb vegetation, inaccessible to

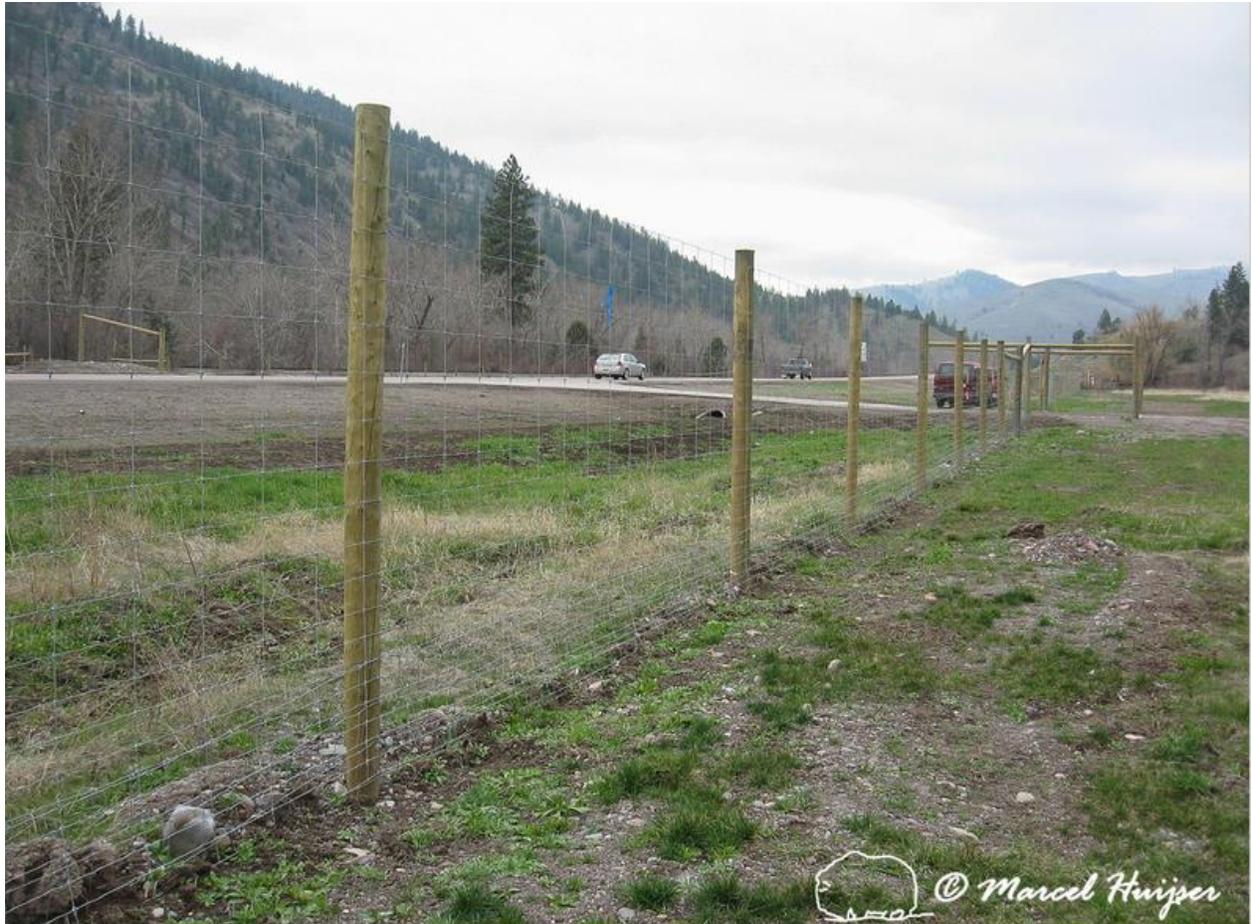
**Figure 36: Wildlife fence (8 ft tall smaller mesh size towards bottom), U.S. Hwy 93, near Ravalli, Flathead Indian Reservation, Montana, USA.**

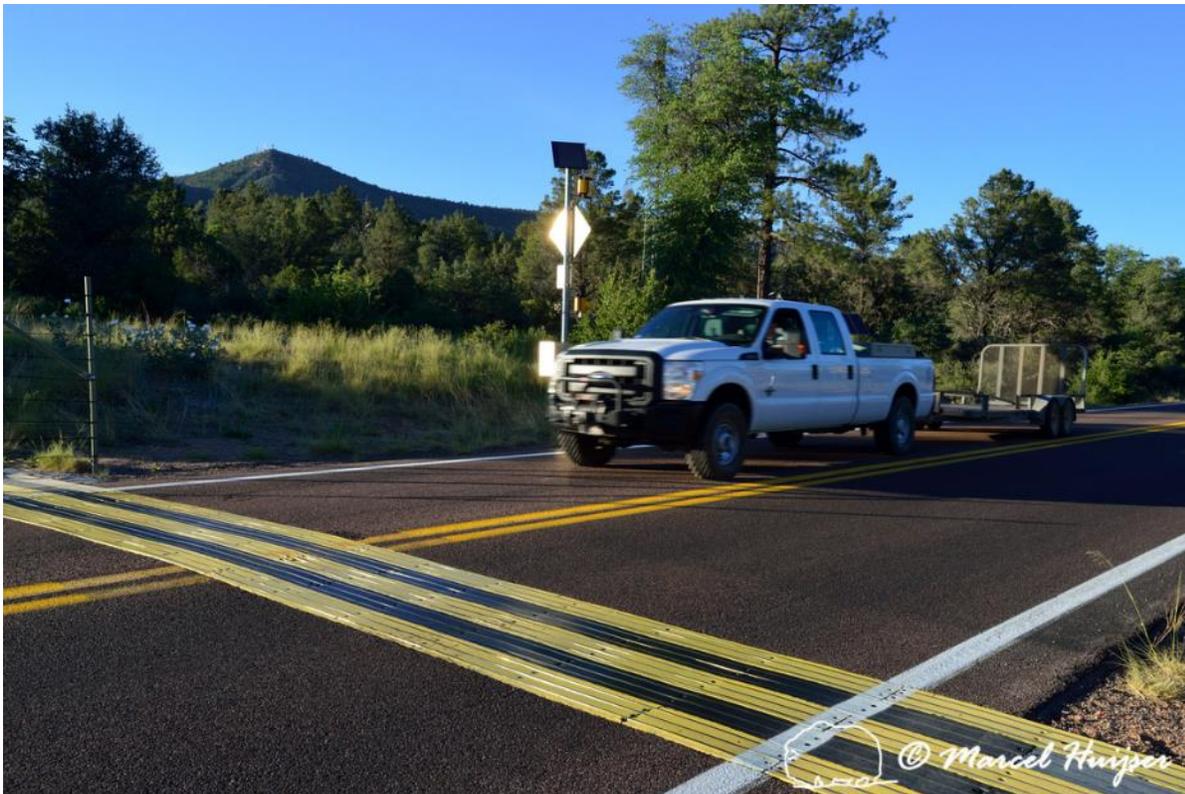
Figure 38: Electric mat (Electrobraided™ / CrossTek™) associated with an animal detection and driver warning system at a fence end, S.R. 260 east of Payson, Arizona, USA.

the deer. We also suggest deer guards or electric mats embedded in the pavement of the highway at the two fence ends to reduce the likelihood that the deer will still access the grass-herb vegetation by walking around the fence ends (Figure 37, 38). In addition, we recommend jump-outs (around 5 ft high) on the side of Wallops Island NWR that allow deer to escape from the fenced road corridor (Allen et al., 2013; Huijser et al., 2015; Figure 39). Obviously, no jump-outs should be installed along the fence on the other side of the highway as that would allow the deer to access NASA-WFF.

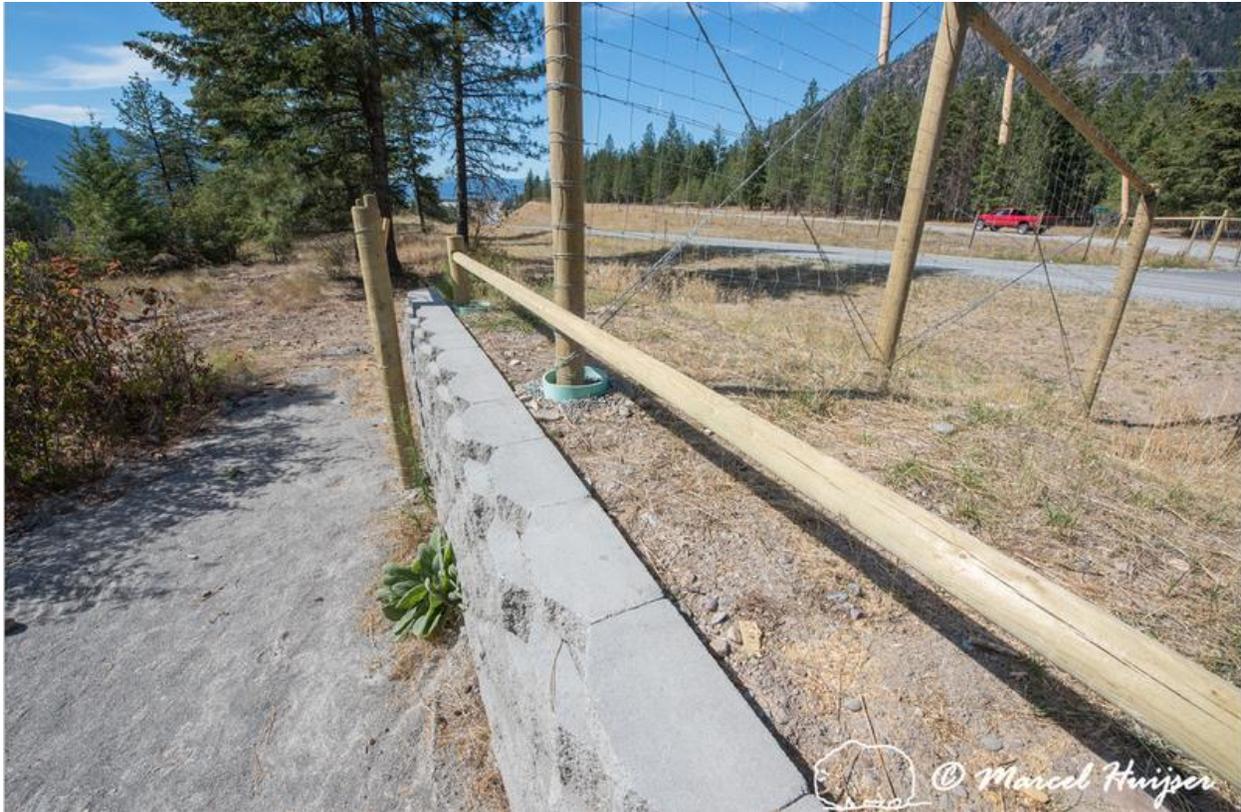
**Figure 39: Wildlife jump-out, near Thompson Falls, Montana, USA. Note the horizontal bar that increase the effective height for animals that want to jump into the fenced road corridor.**

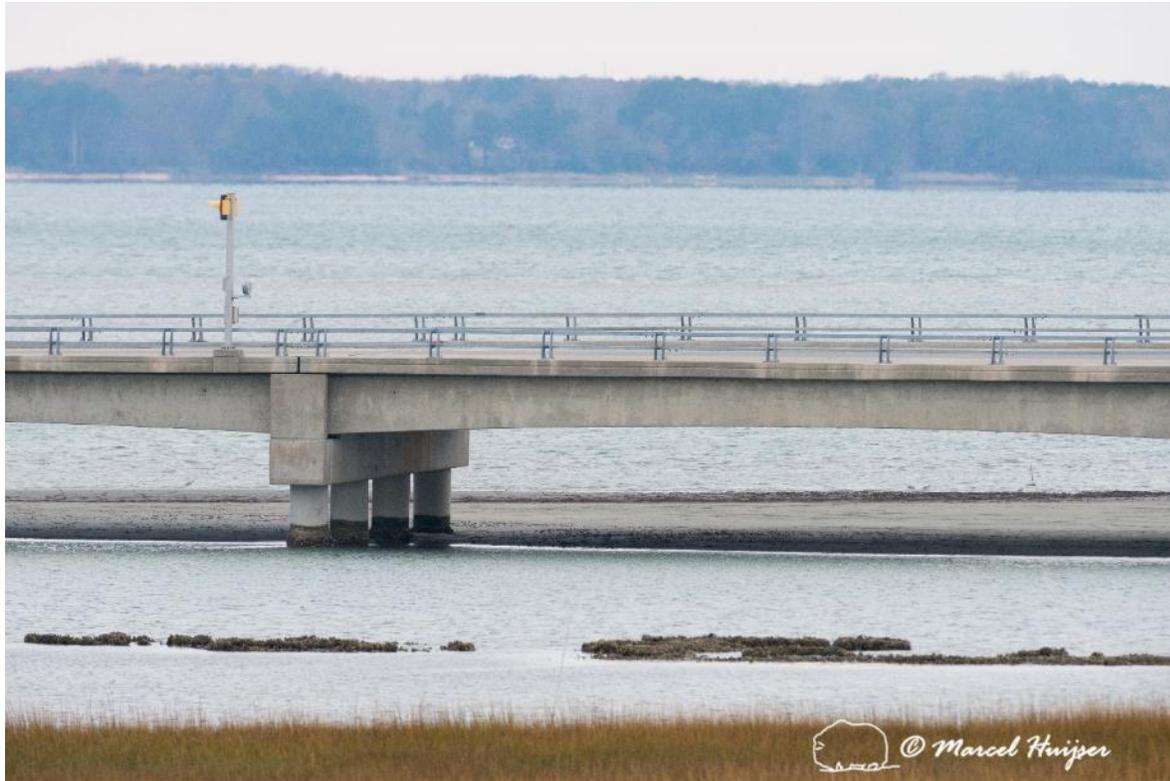
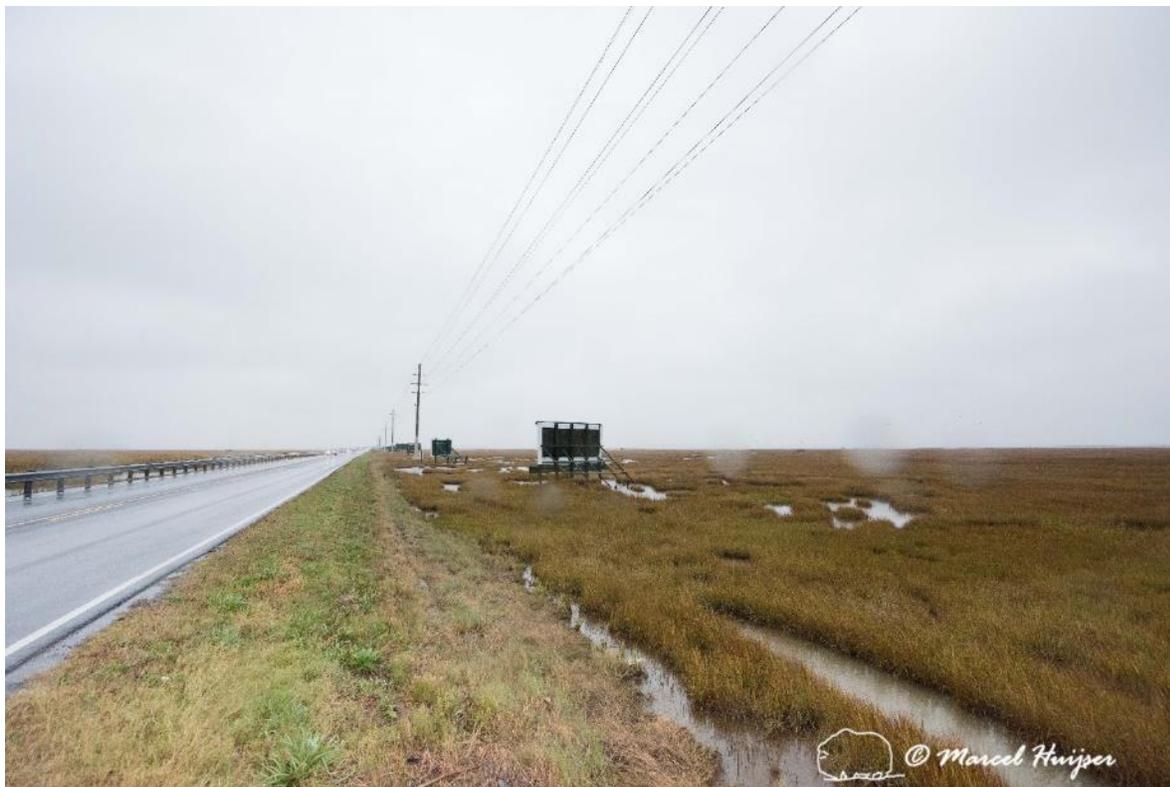
Figure 40: Hwy 175 bridge through Chincoteague Bay and saltmarshes, Chincoteague Island, Virginia, USA.

Figure 41: Hwy 175 causeway through saltmarshes around Chincoteague Bay, Chincoteague Island, Virginia, USA.

Another section of Hwy 175 west (orange in Figure 4) bisects Chincoteague Bay and saltmarshes. Here Hwy 175 is a causeway with bridges across the major channels (Figure 40, 41). The surrounding lands are managed by the NASA-WFF, Virginia Marine Resources Commission, and the town of Chincoteague. Here, road mortality of northern diamondback terrapin is a major concern (Pers. comm. Nancy Finley, Kevin Holcomb and Robert Leffel, USFWS). The northern diamondback terrapin mortality primarily occurs during the nesting season between the end of May and mid-July (Pers. comm. Nancy Finley, Kevin Holcomb and Robert Leffel, USFWS). It is suspected that adult females are attracted to the higher and drier soil of the roadbed to lay their eggs (Pers. comm. Nancy Finley, Kevin Holcomb and Robert Leffel, USFWS).

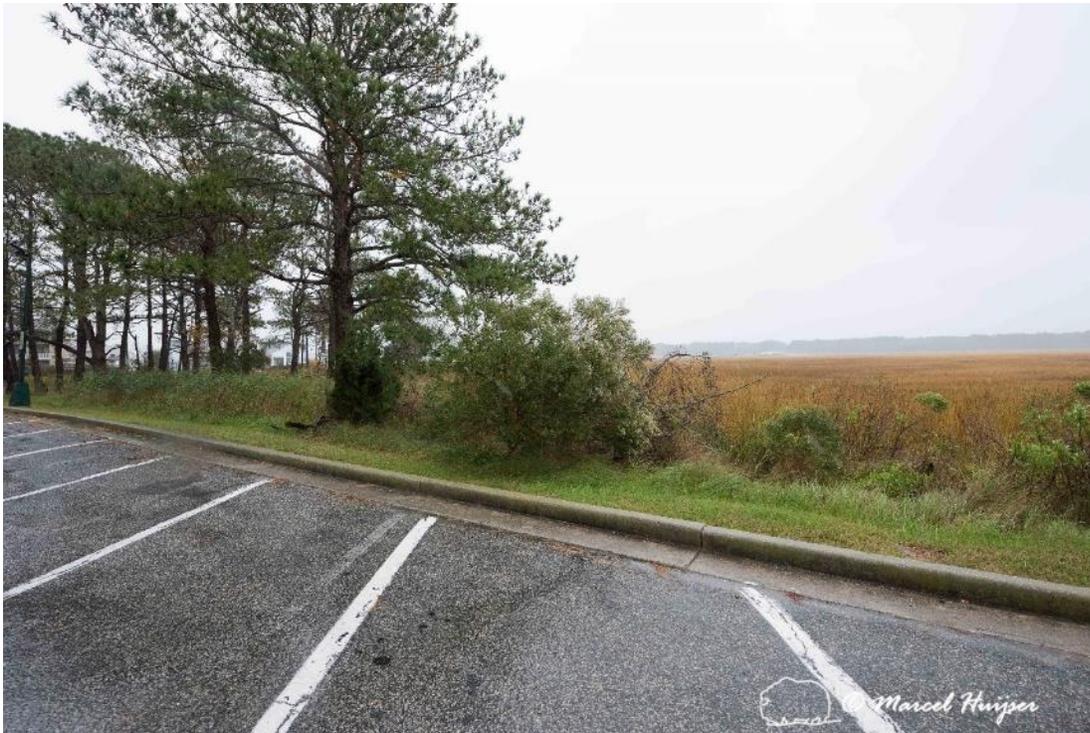
**Figure 42: Parking area at restaurant adjacent to Assateague Bay with the salt marsh and Chincoteague National Wildlife Refuge in the background, Virginia, USA.**

Our recommendations are identical to that for Hwy 175 west (section 5.2). In addition, we suggest impermeable barriers around the parking lot of business that are adjacent to the salt marsh (Figure 42).

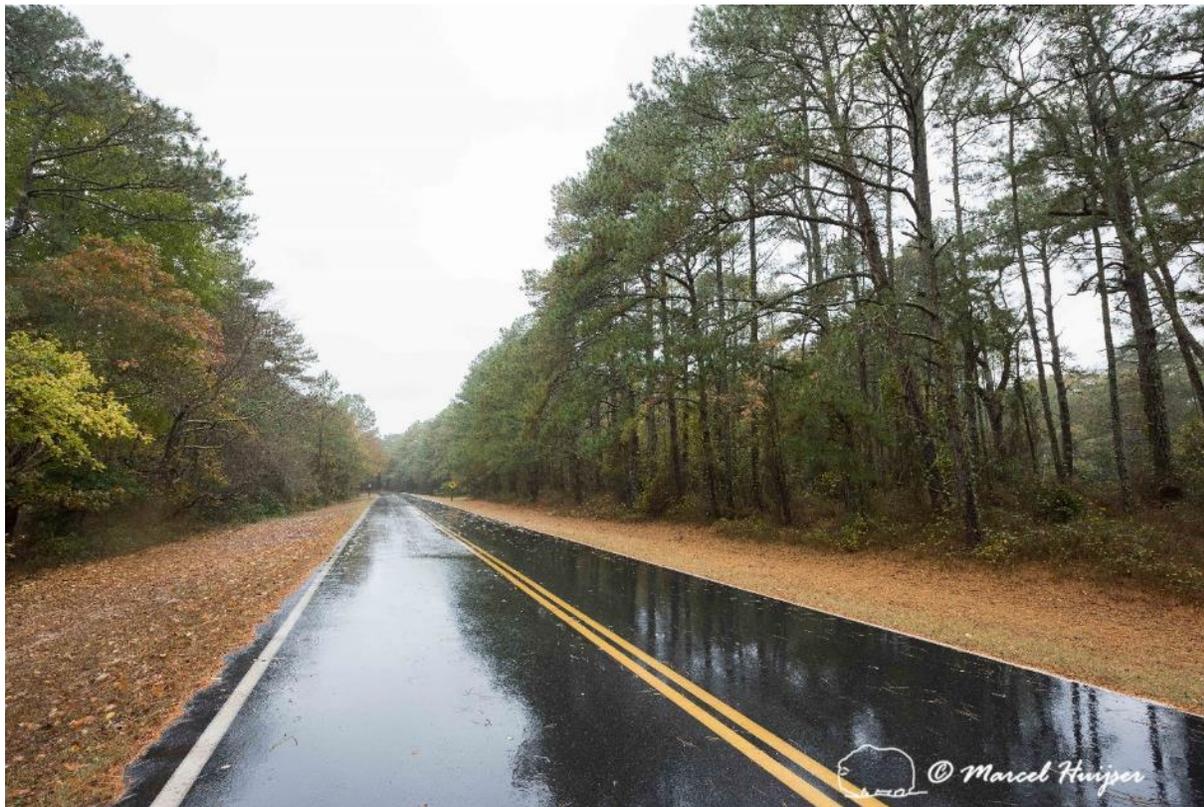
Figure 43: Delmarva fox squirrel habitat present on both sides of the beach access road, near the visitor center, Chincoteague NWR, Virginia, USA.

The current beach access road (blue in Figure 4) is located within Chincoteague. The forested sections of this road have road mortality of the recently delisted Delmarva Peninsula fox squirrel (*Sciurus niger cinereus*) (Pers. com. Nancy Finley, Kevin Holcomb and Robert Leffel, USFWS) (Figure 43). Mortality and connectivity for frogs and toads, salamanders, snakes and turtles are a concern in the wetlands (Figure 44). Common snapping turtles may be the best climbers among the amphibians and reptiles present on the refuge (tree frogs excluded).

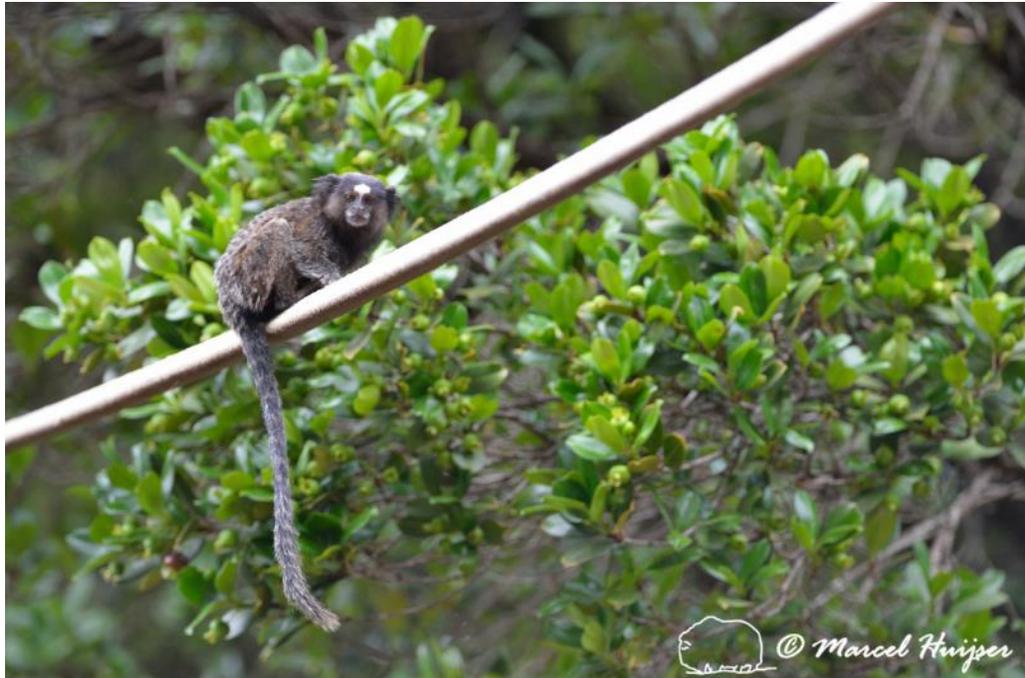
Figure 45: Black-tufted marmoset (*Callithrix penicillata*) on an old firehose over a low volume single lane road, ESALQ campus, Piracicaba, São Paulo, Brazil.

Arboreal crossing structures for squirrels can range from single wires or old fire hoses to rope ladders, to solid metal structures of variable design and width (see e.g. Figure 45, 46). Based on the behavior of the species fox squirrel (*Sciurus niger*) all types of arboreal structures are likely to be used by the Delmarva Peninsula fox squirrel (*Sciurus niger cinereus*). Female fox squirrels may have an average home range size on about 20 ha (Prince et al., 2014). Based on the home range radius, structures should be about 250 m apart at a maximum to allow, on average, all females that have the center of their home range on or adjacent to the road, access to at least one crossing structure. Care should be taken that the structure is physically connected to the canopy on both sides of the road (e.g. through multiple ropes between the end of the structure and the canopies of the surrounding trees).

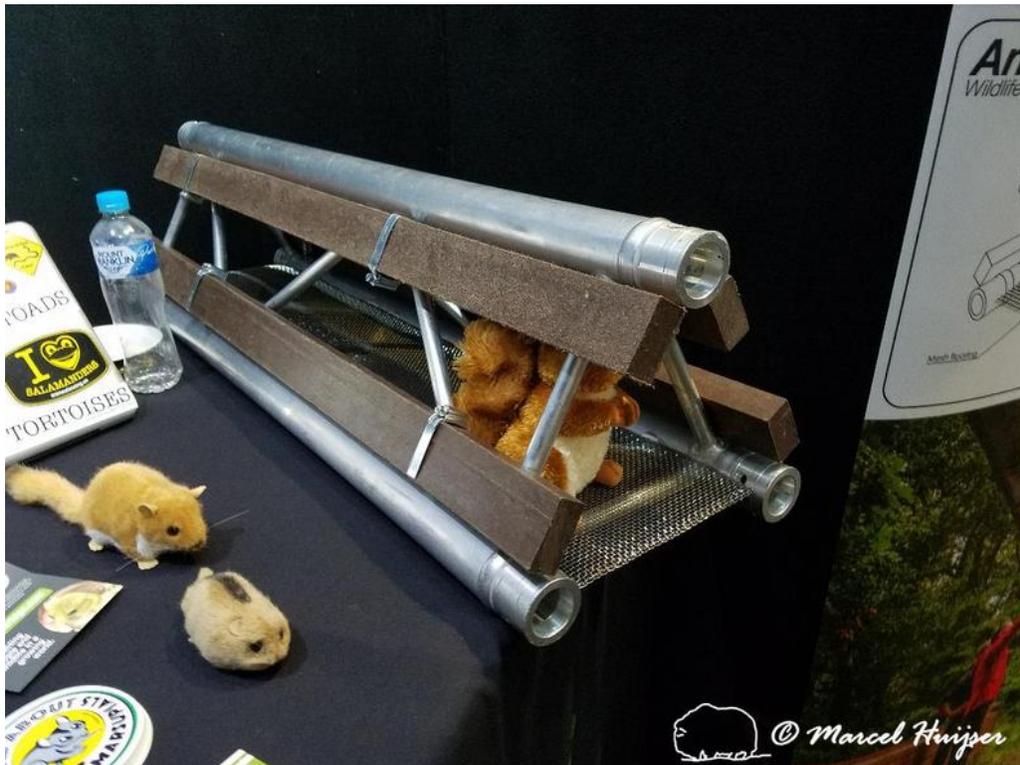
Figure 46: Triangular shaped aluminum wildlife bridge manufactured by Animex (section shown at a conference booth). This type of structure was used readily by Eurasian red squirrel (*Sciurus vulgaris*) (Animex 2018b).

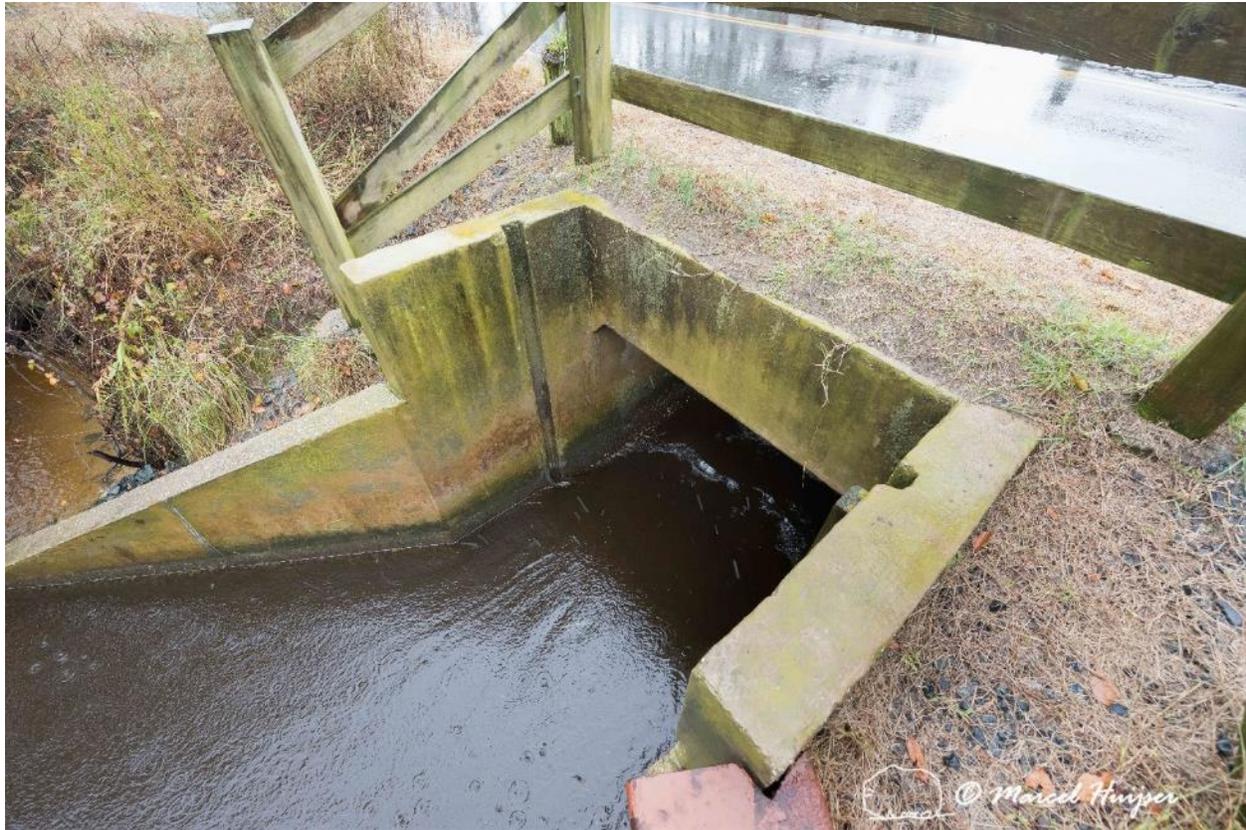
**Figure 47:** Box culvert at the current beach access road, Chincoteague National Wildlife Refuge, Virginia, USA.

Further east, closer to the beach, the current beach access road is a causeway with salt marshes on either side of the road. There is only a small box culvert that allows the brackish water to flow in and out (Figure 47), resulting in restricted tidal flow to Swan Cove Pool. The water velocity appears too high to allow turtles to pass upstream. Restoring tidal influence, and thereby restoring habitat for northern diamondback terrapin seems possible. Part of the causeway can be made into a bridge (Figure 48). The bridge should preferably also have semi-aquatic and terrestrial habitat on both sides allowing for semi-aquatic and terrestrial species to pass under the bridge (Clevenger & Huijser, 2011).

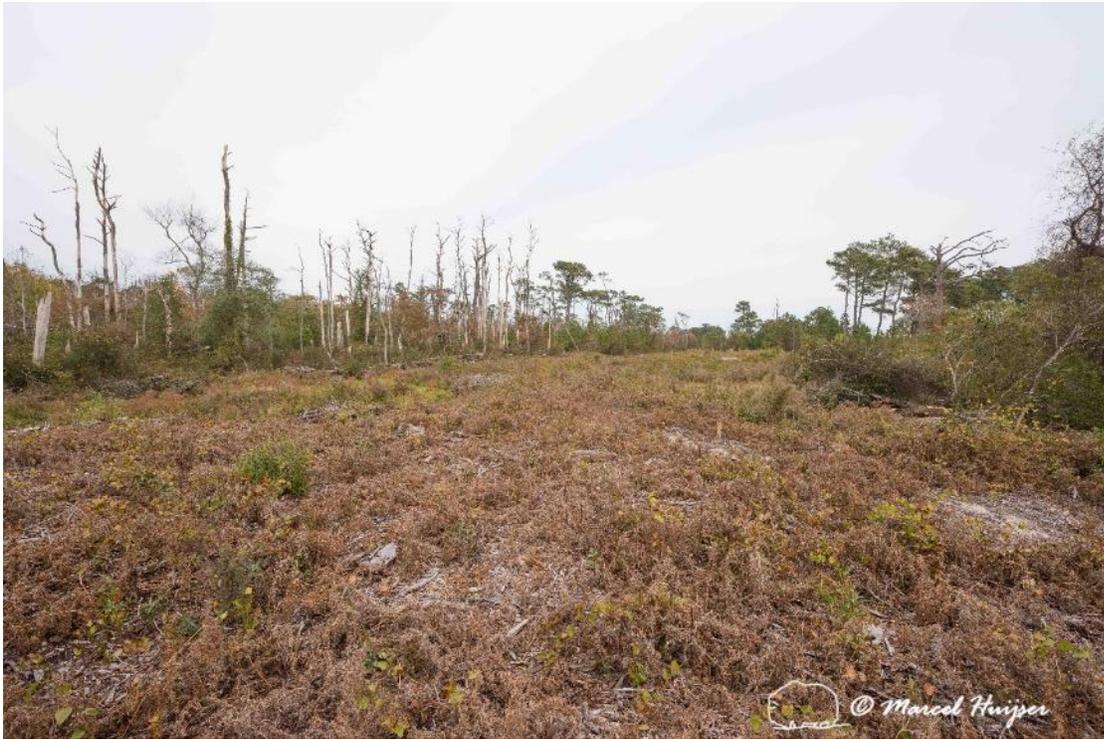
**Figure 49: Route cut through for new beach access road through maritime forest, Chincoteague National Wildlife Refuge, Virginia, USA.**

A new beach access road (purple in Figure 4) is under construction (vegetation has largely been cut) within Chincoteague NWR and the Assateague Island National Seashore from Snow Goose Pool to just north of Pintail Pool (Figure 49, 50). Likely future road mortality of the Delmarva Peninsula fox squirrel and likely future road mortality and reduced habitat connectivity is a concern for frogs and toads, salamanders, snakes and turtles (Pers. comm. Nancy Finley, Kevin Holcomb and Robert Leffel, USFWS).

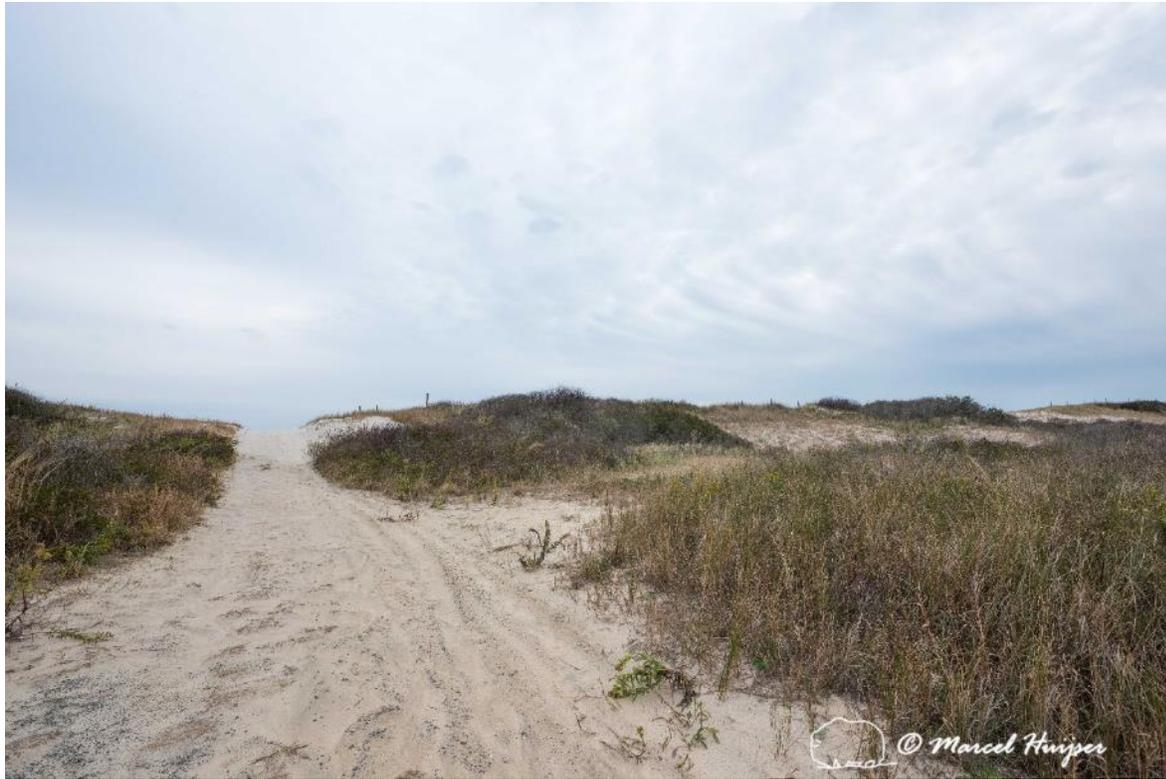
**Figure 51: This will be the new beach access point, Chincoteague National Wildlife Refuge, Virginia, USA.**

The parking area for the new beach access will be just behind the coastal dunes. We suggest that the beach visitors will cross the dunes on a boardwalk to minimize damage to the dune vegetation and to keep the roots intact to withstand water and wind erosion (Figure 51, 52).

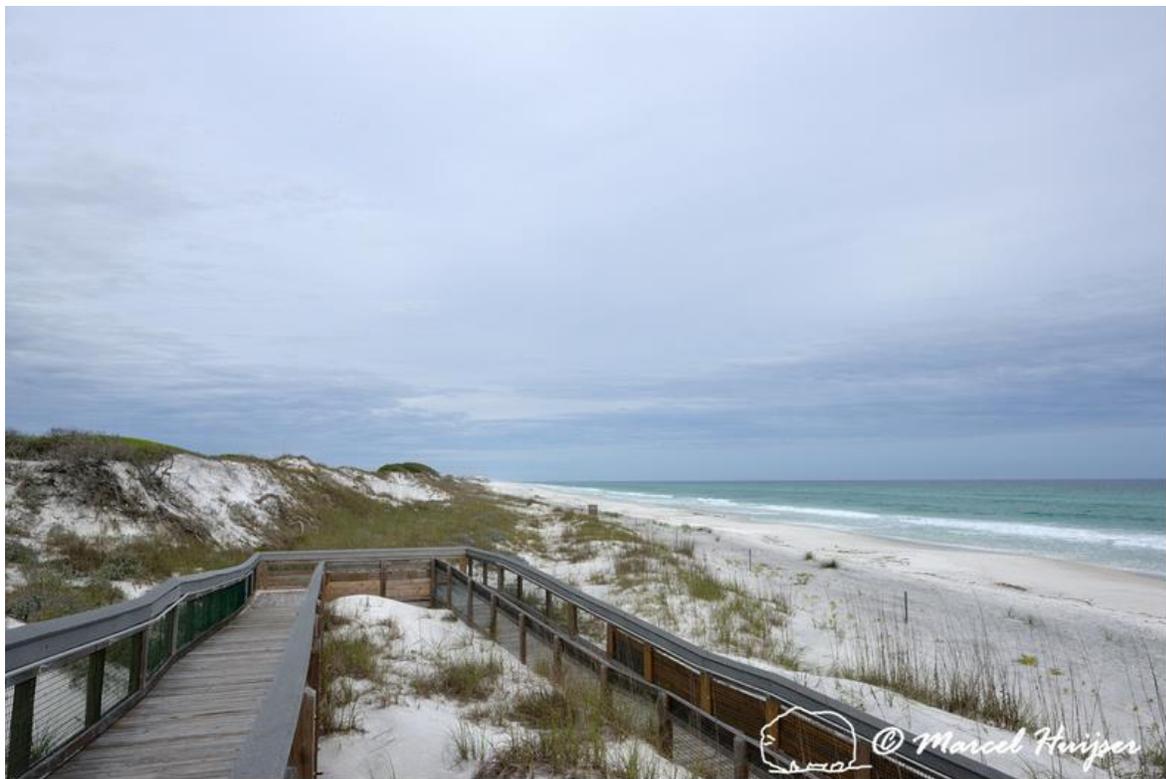
**Figure 52: Boardwalk across coastal dunes to reduce erosion, east of Seagrave Beach. Florida, USA.**
