**Measures to reduce bighorn sheep collisions –
Highway 93/95 Mile Hill and Radium, British Columbia**

BC Ministry of Forests, Lands, Natural Resource Operations and Rural Development

April 2021

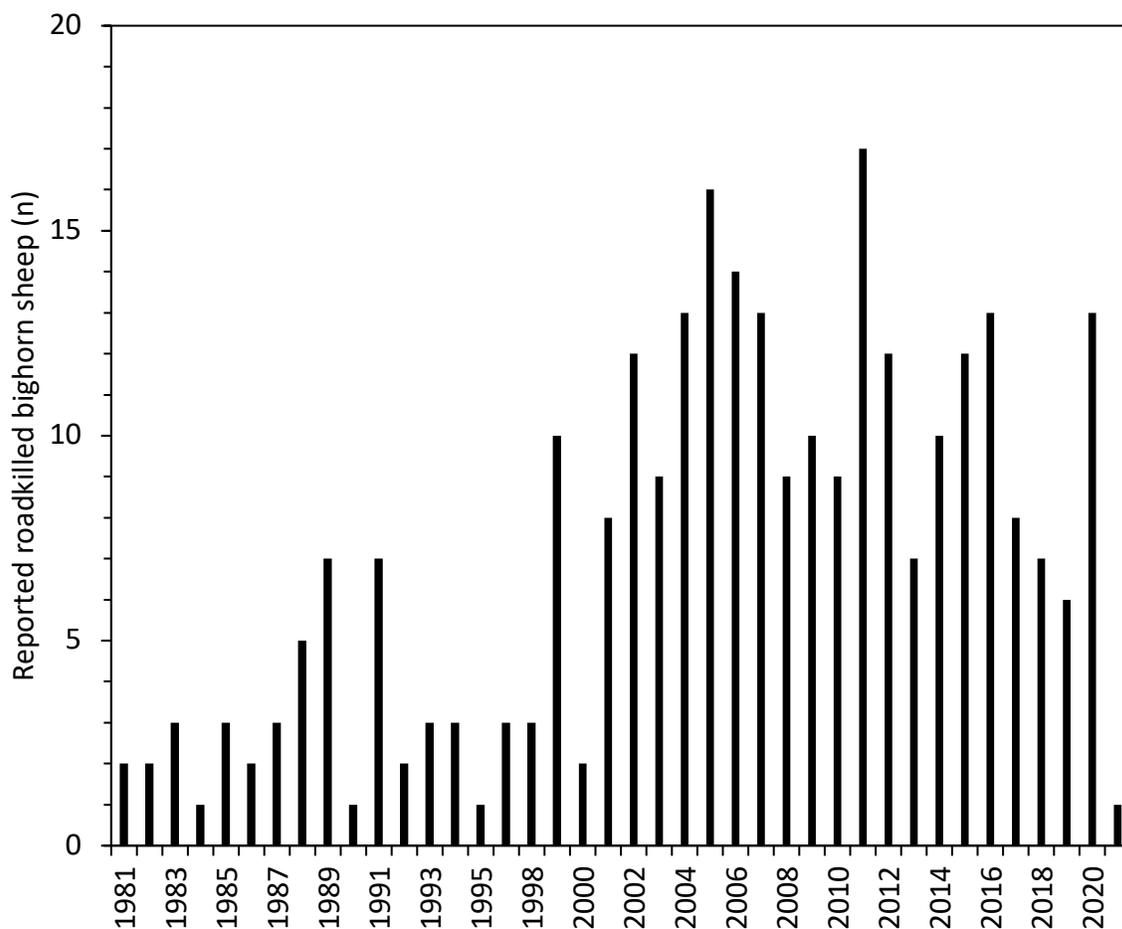
Figure 2. Number of reported road-killed bighorn sheep in the Radium Hot Springs area, 20 Dec 1981 and 5 Jan 2021 (Data provided by Parks Canada).

Records of the number of reported road-killed bighorn sheep are maintained by Parks Canada. The number of road-killed bighorn sheep per year was similar between 2001-2010 (average 11.30, SD 2.67) and 2011-2020 (average 10.50, SD 3.51) (Figure 2).

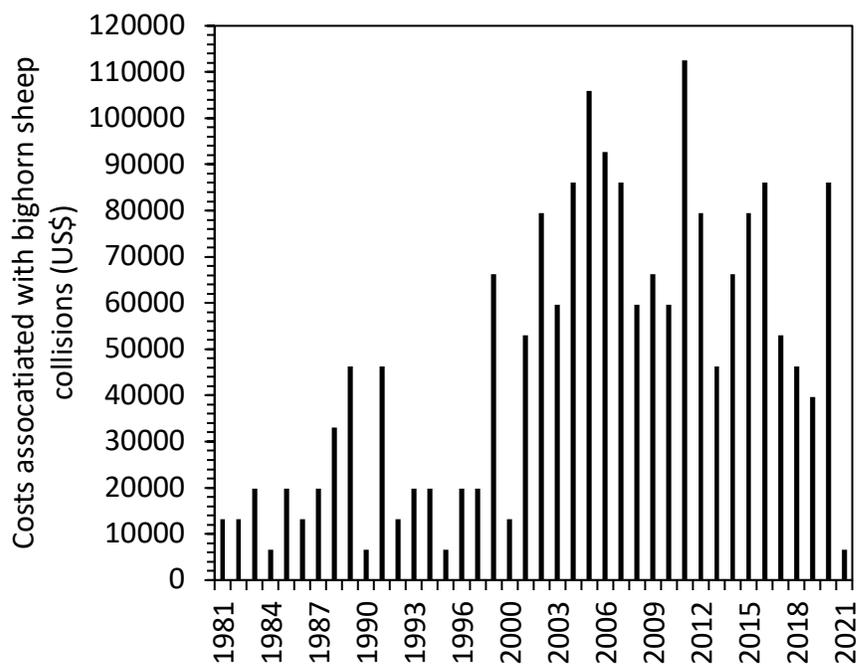
Figure 3. The costs (in US\$) per year associated with bighorn sheep-vehicle collisions in and around Radium Hot Springs (based on Huijser et al., 2009).

To estimate the economic costs associated with bighorn sheep-vehicle collisions, the number of road-killed bighorn sheep per year was multiplied by US \$ 6617 (based on their similarity in size to “deer” in Huijser et al., 2009) (Figure 3). The economic costs associated with road-killed bighorn sheep per year in the Radium Hot Springs area was similar between 2001-2010 (average US\$ 74,772, SD 17,659) and 2011-2020 (average US\$ 69,479, SD 23, 186) (Figure 3). Note that this is a conservative estimate, primarily based on costs associated with vehicle repair costs, and costs associated with human injuries and human fatalities. Values associated with biological conservation are likely substantial, but they were not part of this analysis.

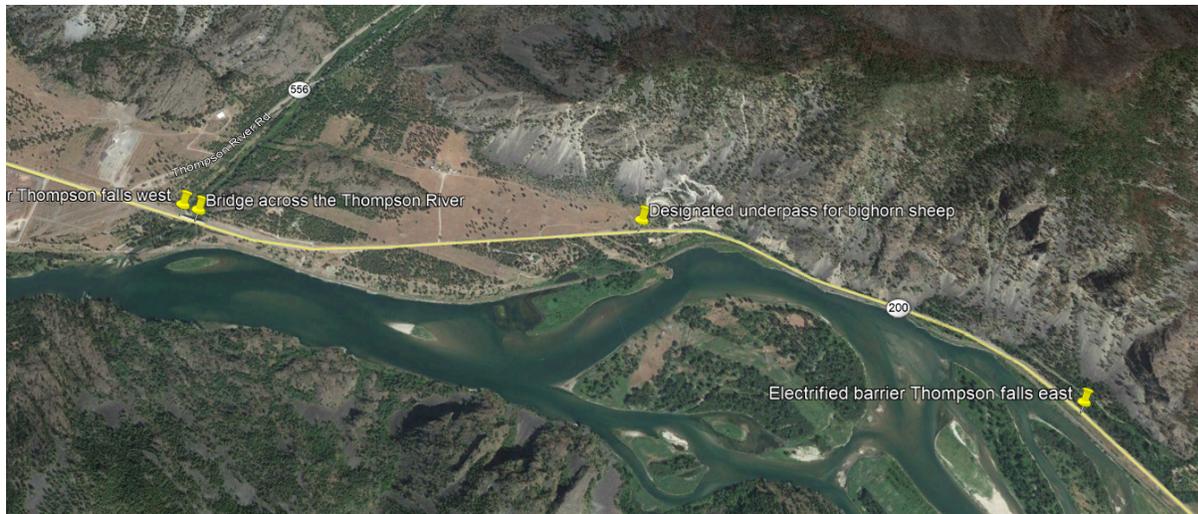
The two fence ends, the existing bridge across the Thompson River, and the location of the underpass designed for bighorn sheep.

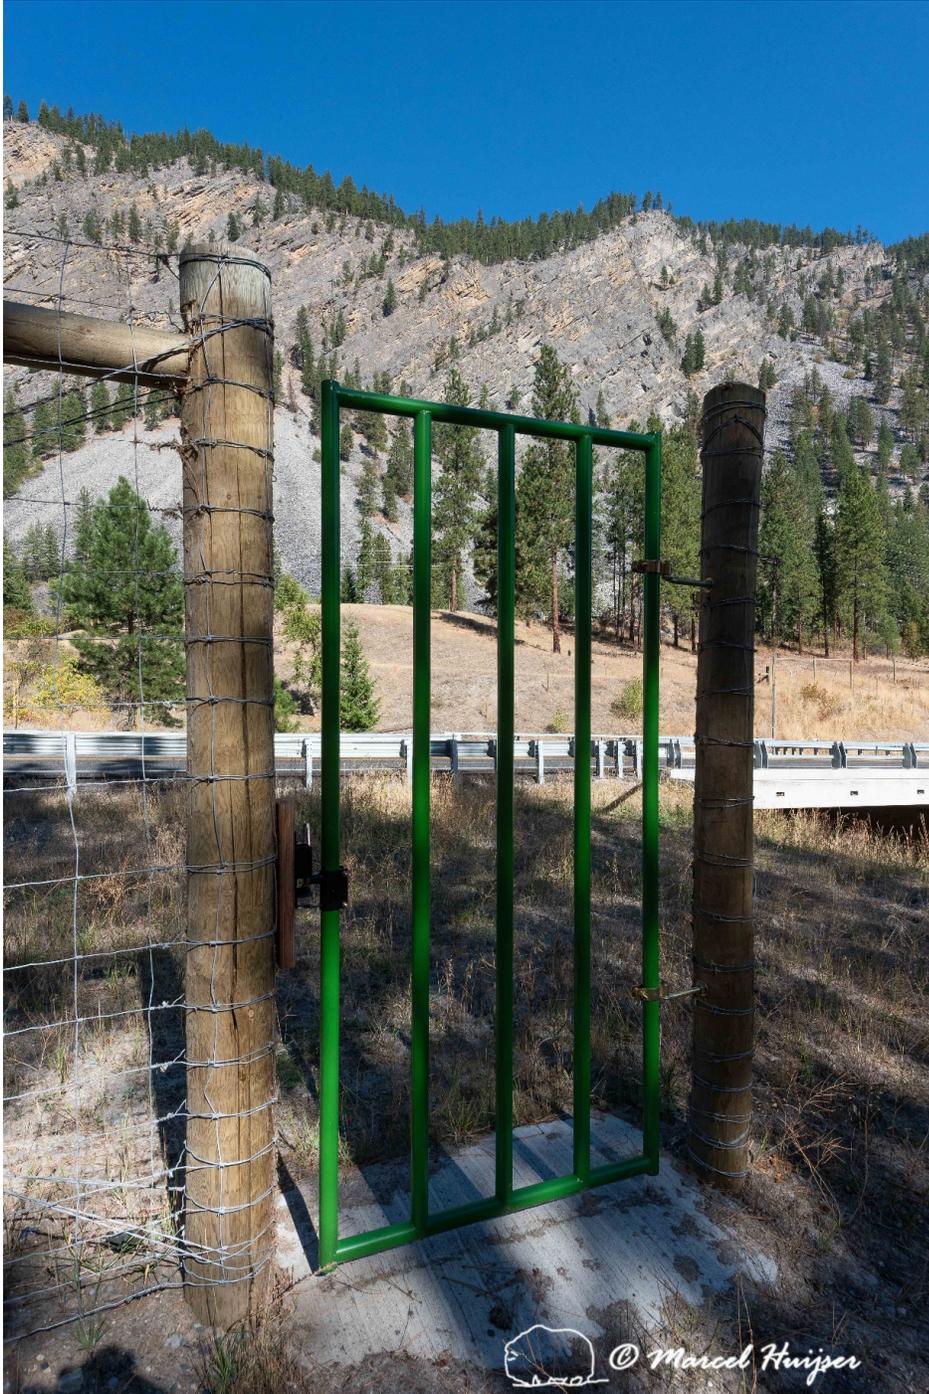
Gate through fence to provide access to wildlife underpass for maintenance and research, Thompson Falls, Montana

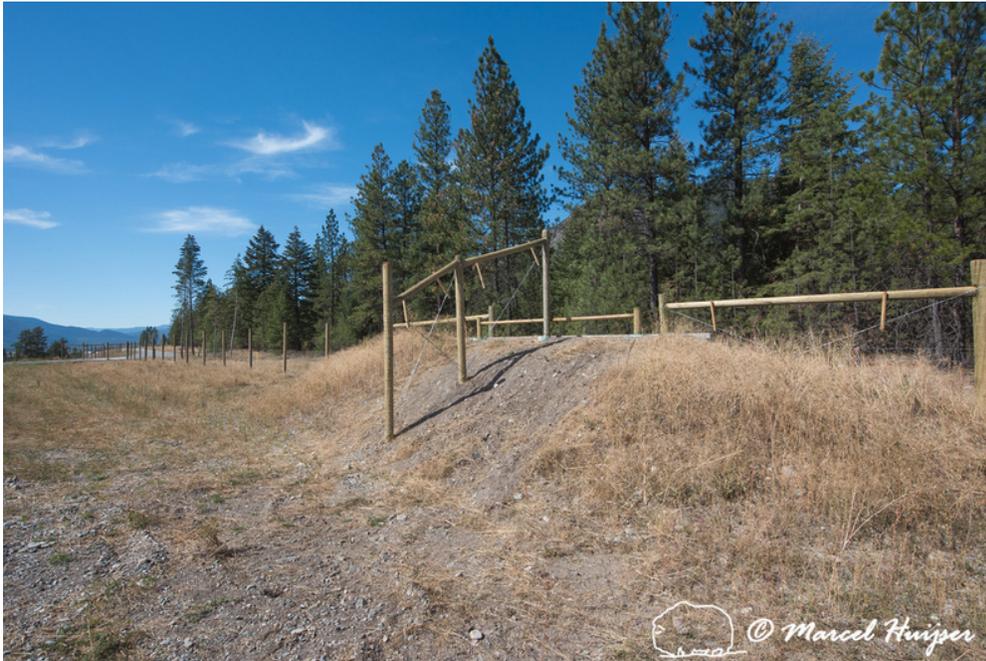
Wildlife jump-out, primarily for bighorn sheep, Thompson Falls, Montana

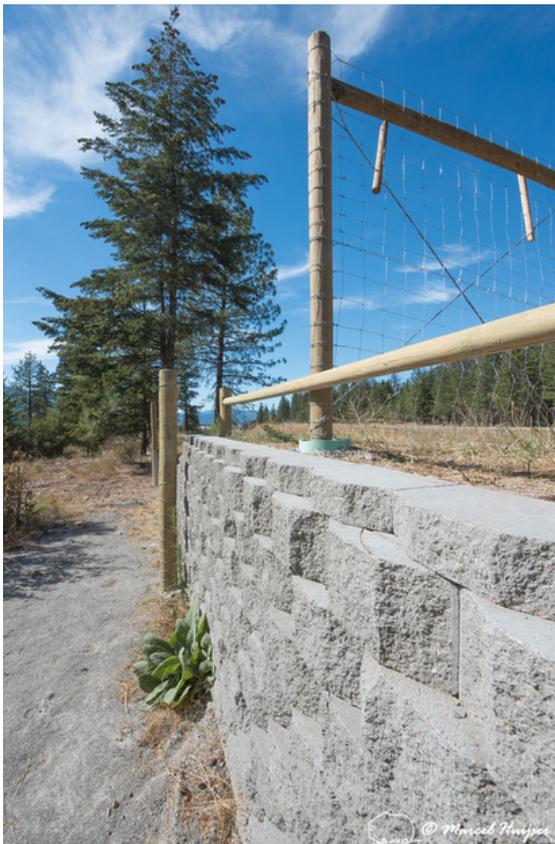
Wildlife jump-out, primarily for bighorn sheep, Thompson Falls, Montana

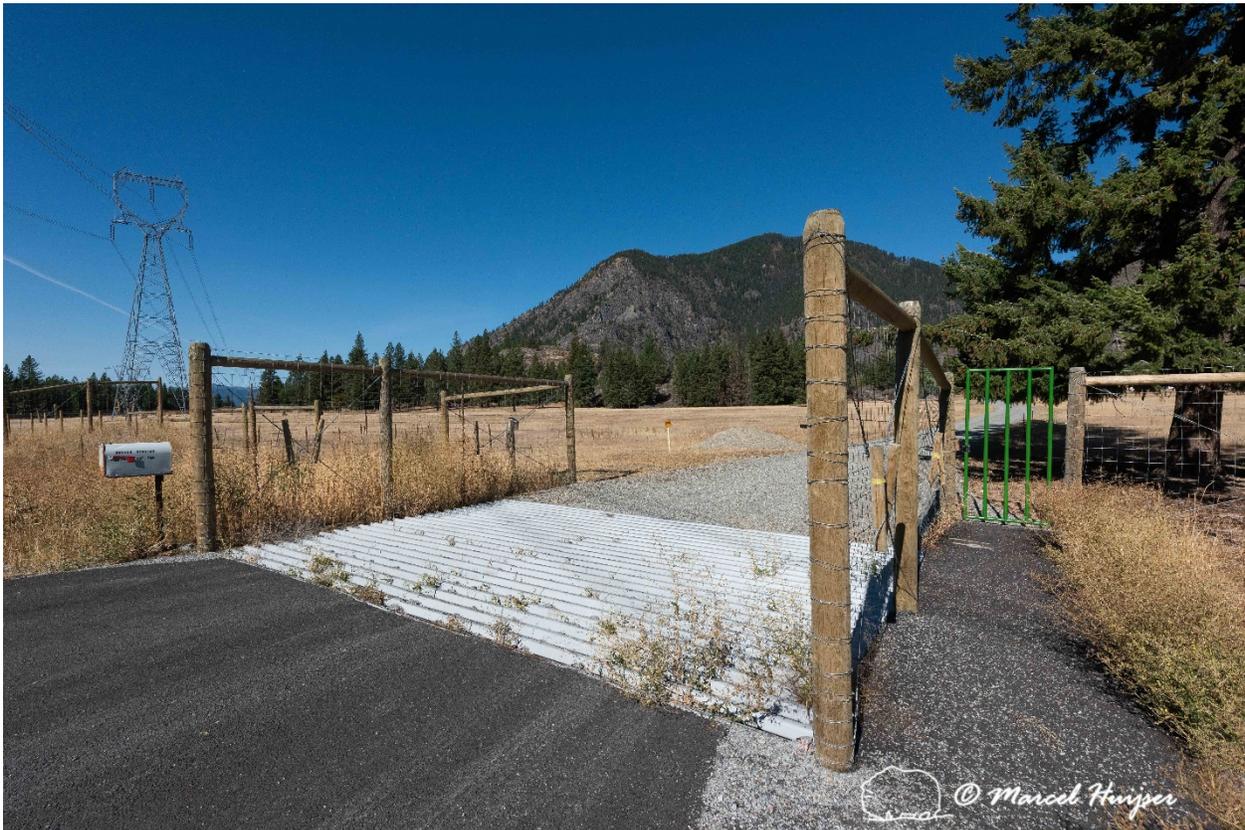
Wildlife guard and gate at access road, to keep wildlife, primarily bighorn sheep, out of fenced road corridor, Thompson Falls, Montana

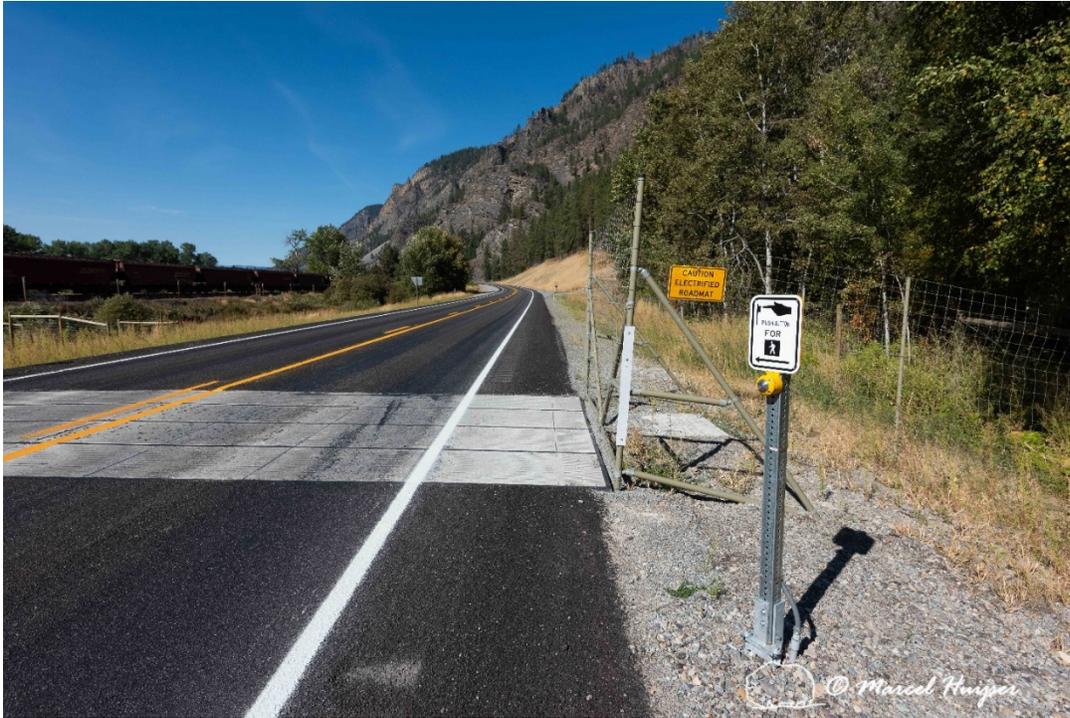
Electrified barrier embedded in travel lanes to keep large mammals, including bighorn sheep, out of fenced road corridor, Thompson Falls, Montana

- Note: there is an existing large bridge across Thompson River on the west end. The fence starts at the east side of the bridge, but the electrified barrier is located at the west side of the bridge to reduce the probability that bighorn sheep enter the bridge.

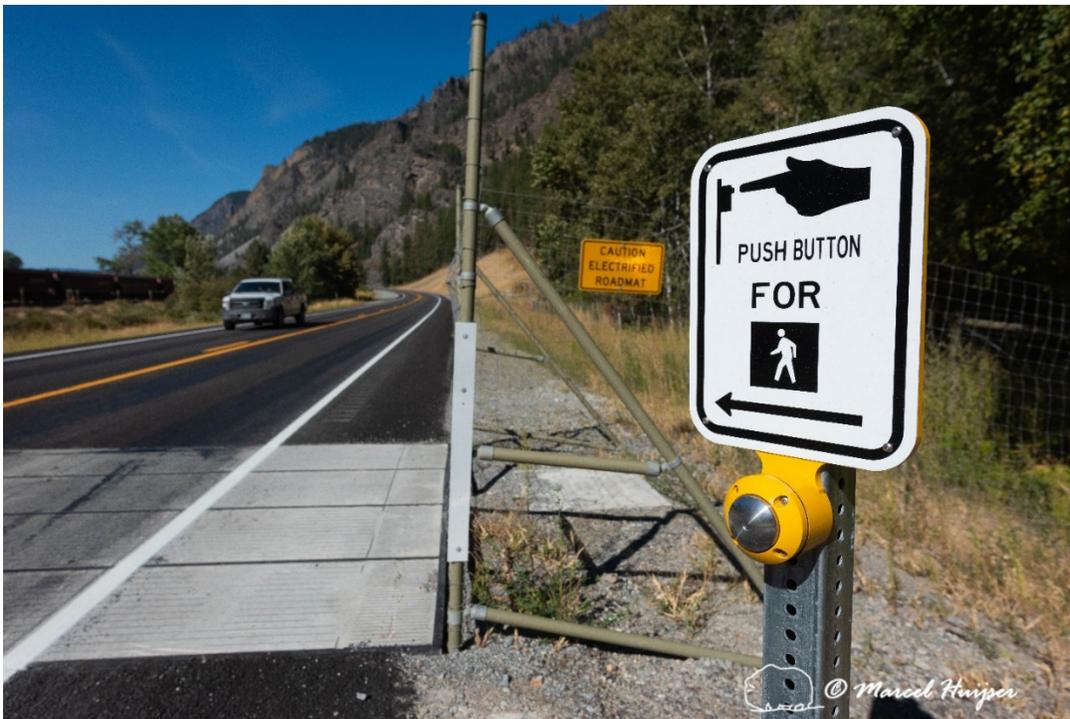
Push button on timer for pedestrians at an electrified barrier embedded in travel lanes to keep large mammals, including bighorn sheep, out of fenced road corridor, Thompson Falls, Montana

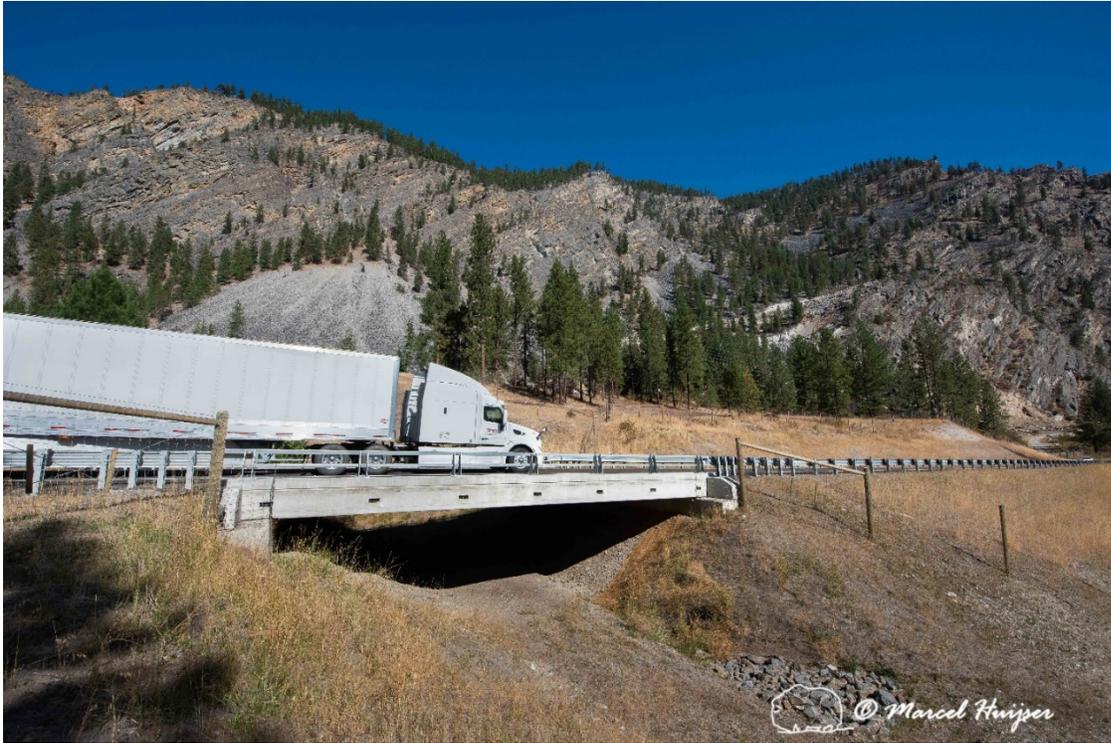
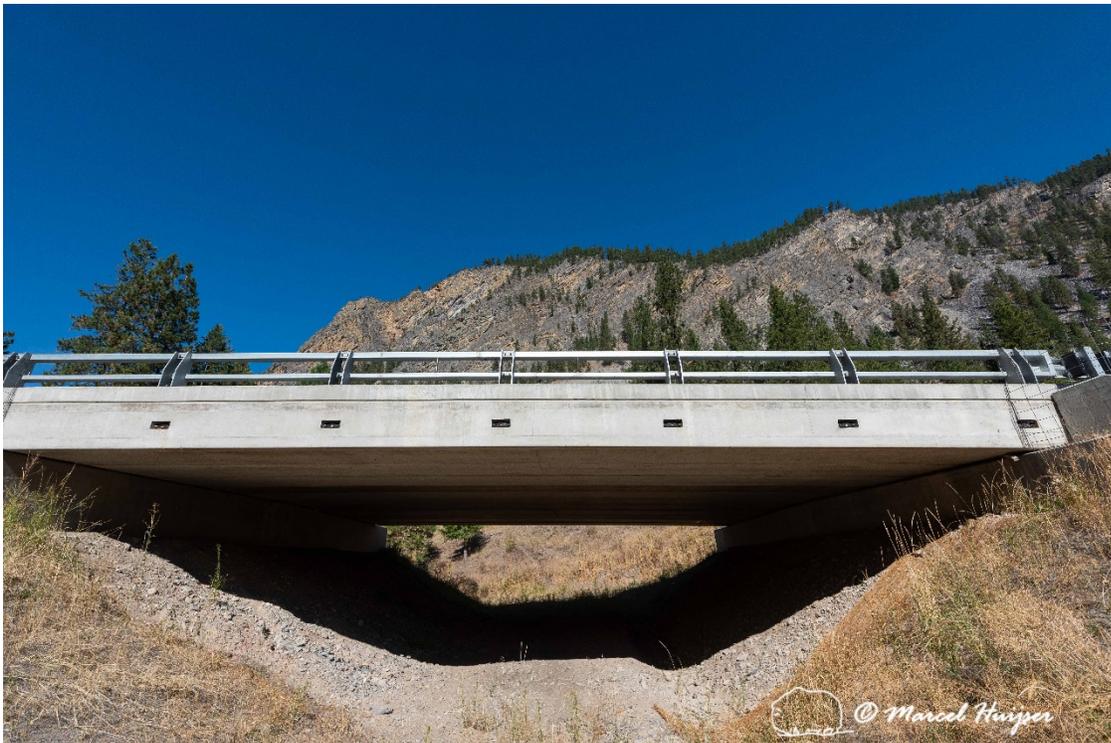
Wildlife underpass, primarily designed for bighorn sheep, Thompson Falls, Montana

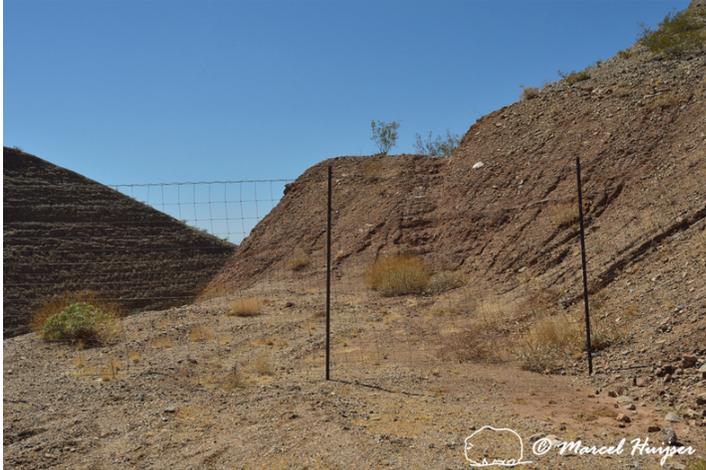
Wildlife fence designed for desert bighorn sheep, US Hwy 93, Arizona

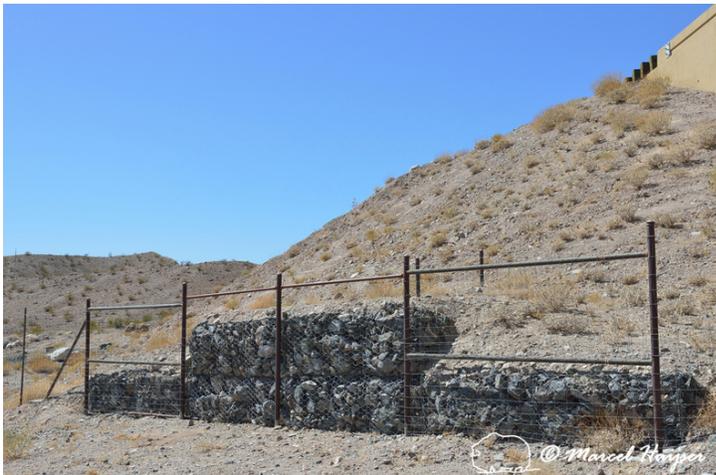
Wildlife jump-out or escape ramp with bar, at wildlife underpass designed for desert bighorn sheep, US Hwy 93, Arizona.

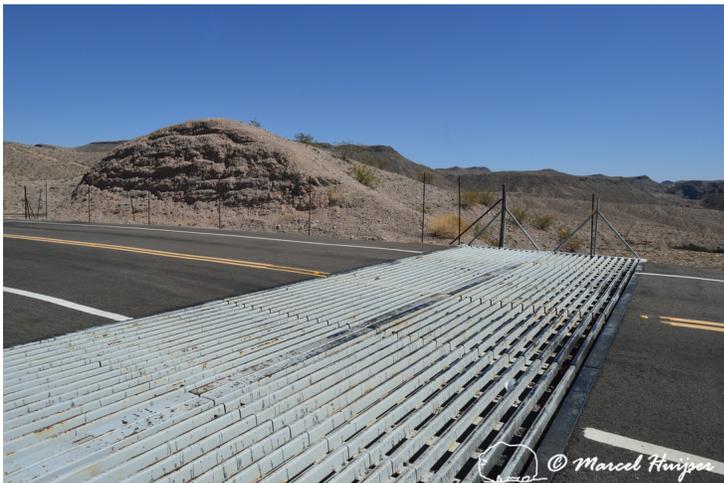
Double wide wildlife guard at access road US Hwy 93, Arizona.

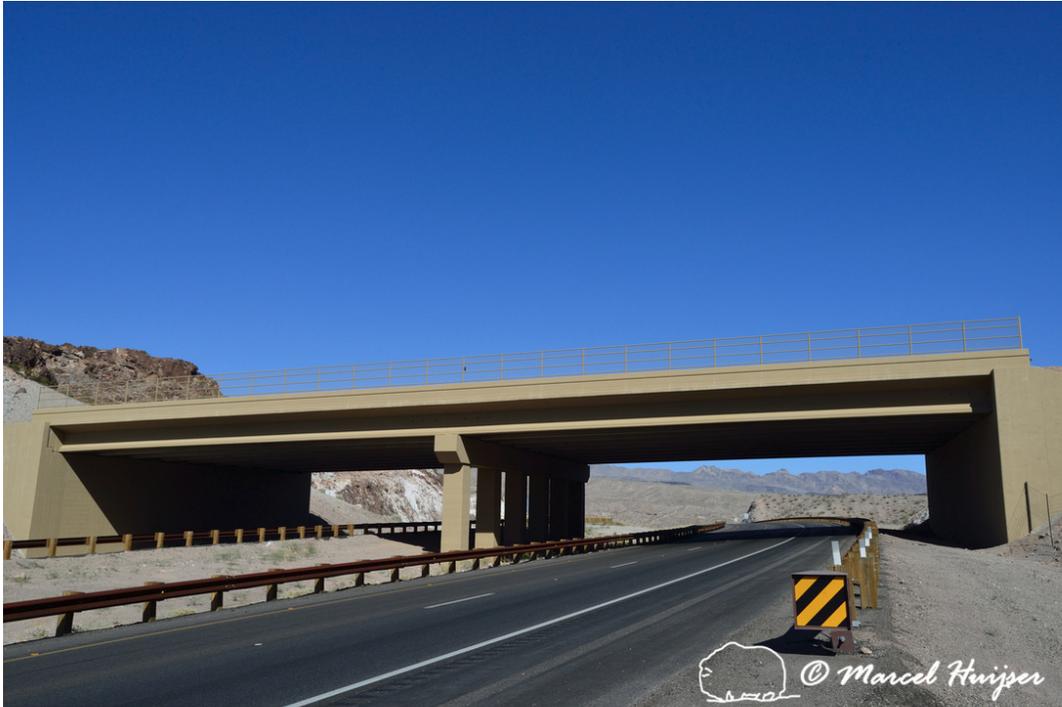
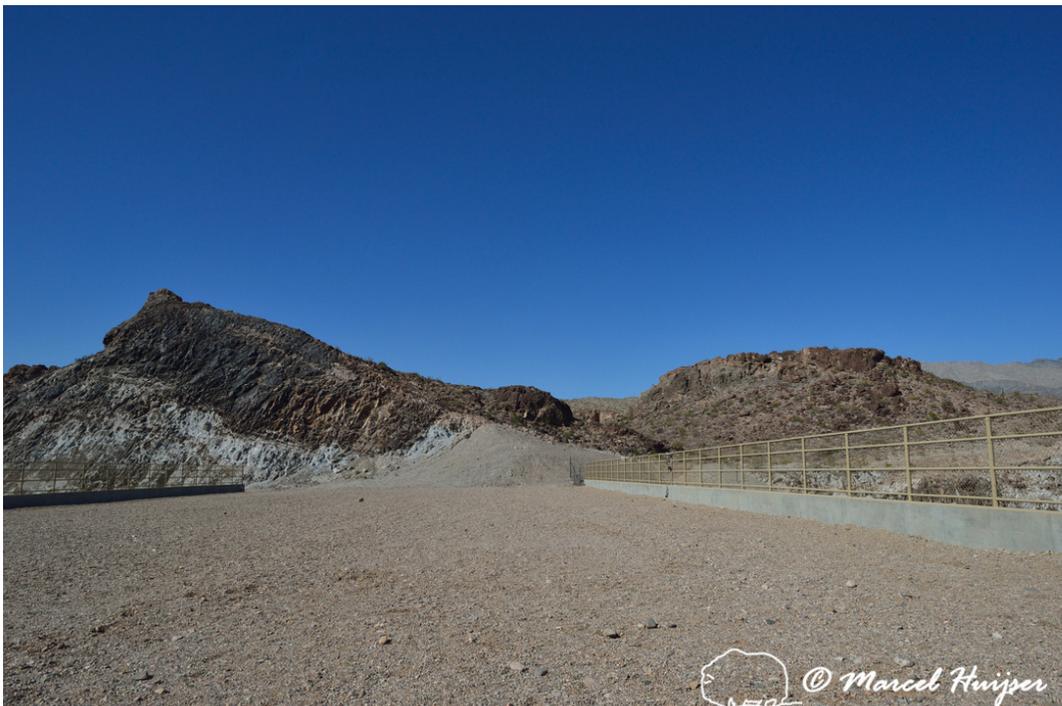
Wildlife overpass designed for desert bighorn sheep, US Hwy 93, Arizona. This particular overpass is about 30 m wide and it is the most northern of three wildlife overpasses in the area.

Wildlife overpass designed for desert bighorn sheep, US Hwy 93, Arizona. This particular overpass is about 30 m wide and it is the most northern of three wildlife overpasses in the area

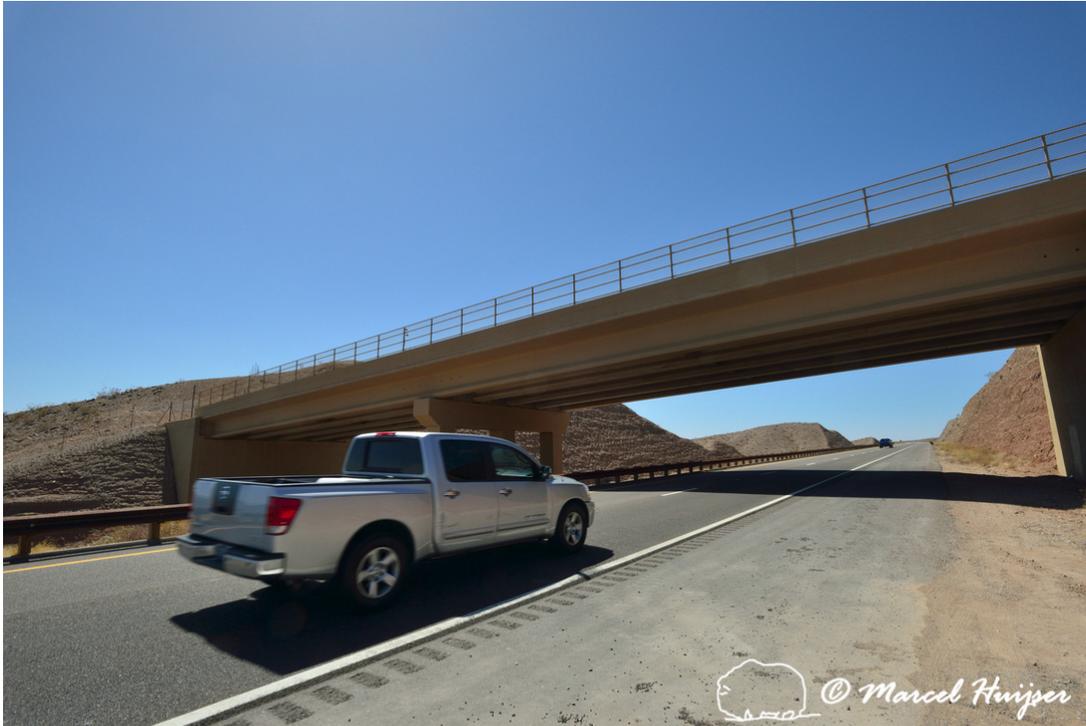
Wildlife overpass designed for desert bighorn sheep, US Hwy 93, Arizona. This particular overpass is about 15 m wide and it is the most southern of three wildlife overpasses in the area.

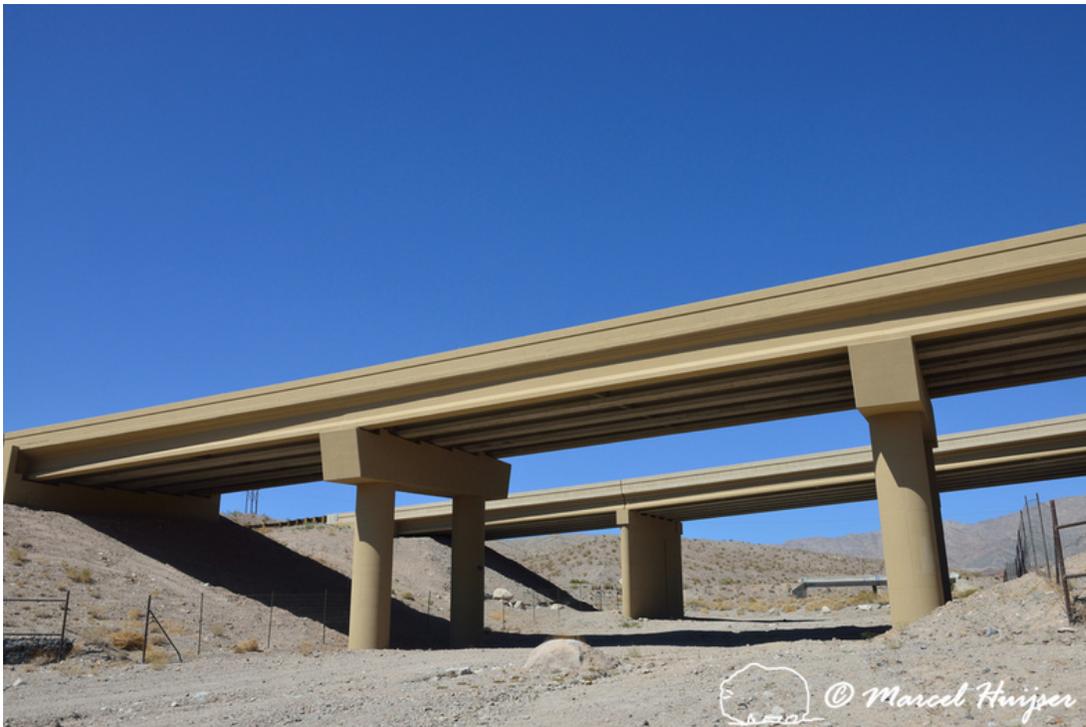
Underpass for desert bighorn sheep at a desert wash, White Rock Canyon bridge, US Hwy 93, Arizona.

- MP 13.1
 - MP 6.0
 - MP 5.2
- 2 underpasses (bridges) at desert washes:
 - White Rock Canyon Bridge (MP 4.2).
 - Devils Wash Bridge (MP 8.0).

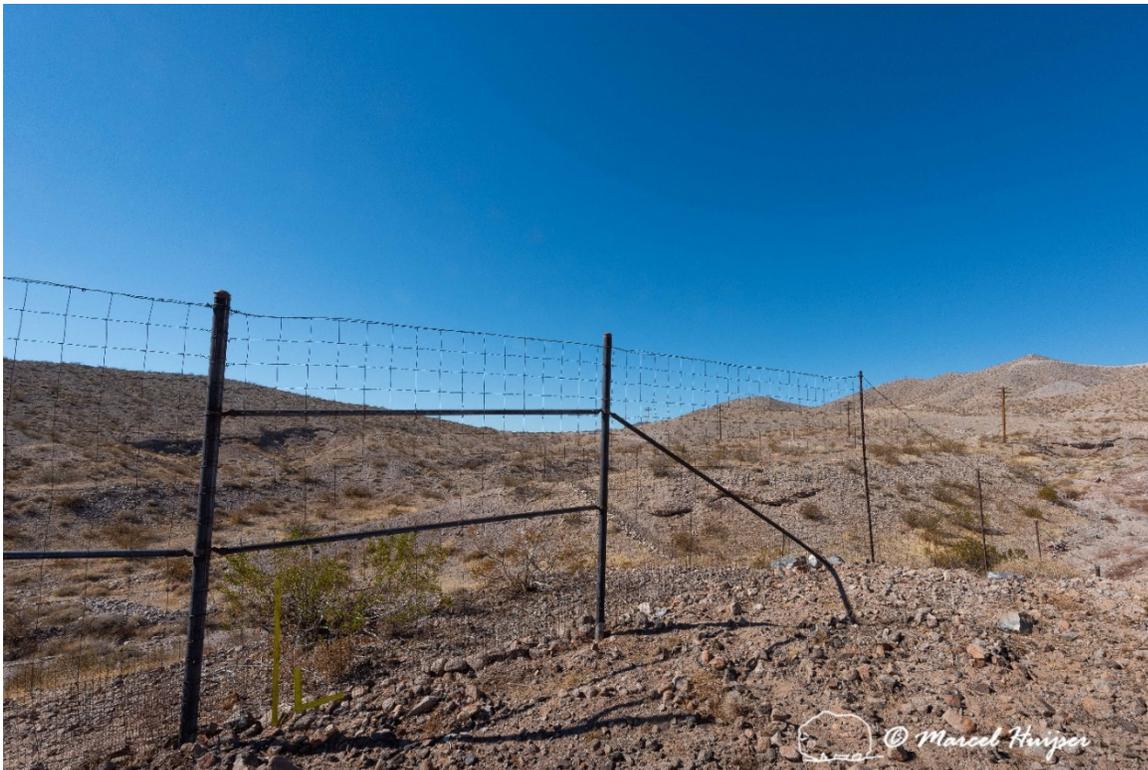
Wildlife fence (8 ft tall (2.4 m)), primarily for desert bighorn sheep, I-11, near Boulder City, Nevada.

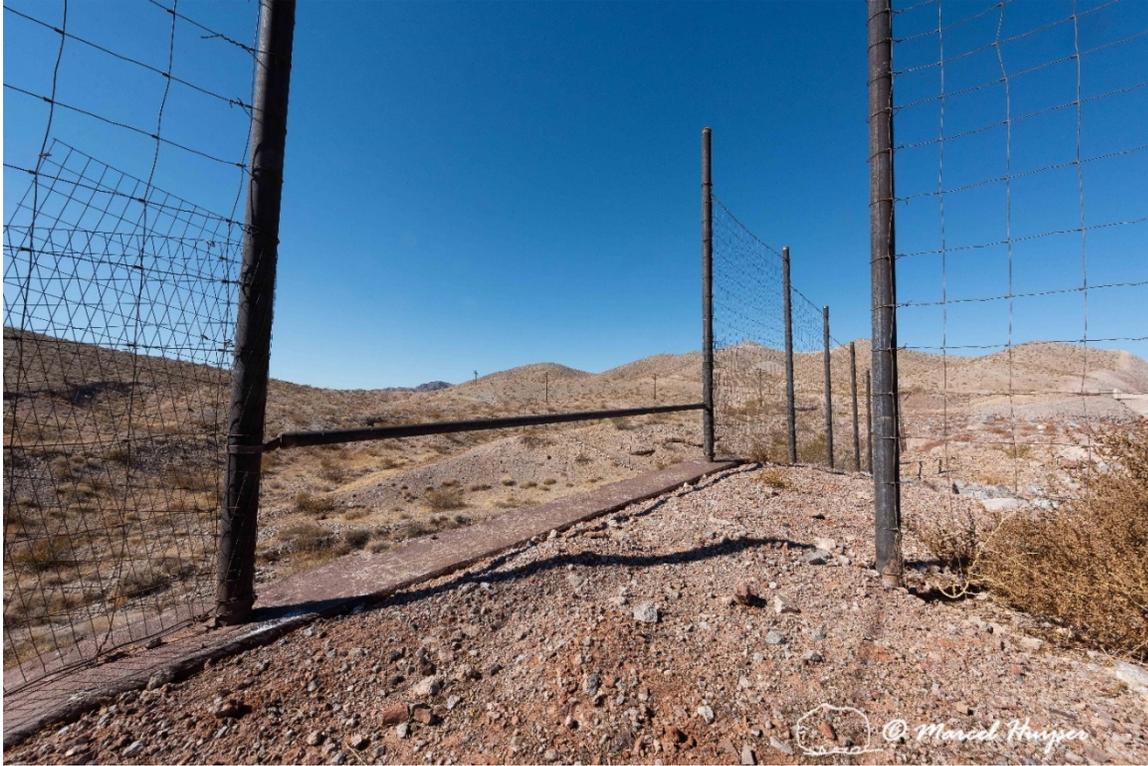
Wildlife jump-out, primarily for desert bighorn sheep, I-11, near Boulder City, Nevada.

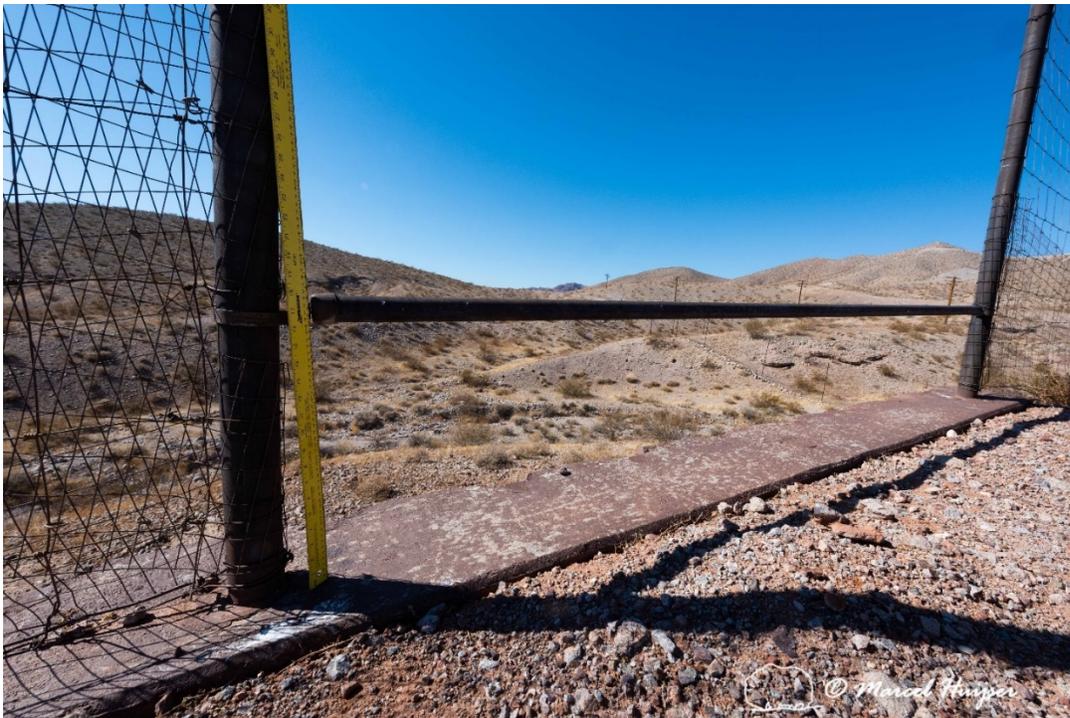
Wildlife jump-out, primarily for desert bighorn sheep, I-11, near Boulder City, Nevada. The bar is about 17 inches above the top of the jump-out.

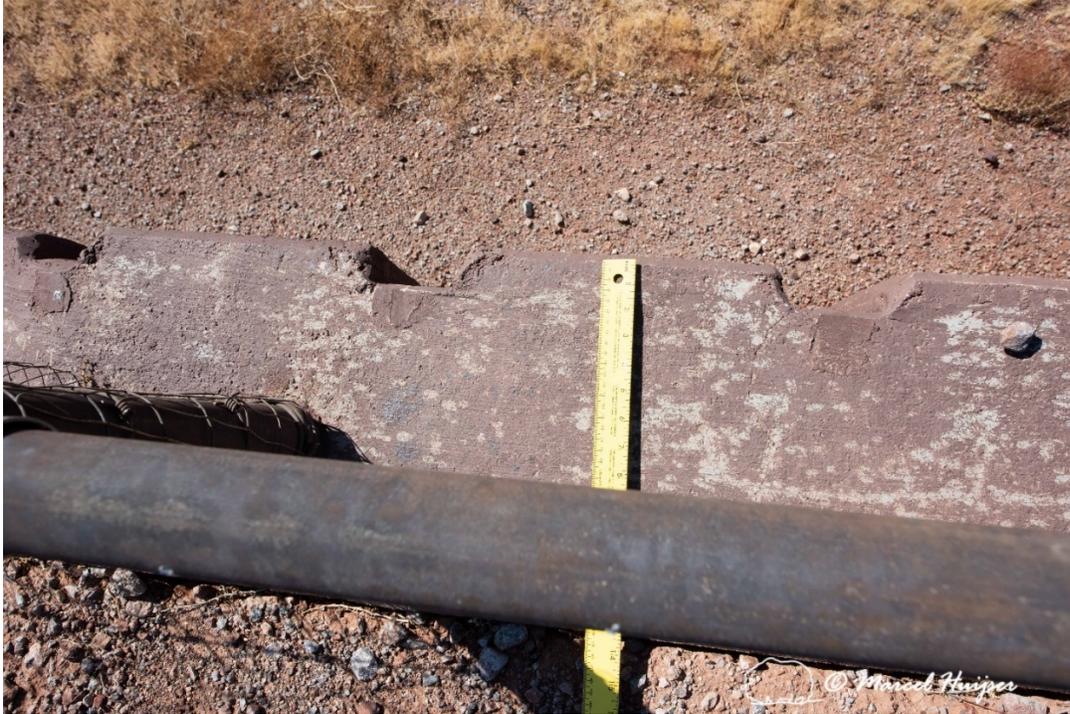
Wildlife jump-out, primarily for desert bighorn sheep, I-11, near Boulder City, Nevada. The bar is in-line with the fence, about 8-9 inches from the face of the jump-out.

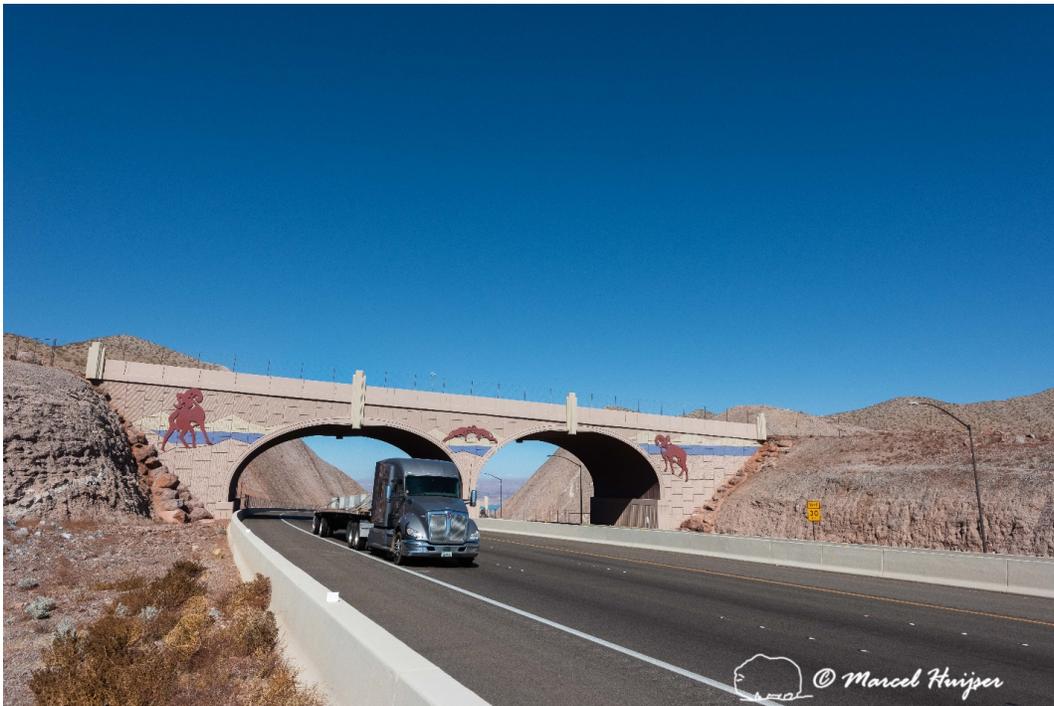
Wildlife overpass for desert bighorn sheep at Eldorado ridge, I-11, near Boulder City, Nevada. The overpass is about 50 ft wide (15.2 m).

- Wildlife fence, 8 ft (2.4 m tall)
- Wildlife jump-outs
- Overpass for bighorn sheep at Eldorado Ridge. 50 ft (15.2 m) wide Constructed in 2018, Overpass cost was \$1.2 million (Las Vegas Review-Journal, 2018; (Personal comment Jeff Gagnon, Arizona Game and Fish Department, 2 March 2021).

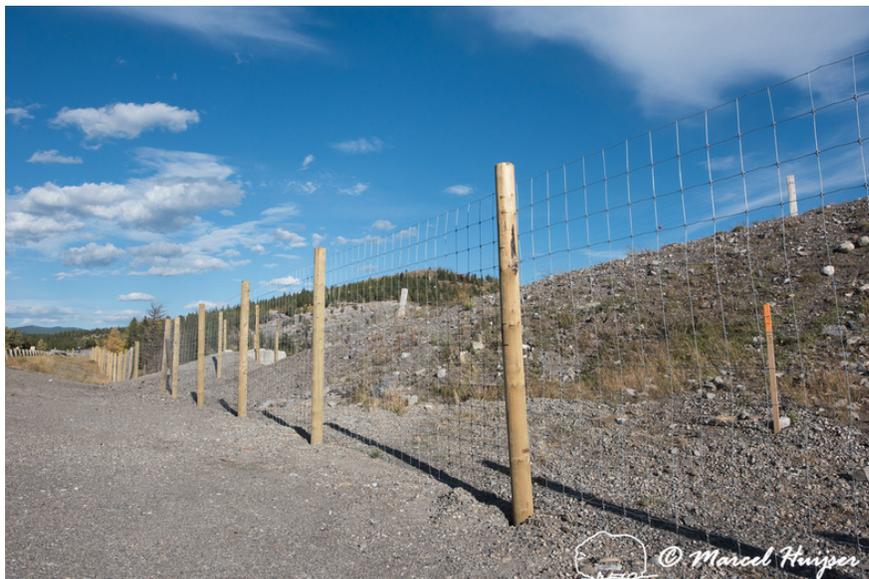
Wildlife fences for bighorn sheep, Hwy 3, Crowsnest Pass, Alberta, Canada

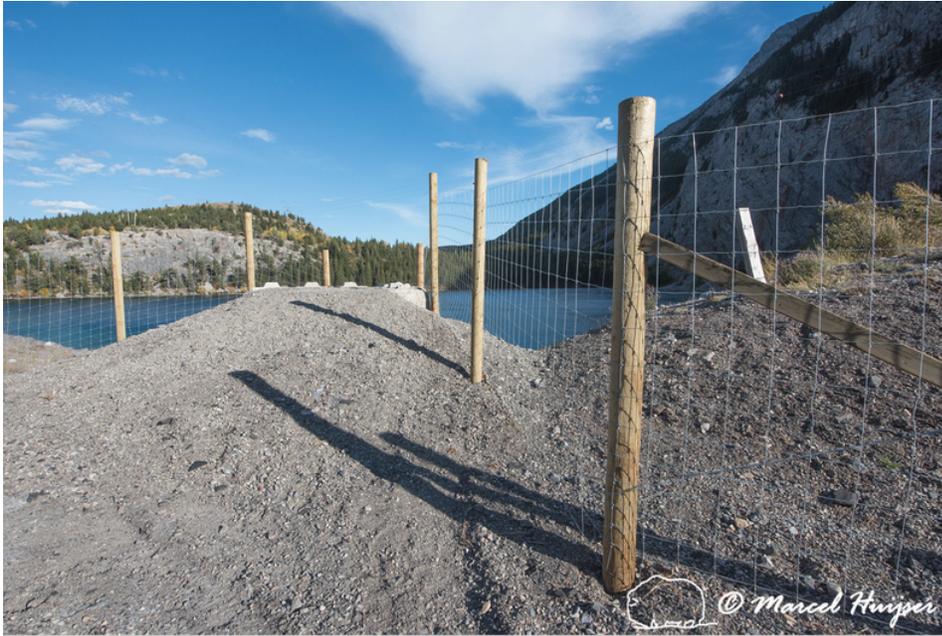
Jump-out for bighorn sheep, Hwy 3, Crowsnest Pass, Alberta, Canada

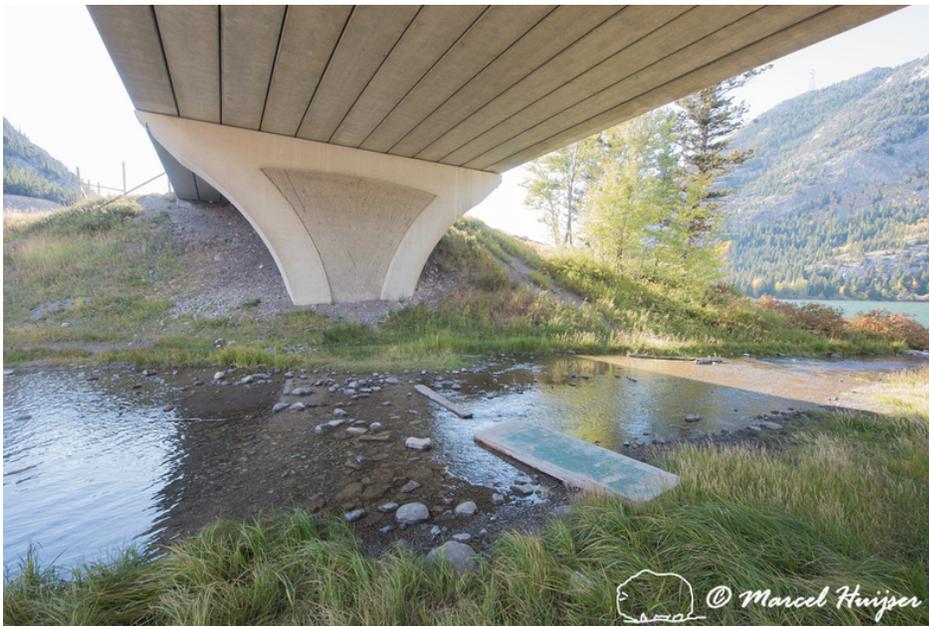
Underpass for hydrology and bighorn sheep, Hwy 3, Crowsnest Pass, Alberta, Canada

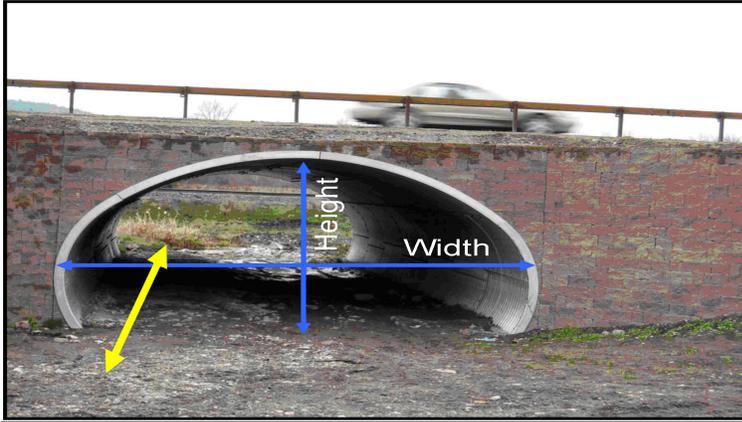
Figure 4: Width and height measurements of wildlife underpass structure. Length is shown as yellow arrow (Credit: Marcel Huijser/WTI).

The *recommended* and *minimum* dimensions for each of the 11 wildlife crossing types are provided in the FHWA guidelines (Clevenger and Huijser 2011). The measurements are for crossing structures designed for 4-lane highways. See Figure 4 for how crossing structure length, height and width are measured. The guidelines should be followed if the crossings are at minimum to allow for the simplest and most basic connectivity requirement of crossings structures, i.e., the exchange of individuals within populations. Crossings designed for exchange of individuals may not allow for normal demographic processes, thus allowing passage use by few individuals and biased towards male movement. Both genders need to mix freely across the highway for wildlife crossings to perform effectively, and post-construction monitoring should be able to verify use and performance.

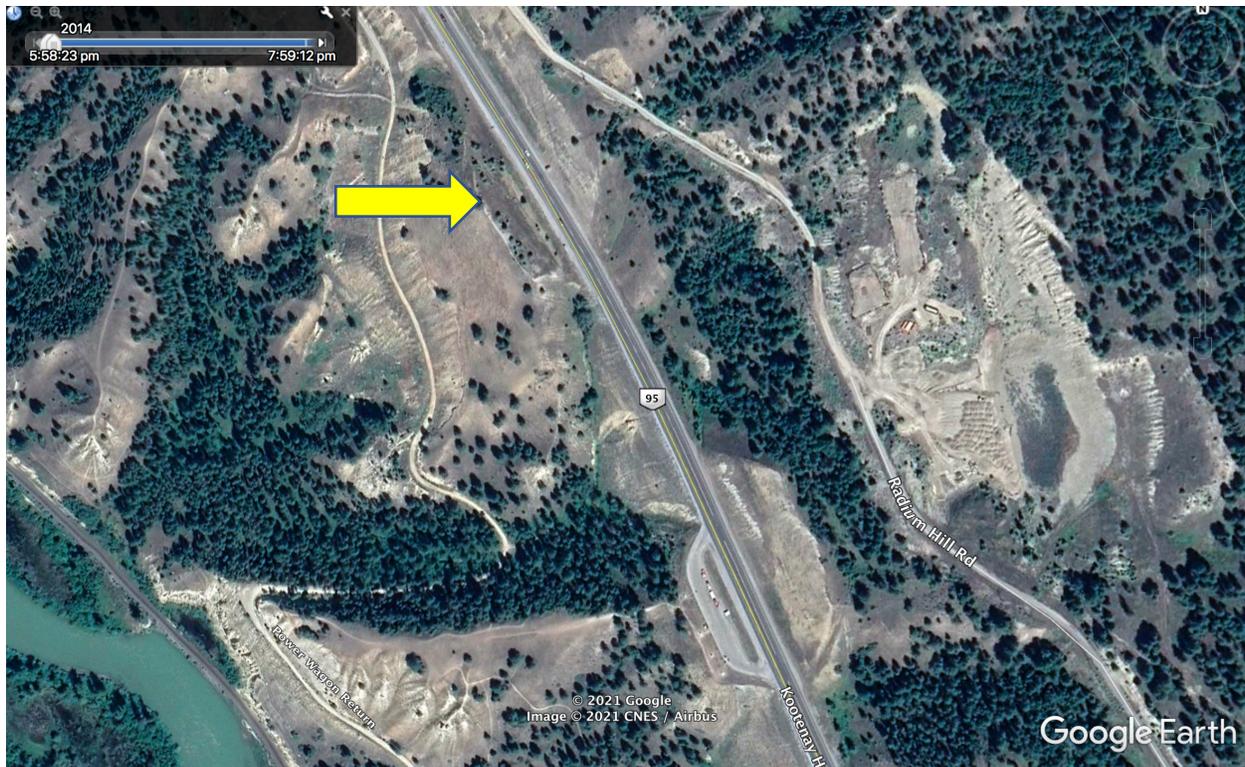
Figure 5. Location of proposed wildlife overpass (shown by arrow) at through-cut section of Highway 93/95.
