**Measures to reduce bighorn sheep collisions –
Highway 93/95 Mile Hill and Radium, British Columbia**

BC Ministry of Forests, Lands, Natural Resource Operations and Rural Development

April 2021

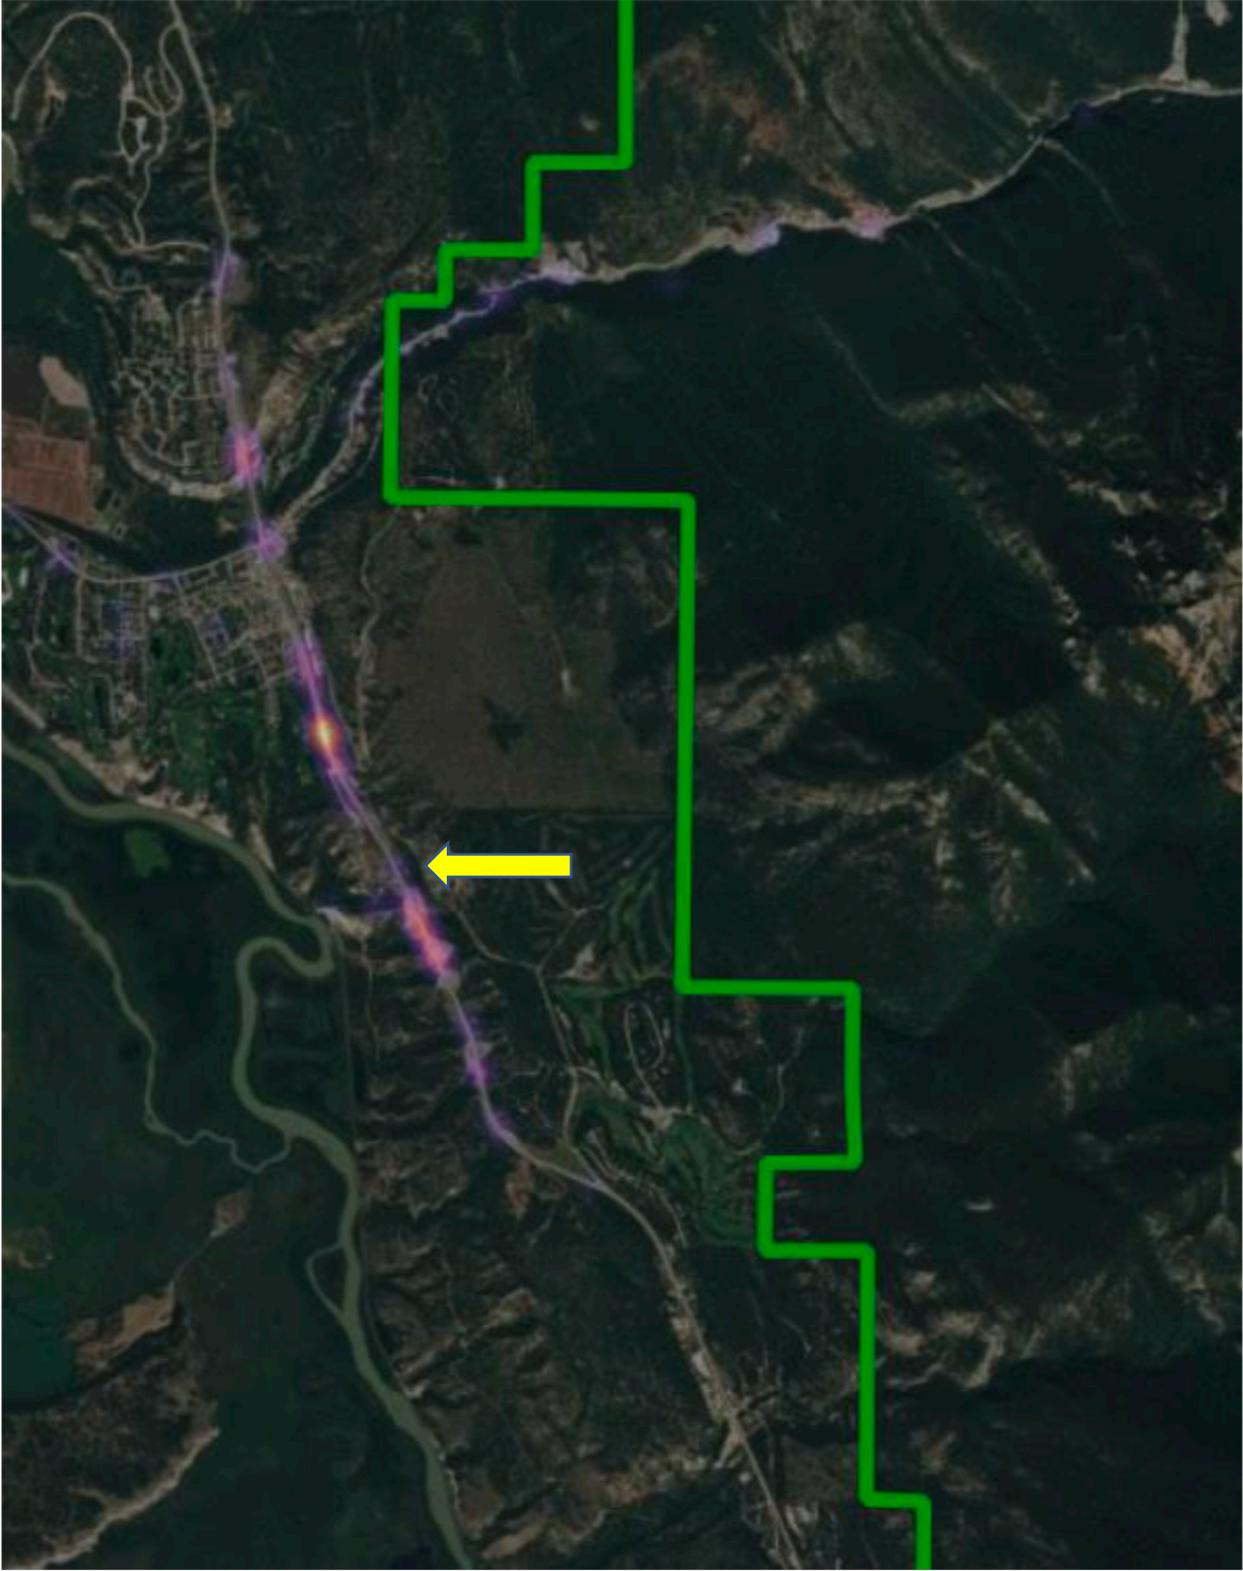
Figure 6. Location of bighorn sheep-vehicle collision clusters near proposed wildlife overpass (arrow) along Highway 93/95..

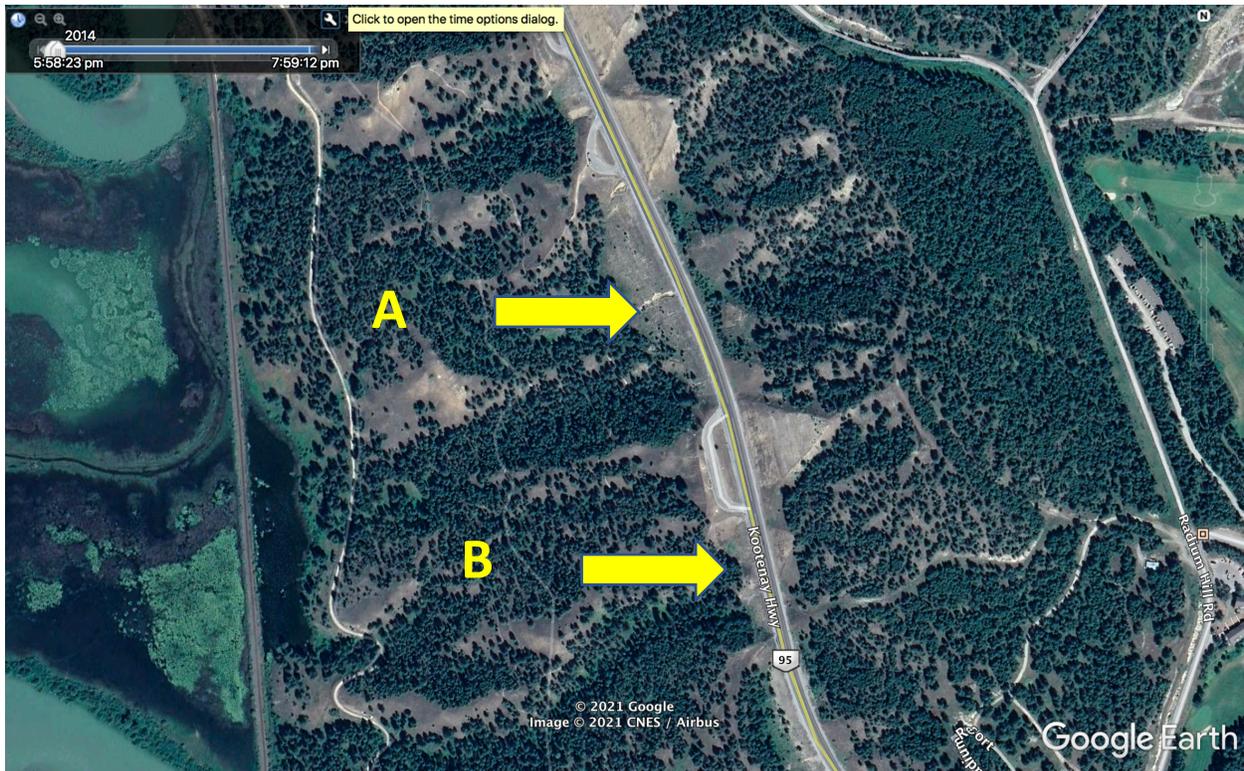
Figure 7. Location of proposed wildlife underpasses shown as option A and option B on Highway 93/95.

The location of the wildlife underpass is more flexible in placement. The underpass should not be in close proximity to the overpass, to allow for a greater area of permeability across Hwy 93/95. The two ravines (Sites A & B; Figure 7), consisting of fill material when constructing the highway, both at the south end of the project area, are suitable locations for a wildlife underpass. We recommend that the wildlife underpass be located at the southernmost ravine (Site B). Slopes and approaches are more suitable at this location compared to Site A, despite there being less fill at road profile.

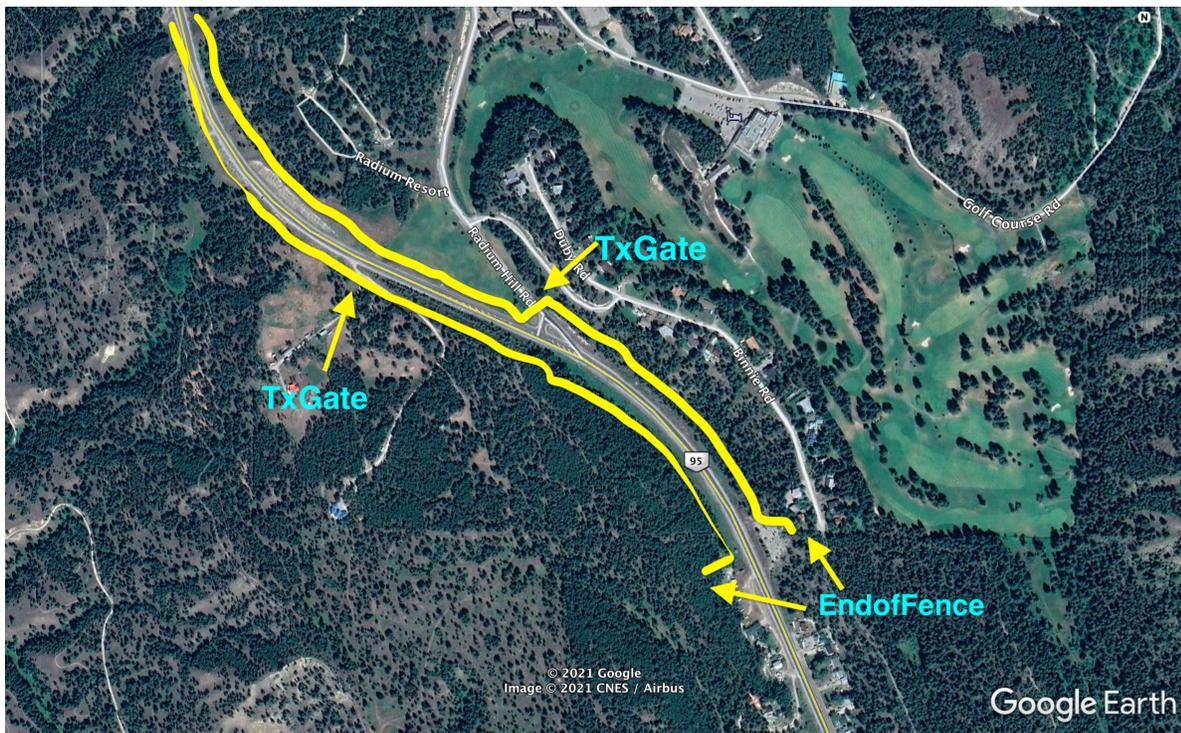
Fence end configuration at south end of project area near Dry Gulch. West fence should be as close to road edge as possible, with barrier (jersey, guardrail) between road edge and fence. East end of fence terminates at top of cut slope.

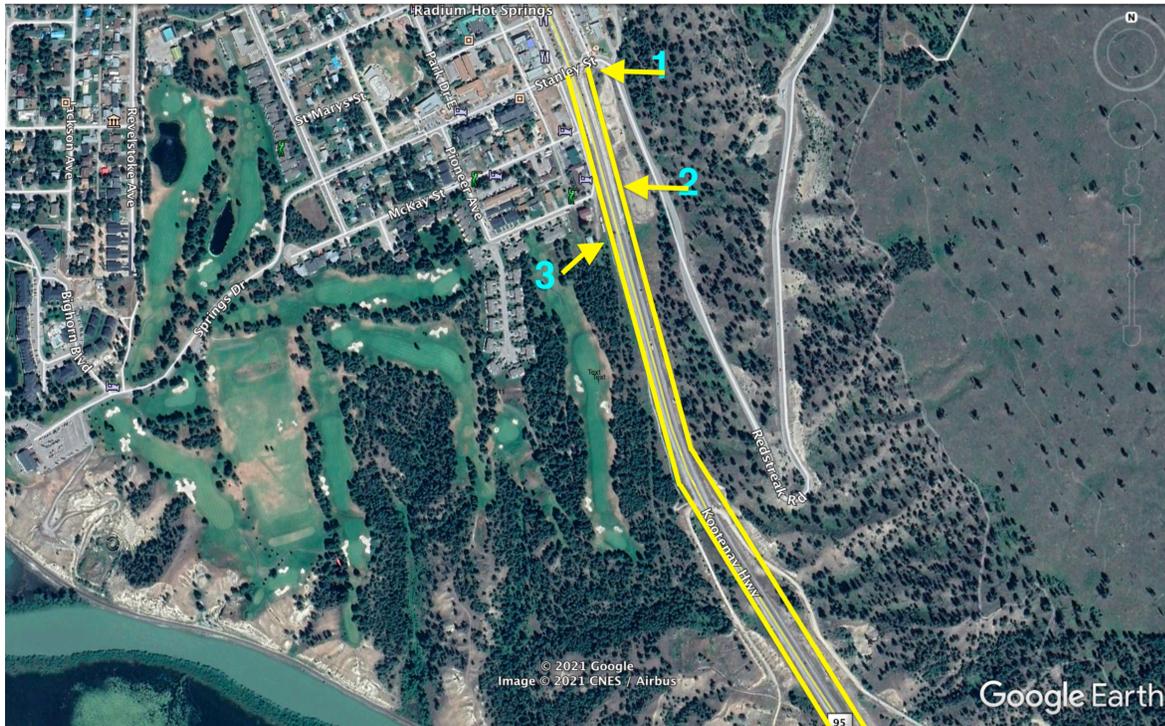
Fence end Alternatives 1, 2 and 3 as part of continuous fence along Highway 93/95. Electrified wildlife guard placed on highway at fence ends. Fence situated as close to highway edge as possible with barriers at road edge (guard rail or Jersey).

- 3) Recommend fence terminate approximately 150 m south of Alternative 2. The fence should not be staggered, and be as close to road as possible to reduce likelihood of animals walking in between fences in the right of way. This configuration also uses an electrified wildlife guard at the termination point.

- The reason for the preferred alternative 1 is that the further the fence goes into the urban area of Radium Hot Springs, the less likely there will be end runs by sheep. Sheep may funnel or continue to cross highway at fence termination points. However, reduced design speeds (see below) is proposed to reduce the probability of crashes. We recommend the speed reduction approach rather than animal-detection system at fence end because most detection system projects fail (technical, funding, management, political issues), and there are practical issues if there are access roads (false detections or gaps in coverage of the system).

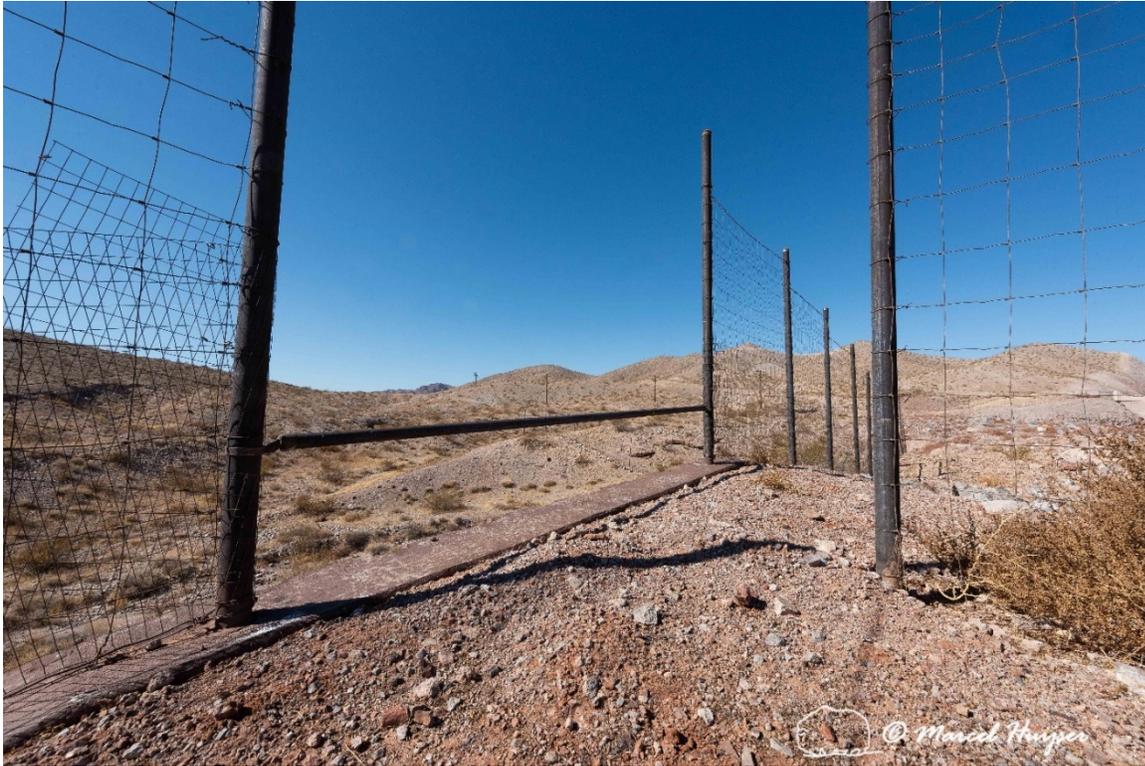
Recommended jump-out design with bar on top jump out.

Face of jump-out 2.1 - 2.4 m tall, add a bar 45-50cm above the top of the jump-out (Huijser et al., 2015; Gagnon et al., 2020). The bar reduces the likelihood that animals will jump up into the fenced road corridor. Animals on top of the jump-out can still take advantage of the relatively low height of the jump-out by stepping over the bar as they jump down. The face (wall) can be concrete or concrete blocks, but they should not allow for sheep to have edges or ridges which would allow them to climb the face; the face should be smooth without foot holds, or the face should be fenced off. The bar should be just inset from the face (see image in the case studies for BI-11, Nevada). Jump-outs should have similar number, on both sides of the highway, be located near fence ends and within the first 500 m from fence ends. They should be located in places where fence can be run further away from highway, preferably behind vegetative cover, in areas of reduced noise and disturbance from highway traffic. From these two locations associated with fence ends, jump-outs should be located approximately every kilometre along the project area. Jump-outs on opposite sides of the road do not have to be aligned, especially not if this would suggest to wildlife that they can leave the fenced road corridor on the other side before they jump up into the fenced road corridor. Designs and guidelines are found in Clevenger and Huijser (2011, Huijser et al. 2015). This aspect of project planning tends to occur at later stage and once fence alignment is confirmed, the location of jump-outs can be determined by site visit.

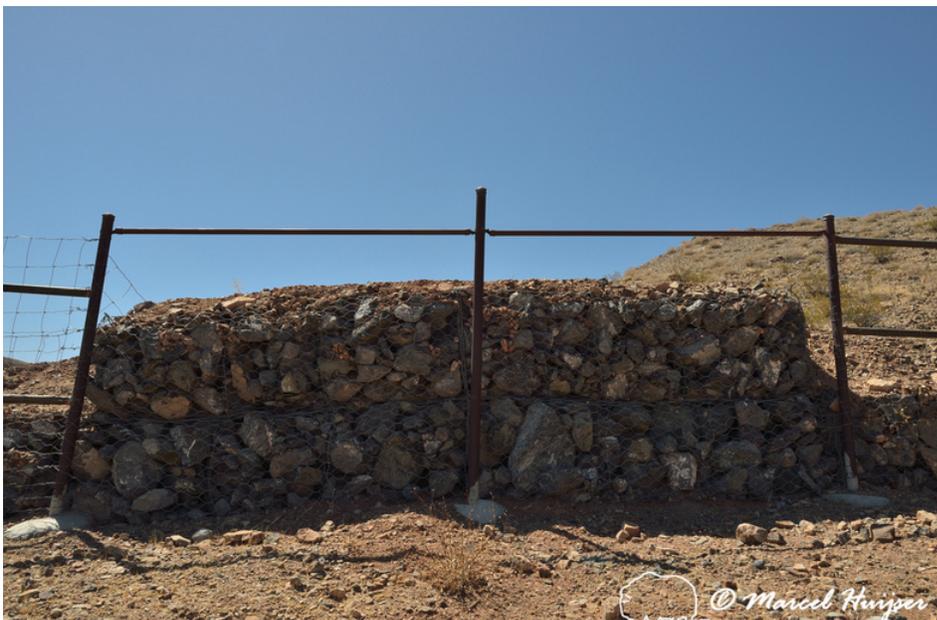
Recommended face for jump-out: Gabion baskets behind the wildlife fence. Bighorn sheep cannot put their hooves on the rocks to get into the fenced road corridor.

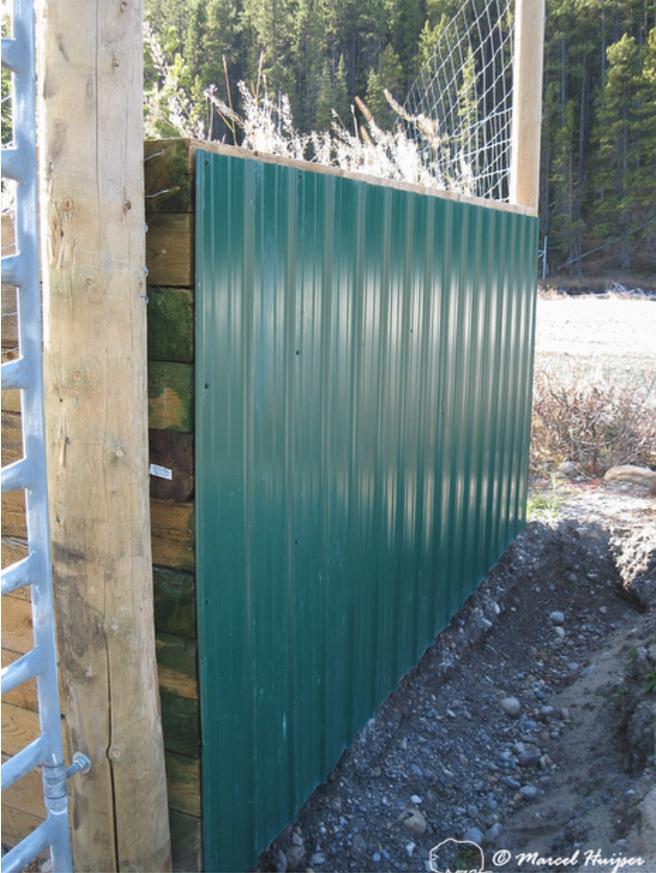
Recommended smooth face (metal sheet) for jump-outs so that bighorn sheep cannot step up on edges on the face.

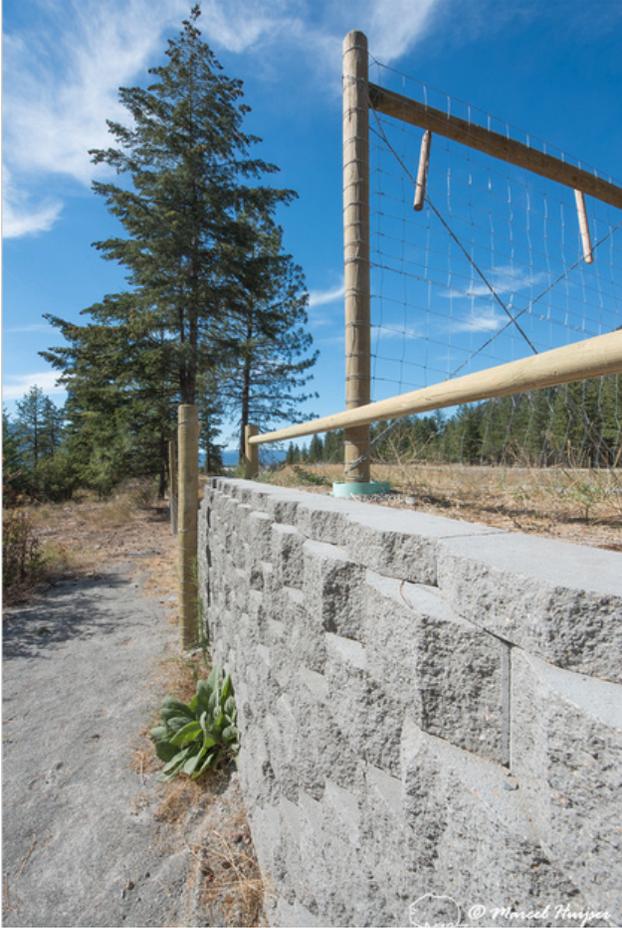
Not recommended: While the concept of concrete blocks is recommended for a jump-out, a design that allows for edges such as in the image above is NOT recommended. Sheep can place their hoofs on these edges helping them to gain access to the fenced road corridor.

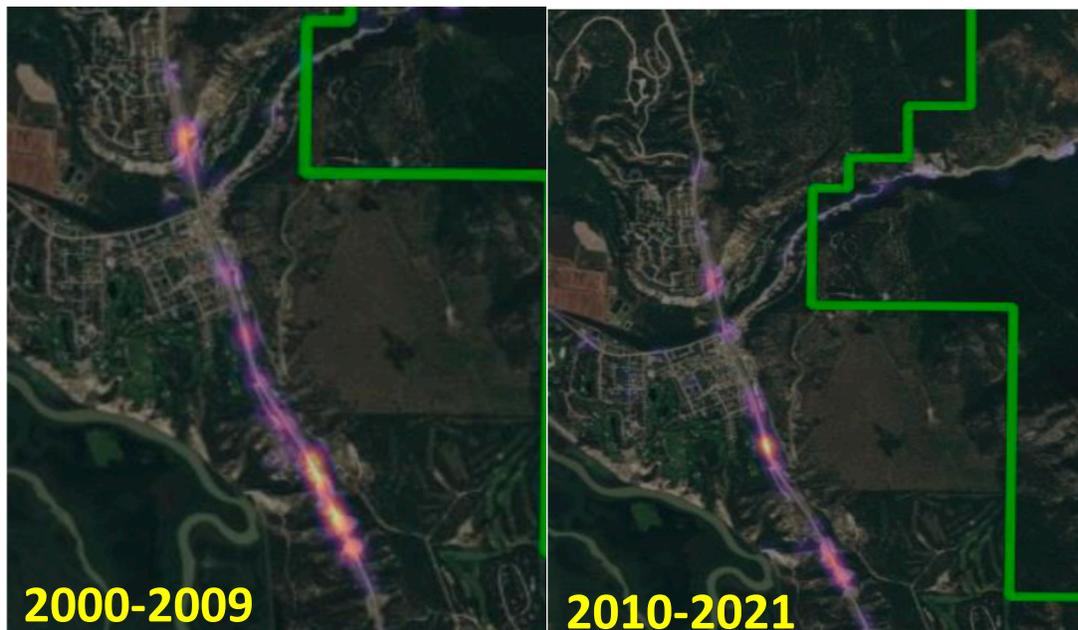
Figure 8. Bighorn sheep-vehicle collisions clusters in urban area during two periods: 2000-2009 and 2010-2021.
